Rehabilitate Pipelines With Minimal Downtime

More than one mile of a large-diameter pipeline was retrofitted to its original condition with minimal downtime and no excavation, underlining the versatility and effectiveness of fiber-reinforced polymer technology and the experience of the project team. **BY MO EHSANI AND CARLOS PEÑA**

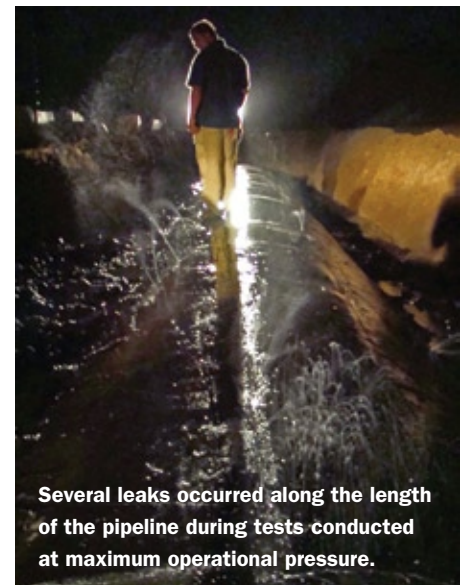
Several leaks occurred along the length of the pipeline during tests conducted at maximum operational pressure.

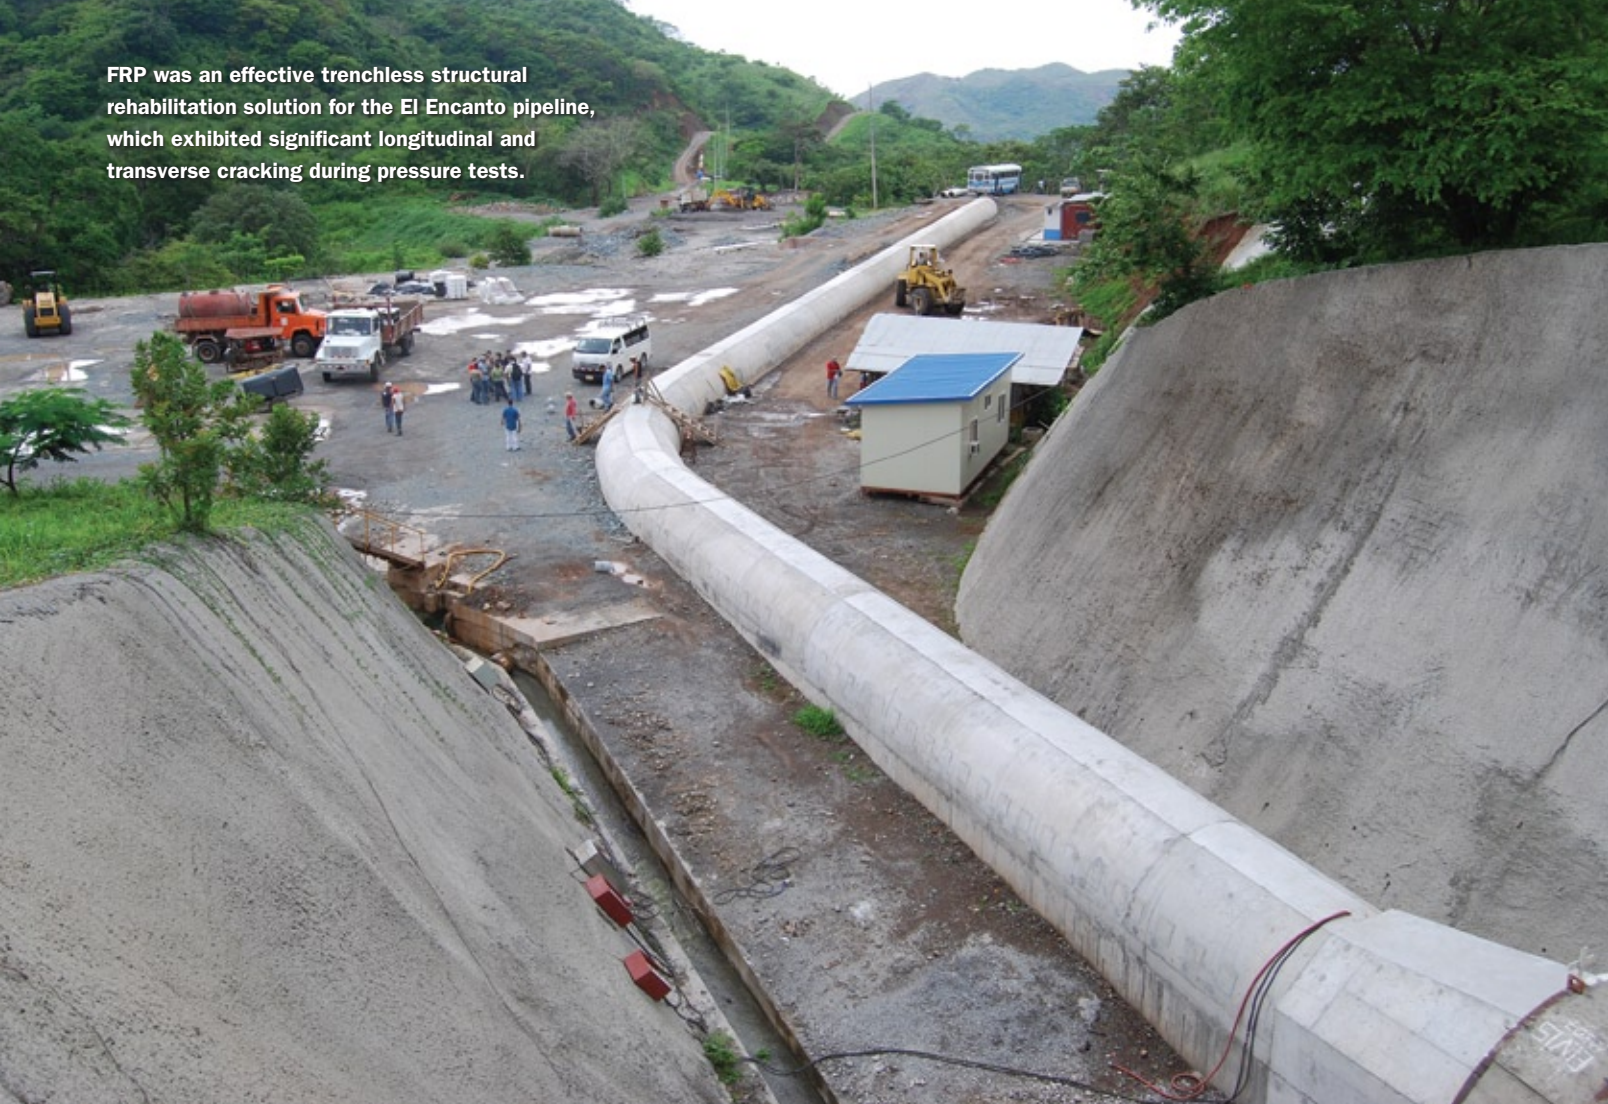
FRP was an effective trenchless structural rehabilitation solution for the El Encanto pipeline, which exhibited significant longitudinal and transverse cracking during pressure tests.

Although the structural design had properly addressed the pipeline's strength requirements and accounted for design pressure and hydrodynamic loads, the pipeline's serviceability requirements were overlooked. During a pressurized test, the pipeline exhibited significant longitudinal

and transverse cracking, which caused leaks that accounted for as much as 20 percent of lost flow.

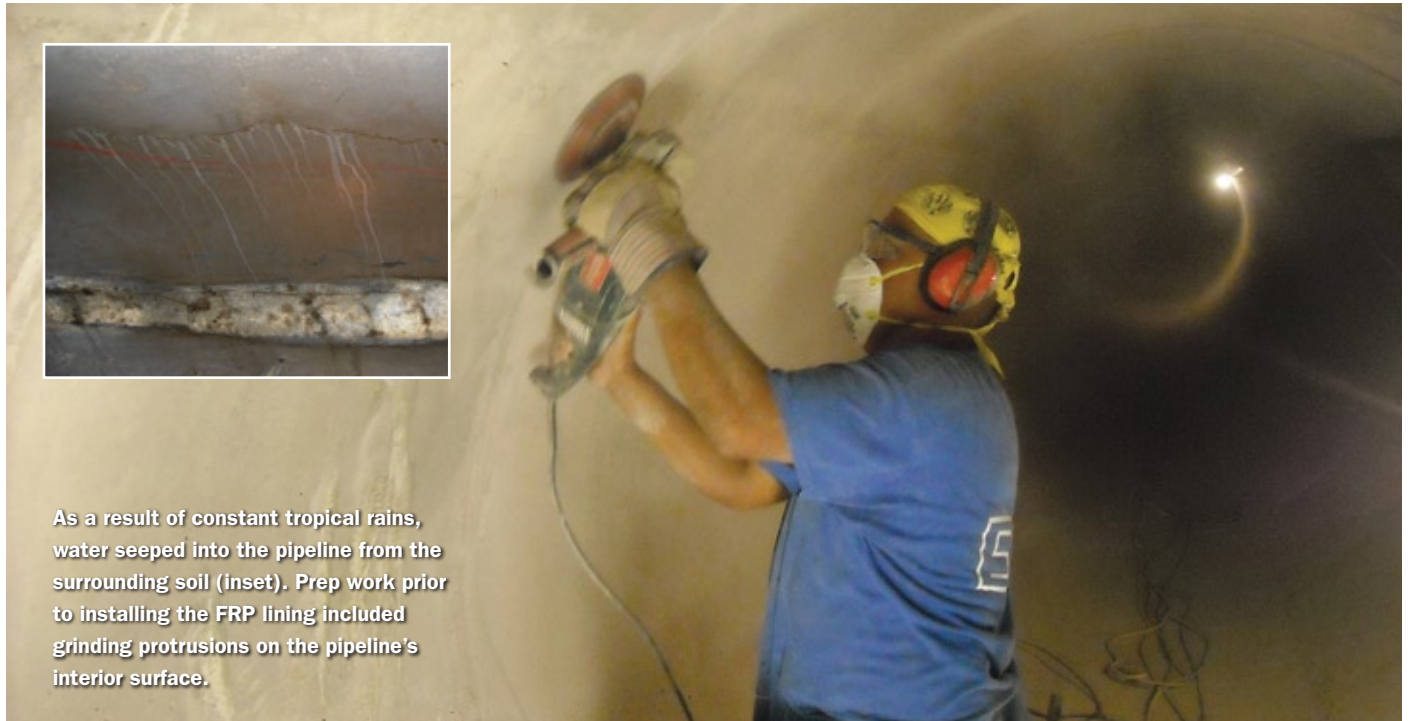
tropical rains. Because most of the pipeline is underground, water draining down the mountainside keeps the surrounding soil saturated, which generates seepage pressures. With the pipeline empty, seepage water was observed to drain through some of the longitudinal cracks.

As a result of constant tropical rains, water seeped into the pipeline from the surrounding soil (inset). Prep work prior to installing the FRP lining included grinding protrusions on the pipeline's interior surface.

the cast-in-place construction process caused significantly more surface irregularities than those associated with more traditional precast pipes. Evidence of cast-in-place procedures, such as construction joints, formwork fins, etc., was visible in the pipeline. The pipeline was pressure washed with 7,000 psi machines to remove any scour, sediment, curing compounds, and any other substance that could hinder the bond between the FRP and the pipe surface.

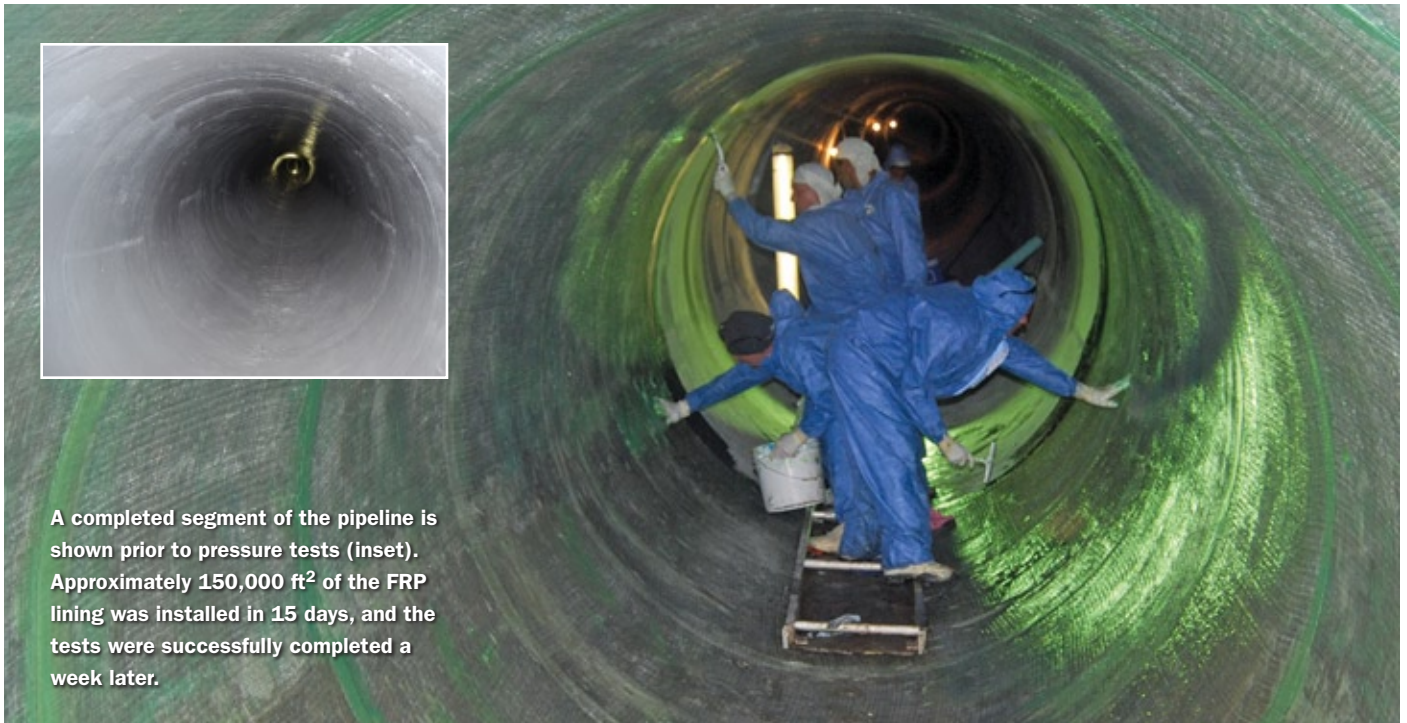
A completed segment of the pipeline is shown prior to pressure tests (inset). Approximately 150,000 ft² of the FRP lining was installed in 15 days, and the tests were successfully completed a week later.

The average production rate of each of the four installation stations was 2,500 ft² of FRP lining installed in an average eight-hour workday. The operation continued seven days a week, and complete installation of the approximately 150,000 ft² of FRP lining system was accomplished in 15 days. This included applying the epoxy top coat. To ensure maximum bond, the application took place before the lining was fully cured—i.e., the surface was still tacky on contact.

The FRP lining installation was completed July 8, 2009, and pressurized test runs were successfully completed on July 15. More than one mile of a 7-ft-diameter pipeline was successfully retrofitted to its original condition in three weeks (one week of prep work and two weeks of FRP lining installation). The FRP lining is expected to require no maintenance and to have a useful life that will at least match the pipeline's operational lifetime.
