Breathing New Life into Old Water Pipelines: Renewal Case Studies in the Southeast U.S.

Author: Tim Ball
Jacobs Engineering Group Inc.
Tim.ball@jacobs.com

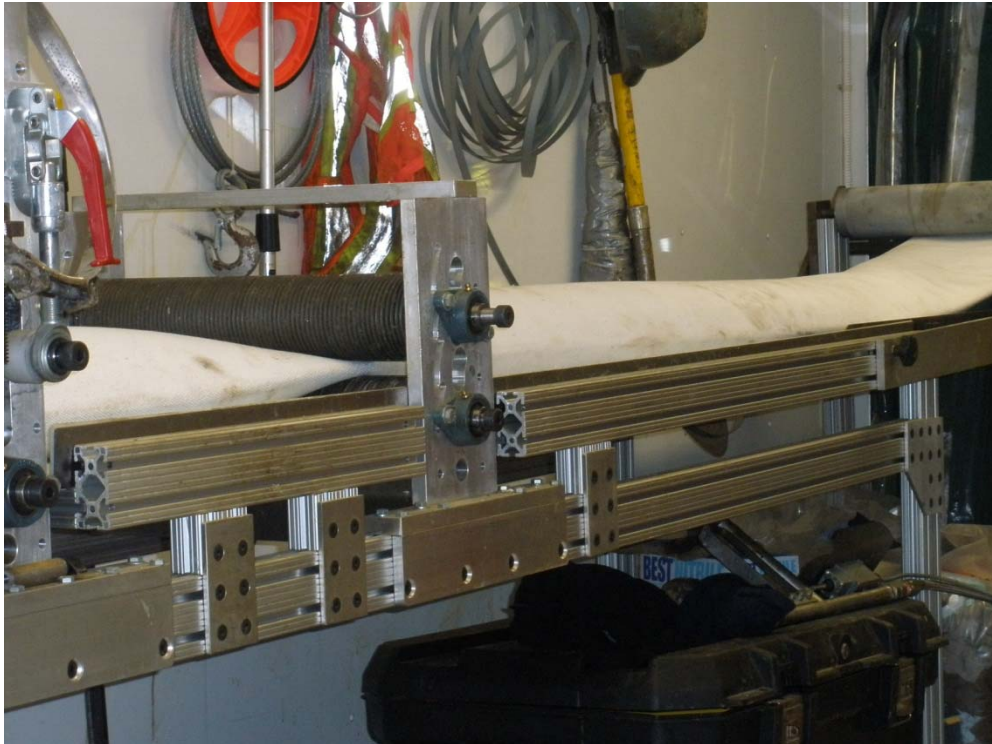
Figure 1: Tube filled with epoxy resin, roller system

Installation of the lining is a pull-in process rather than an inversion process. That is, the tube is pulled through the pipe with a winch rather than being inverted with a column of water. The tube consists of two distinct layers of woven fabric, one inside the other. An ambient cure epoxy resin is injected between the fabric layers and evenly distributed by a pair of rollers, *Figure 1*. The inner most layer is coated with a water proof polymeric membrane to prevent the uncured epoxy from flowing through the inner fabric layer.

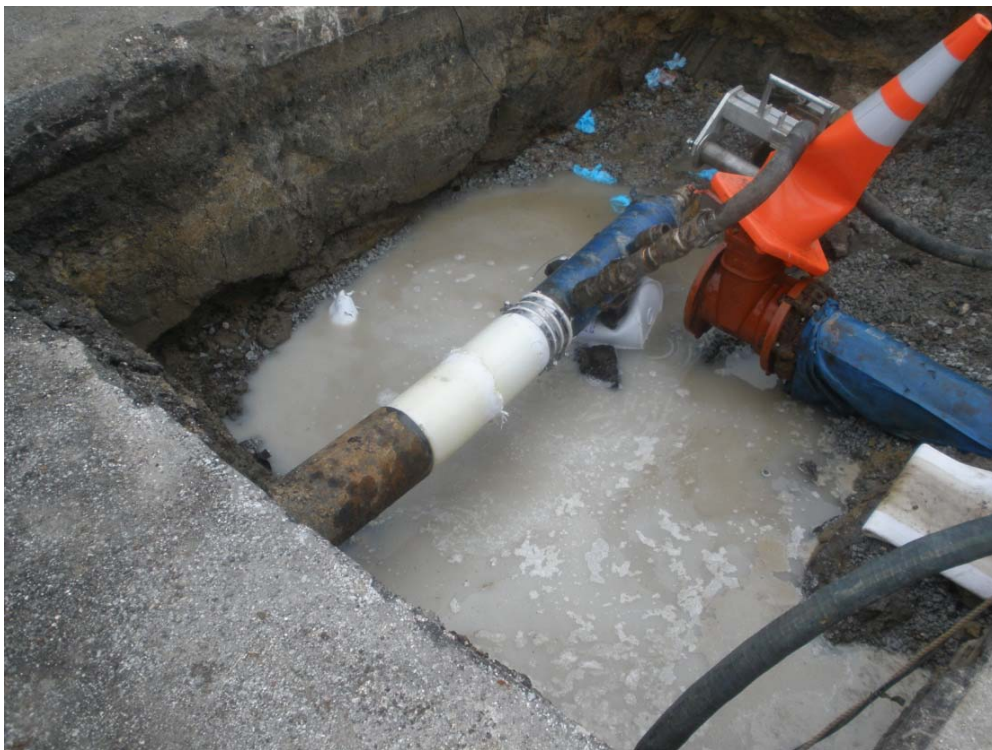
Figure 2: Rounded Aqua-Pipe® after swab pass into receiving "cannon"

Once the tube is pulled through the host pipe the inner liner only is stretched at 3,000-lbs to insure there is no excess material inside the pipe that could cause undue wrinkling. At this stage the pig, or swab, launching and receiving “cannons” are attached to the free ends of the liner. The foam pigs, which are double the diameter of the host pipe, are launched using water. As these foam pigs traverse the tube the Aqua-Pipe® liner is pressed against the inside wall of the host pipeline, *Figure 2*. The epoxy resin is forced into the fabric layers fully saturating both.

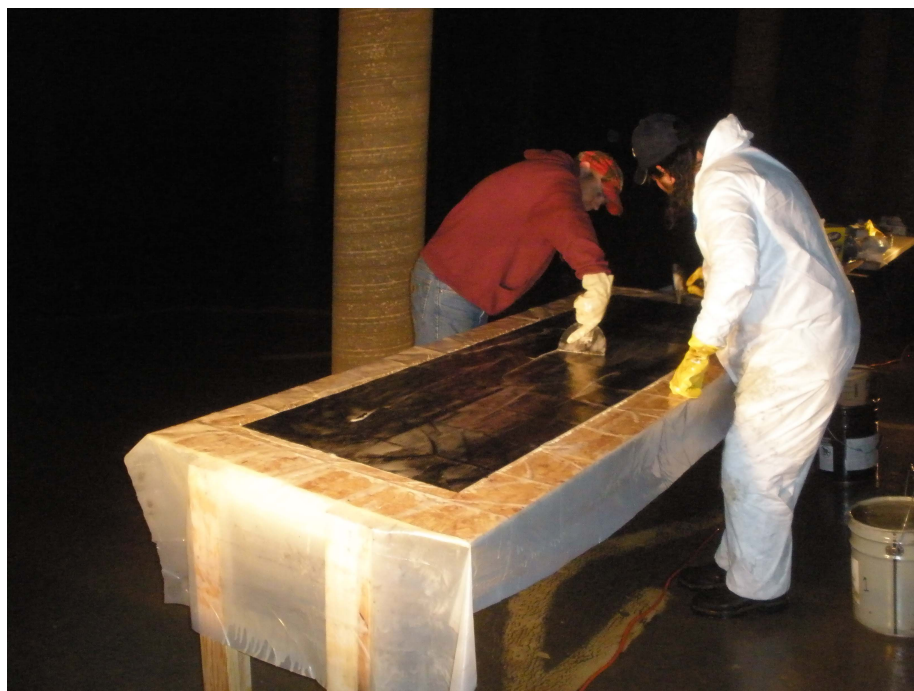
Figure 3: Wetout of carbon fiber textile

The raw material was supplied in rolls of 2-foot width. The carbon fiber textile was cut to length to allow for approximately 6-inch of overlap of each piece. Each piece was then 'wet out', *Figure 3*, with epoxy and folded in half longitudinally creating a double layered, 1-foot wide strip. The carbon fiber material was applied circumferentially in overlapping segments. The strips were applied to the pipe wall, overlapping approximately 1-inch circumferentially. Once the first application had dried sufficiently a second double layer was applied. Due to the degree of degradation in one of the pipe segments, longitudinal strips were also applied to this joint, *Figure 4*. The longitudinal material was applied at the crown, springline (both sides), and the flowline. The longitudinal strips were installed between the two circumferential applications. The limits of the lining included the entire length (20-feet) of each joint plus an additional 1-linear foot past the bell and spigot end of each.

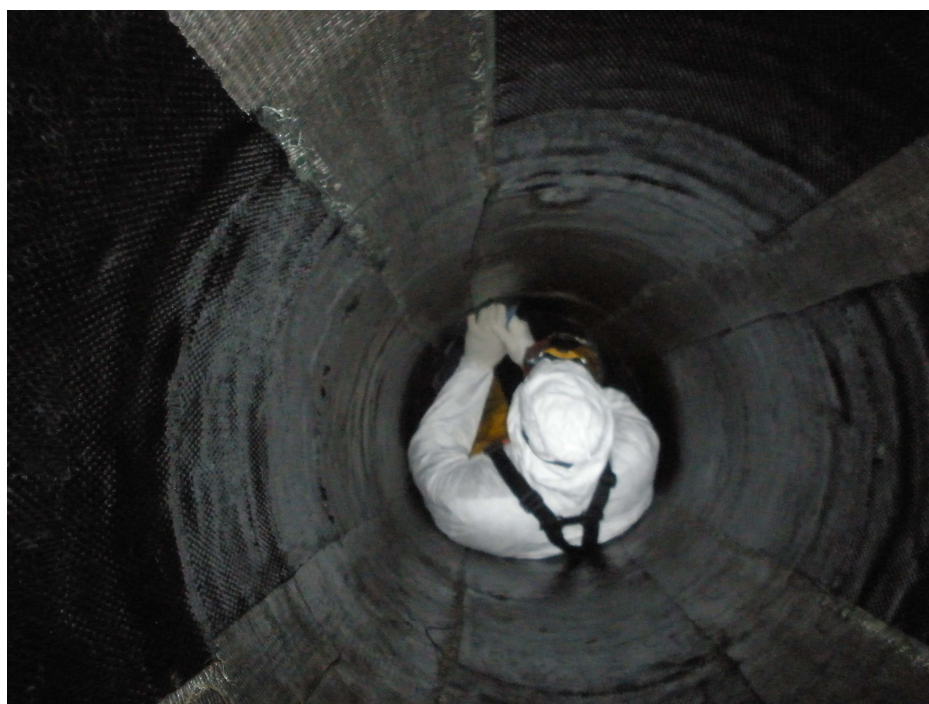
Figure 4: Installation of longitudinal ribs

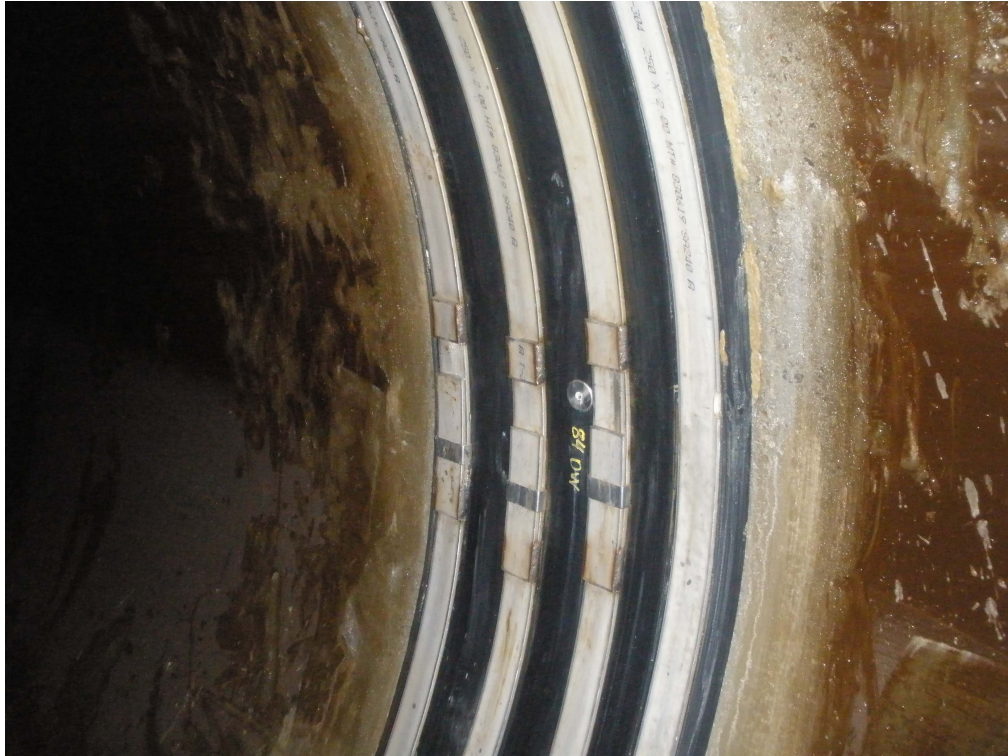
Cobb County Marietta Water Authority operates a 105-million gallon per day water treatment plant north of Atlanta, Georgia. The discovery of fluoridated water in the ground water underdrain system was the initial indication of a potential leak at the Plant. During unrelated construction, excessive amounts of ground water was encountered leading the utility to suspect they may have a breach in one of the large diameter pipeline on site. A man-entry inspection of an 84-inch prestressed concrete cylinder pipe (PCCP) revealed a circumferential break in the pipe near a bell and spigot joint. The failure was widest at the pipe's crown and ran to the springline on both sides. The proximity of the crack led the inspectors to suspect the weld at the bell ring had failed.

Figure5: 84-inch diameter WEKO-SEAL®

In this installation an extra wide seal was used. It was held in place with 4-individual stainless steel bands, *Figure 5*. The installation process routine is fairly simple and consists of the following procedure:

- the joint or crack is pack with hydraulic cement to eliminate voids behind the rubber seal
- the pipe wall is coated thoroughly with a food grade lubricant
- the seal is centered over the joint or crack
- the stainless steel bands are jacked into place on either side of the seal
- an air test is performed to assure a tight seal between the pipe wall and the rubber seal
