Nashville, TN
March 11-15, 2012

Paper B-4-02

Rehabilitating High-Temperature Aeration Piping at a Wastewater Treatment Plant – Challenges Faced and Lessons Learned

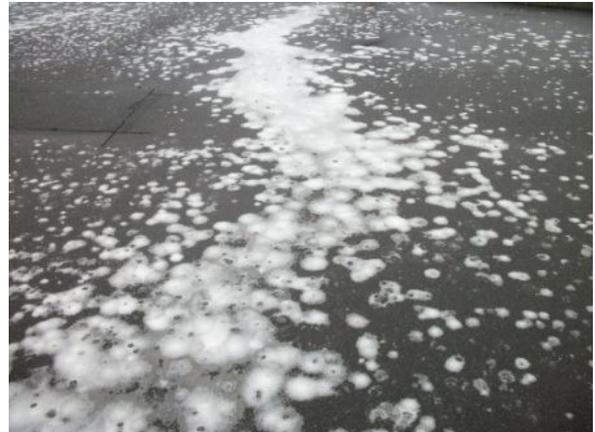
The piping from the blower building to the flood control bridge was installed in 1980. The piping between the flood control channel bridge and the aeration basins was installed in 1979. Since the system was installed, indications of air leakage, evidenced in the form of air bubbles on the pavement during rain events, have been observed as shown in Figure 1.

Figure 1. Air bubbles escaping from the pipe

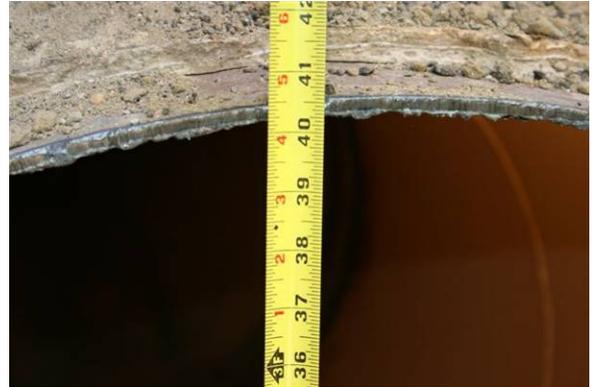
Because the 42-inch diameter air pipe was such a critical component to EWA's secondary treatment process, it was impossible to take the pipeline out of service for inspection prior to the start of construction. When the cross connection was completed and the air pipe was finally decommissioned, access pits were dug and the pipe was exposed for inspection. At that time, it was determined that the steel pipe was in the early stages of failure. The pipe was out of round by approximately

10% smaller than its original diameter in the vertical direction and now appeared to be an oval.

Figure 8. The host pipe was out of round.

- Jacks were placed intermittently within the pipe so as to tack the crown of the pipe up until sliplining operations commenced. This was to prevent any further collapse of the pipe crown.
- Protrusions were ground down at the existing pipe joints.
- Grinding was completed along the existing steel spiral weld to provide as smooth of an internal surface as possible.
- Pipe lubricant was introduced in order to reduce any friction along the sliplining pipe surface as it was jacked into the host pipe.
- An alternate annular space grout mix was proposed and accepted. The alternate grout mix was designed as a thinner mix with better flow capabilities in order to successfully migrate through the tighter annular space.

Despite a tight fit and some initial difficulties during installation, the pipe went in relatively smoothly and was grouted successfully in place.

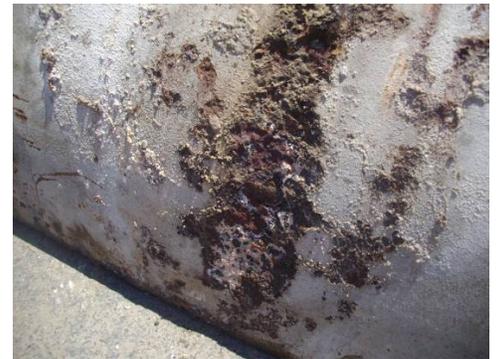
Figure 9. The host pipe was corroded.

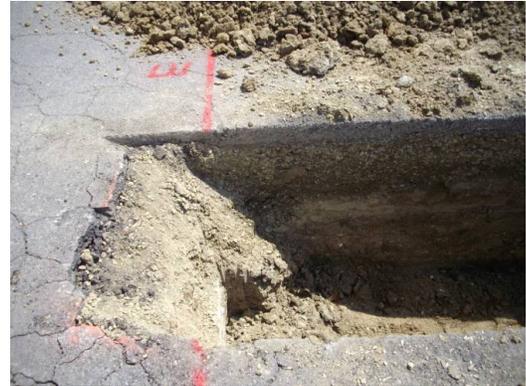
- Results of potholing during construction showed that the air pipe alignment, fittings, and appurtenance locations in field differed from those shown on plant records.
- Several utilities/facilities were found to be crossing air piping and were not shown on plant records.

Figure 10. Electrical line crossing the air pipe.

- Access pits were relocated in order to avoid existing utilities.
- The contractor developed a method to temporarily plug leaks in the 24-inch pipe to allow the 42-inch pipe lining to proceed. A separate project was earmarked for future rehabilitation/replacement of the 24-inch parallel agitation air line.
