## Internal PCCP Force Main Deterioration – Analysis and Rehabilitation

### Abstract

This paper presents a case study of a Prestressed Concrete Cylinder Pipe (PCCP) system that is experiencing deterioration and a failure resulting from internal corrosion. The corrosion mechanism is Sulfuric Acid attack due to Hydrogen Sulfide gas (H<sub>2</sub>S) generated from the wastewater. The PCCP pipeline is located in Regina, Saskatchewan, Canada and was constructed in 1979. The nominal inside diameter is 1350 mm (54") and the pipeline was designed as a sewage force main. In 1999, approximately 75 m (246 feet) of the pipe failed and was replaced with HDPE pipe. In 2008, an internal inspection was conducted downstream of the failed section. The inspection was conducted using man entry and by close circuit television (CCTV). The inspection found five (5) pipe sections under severe corrosion attack where the interior concrete surfaces near the crown of the pipe had deteriorated exposing the reinforcing. Another nine (9) sections also showed early signs of H<sub>2</sub>S attack.

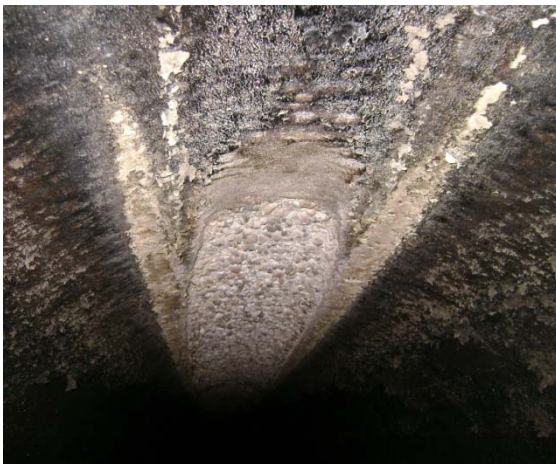
- The concrete surfaces along the pipe invert and below the flow line were in good condition. The surfaces were very hard and dense as indicated by the sounding with a hammer.
- Five (5) pipe sections showed surface corrosion of the concrete surface and exposed aggregates. As shown in Figure 2, the corrosion is concentrated along the crown of the pipe between the one o'clock and eleven o'clock positions. At some locations, the steel cylinder is exposed. The joints between these five (5) pipe sections also showed distress. Extensive concrete spalling and corrosion of the exposed steel bell and spigot rings were also observed. This is shown in Figure 3.
- Nine (9) pipe sections showed early signs of corrosion at the crown of the pipe. This is shown in Figure 4.
- There was extensive sand and gravel debris along the pipe invert.
- The remaining pipe sections were in good condition.

The inspection showed one specific section of the force main experiencing severe distress while the remaining pipe section was in relatively good condition, typical of a 30 year old pipe. It was also obvious that the corrosion defects were caused by  $H_2S/H_2SO_4$  corrosion along the crown of the pipe. The corroded areas were above the flow line and the corroded areas got progressively larger in the upstream direction.

**Figure 2. Surface Corrosion and exposed aggregates.**

- Replacement of eight (8) PCCP pipe sections with HDPE pipe material
- Cleaning and removal of debris downstream of the pipe replacement section
- Installation of a barrier coating on the crown of the pipe between one o'clock and eleven o'clock position on nine (9) sections of pipe.

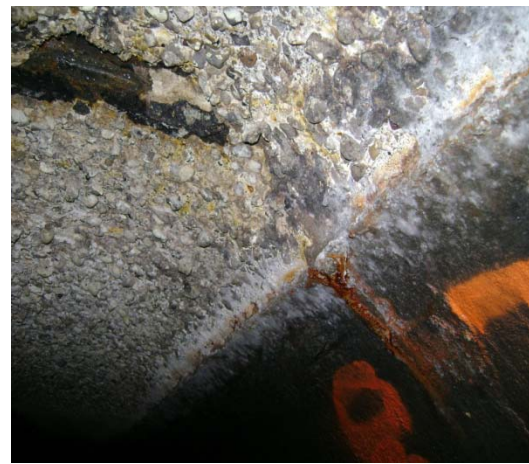
**Figure 3. Spalling and exposed bell and spigot ring.**

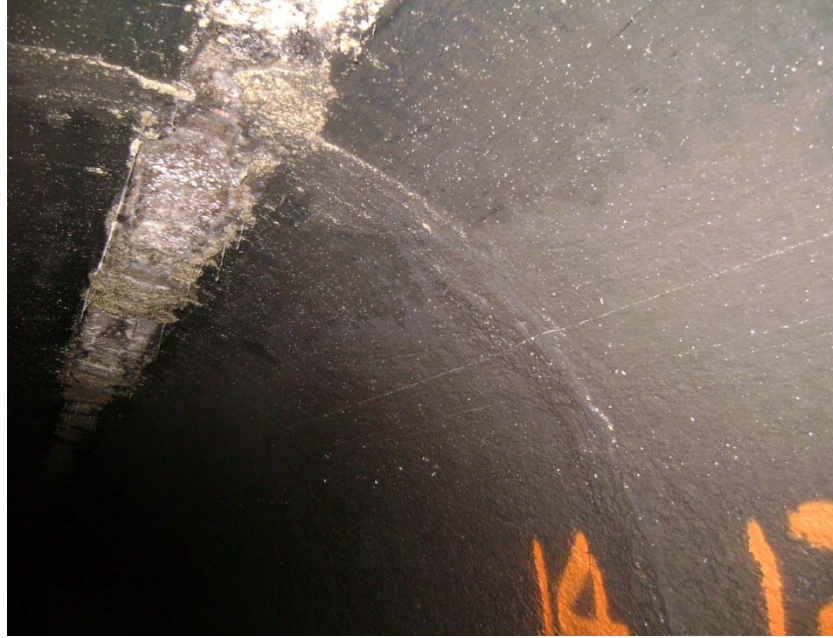
**Figure 4. Early stages of corrosion at crown of pipe.**
