Large Diameter Watermain Condition Assessment and Evaluation

Troy. L. Bowers¹, P.E., Jeffrey S. Jones², P.E., and Tamara S. Connolly³, P.E.

Abstract

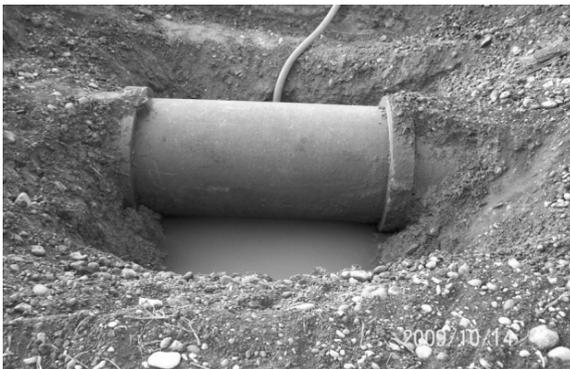
Figure 2 – Concrete Pipe Segment

A sample of concrete pipe from an abandoned portion of Line 1 was cut and removed for inspection. What was initially presumed to be a pipe material similar to concrete cylinder pipe, was in fact found to be reinforced concrete "pressure" pipe. The reinforced pipe wall is approximately 5 inches thick with 1/4-inch diameter steel hoop reinforcement. The pipe joints, located approximately 8-feet on center as shown in Figure 2, were filled with grout and encased with 4-inch thick steel reinforced concrete collars. Figure 3 shows a section view of the concrete pipe joint, which appears to have factory installed collars (top piece) on one end of each pipe, such that a "bell end" (bottom left piece) was fashioned which would then fit over the "spigot end" (bottom right piece) of the adjoining pipe. What is assumed to be factory applied grout is the darker colored grout on the left side of the joint. The concrete reinforcing was colored black on the sample for contrast. Over the past several decades, leaks have been detected and repaired using stainless steel bands at several locations along the concrete portions of the 36-inch pipe. From the exterior, the pipe collars were observed to be in overall good condition. Leaks in the concrete pipe appear to be caused by failing grout seals at the pipe joints. Grout failure is believed to be exacerbated by road and railroad vibrations and settlement.

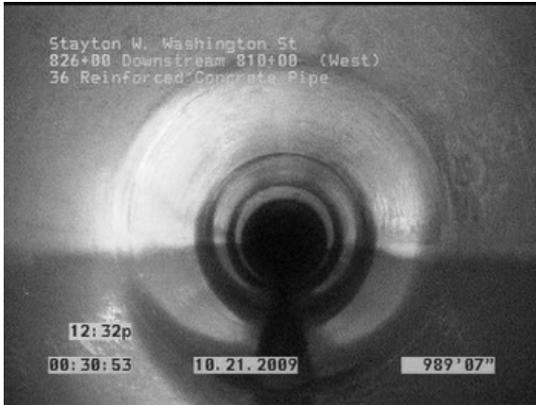
Figure 4 - Concrete Joint Seepage

Figures 4 and 5 below are photos taken inside the 36-inch pipe. Figure 4 shows a portion of the concrete pipe. Damp areas can be seen at each pipe joint from groundwater infiltration. Figure 5 is a typical photo of the steel pipe interior surface. Spots of corrosion and blistered lining are evenly distributed throughout the pipe wall, with a few larger patches evident.

Though the concrete pipe appeared overall to be structurally in good condition, the pipe joints, in most cases, were observed from the pipe interior to be in poor condition. Joints had cracked and failing grout, and in some cases, water was observed infiltrating into the drained pipe during video inspection. A review of all pipeline information collected to date showed a strong correlation between leaking concrete pipe joints and roadway and railroad crossings. Grout failure in the concrete pipe joints at these locations is likely caused by minor ground settlement over time and larger live and impact loads.

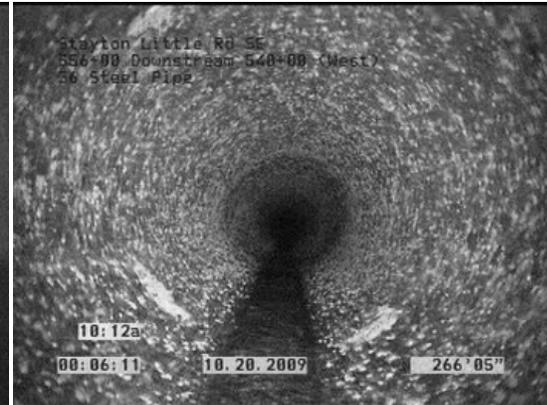
Figure 5 – Typical Steel Pipe Interior

The steel pipe exterior appeared to be in good condition. The pipeline exterior coal tar coating system overall appeared to be intact, with a few exceptions of minor damage caused by tree roots, irrigation piping, or previous excavation damage. The video inspection showed the steel pipe interior surface to have moderate to extensive corrosion occurring due to partial or, in some cases, complete lining failure.
