Large Diameter Watermain Condition Assessment and Evaluation

Troy. L. Bowers¹, P.E., Jeffrey S. Jones², P.E., and Tamara S. Connolly³, P.E.

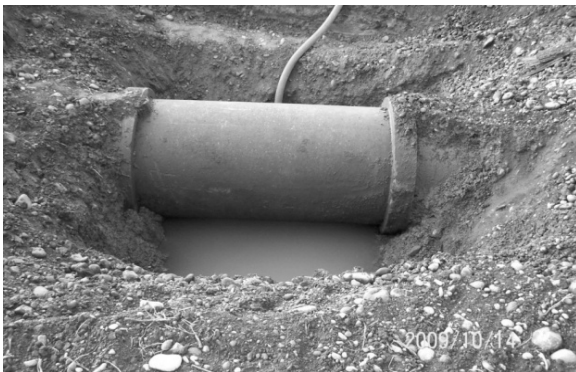
A sample of concrete pipe from an abandoned portion of Line 1 was cut and removed for inspection. What was initially presumed to be a pipe material similar to concrete cylinder pipe, was in fact found to be reinforced concrete "pressure" pipe. The reinforced pipe wall is approximately 5 inches thick with 1/4-inch diameter steel hoop reinforcement. The pipe joints, located approximately 8-feet on center as shown in Figure 2, were filled with grout and encased with 4-inch thick steel reinforced concrete collars. Figure 3 shows a section view of the concrete pipe joint, which appears to have factory installed collars (top piece) on one end of each pipe, such that a "bell end" (bottom left piece) was fashioned which would then fit over the "spigot end" (bottom right piece) of the adjoining pipe. What is assumed to be factory applied grout is the darker colored grout on the left side of the joint. The concrete reinforcing was colored black on the sample for contrast. Over the past several decades, leaks have been detected and repaired using stainless steel bands at several locations along the concrete portions of the 36-inch pipe. From the exterior, the pipe collars were observed to be in overall good condition. Leaks in the concrete pipe appear to be caused by failing grout seals at the pipe joints. Grout failure is believed to be exacerbated by road and railroad vibrations and settlement.

Figure 2 – Concrete Pipe Segment

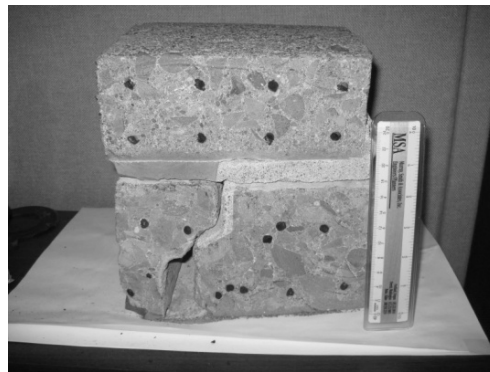
Figure 3 – Concrete Pipe Joint Section

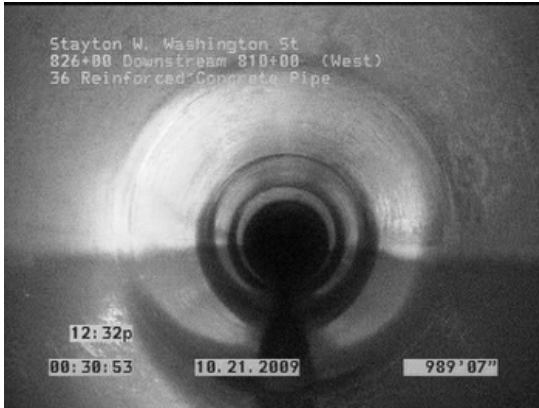
Figures 4 and 5 below are photos taken inside the 36-inch pipe. Figure 4 shows a portion of the concrete pipe. Damp areas can be seen at each pipe joint from groundwater infiltration. Figure 5 is a typical photo of the steel pipe interior surface. Spots of corrosion and blistered lining are evenly distributed throughout the pipe wall, with a few larger patches evident.

Figure 4 - Concrete Joint Seepage

Though the concrete pipe appeared overall to be structurally in good condition, the pipe joints, in most cases, were observed from the pipe interior to be in poor condition. Joints had cracked and failing grout, and in some cases, water was observed infiltrating into the drained pipe during video inspection. A review of all pipeline information collected to date showed a strong correlation between leaking concrete pipe joints and roadway and railroad crossings. Grout failure in the concrete pipe joints at these locations is likely caused by minor ground settlement over time and larger live and impact loads.

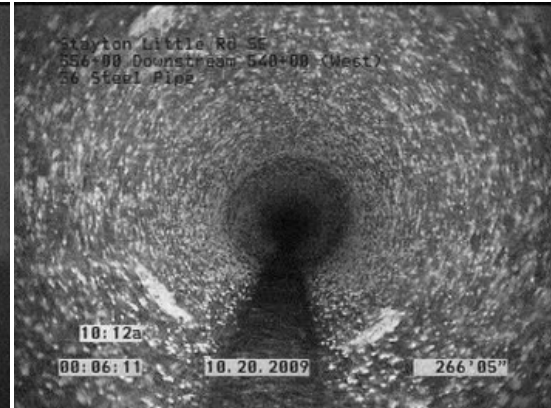
Figure 5 – Typical Steel Pipe Interior

The steel pipe exterior appeared to be in good condition. The pipeline exterior coal tar coating system overall appeared to be intact, with a few exceptions of minor damage caused by tree roots, irrigation piping, or previous excavation damage. The video inspection showed the steel pipe interior surface to have moderate to extensive corrosion occurring due to partial or, in some cases, complete lining failure.
