Observations from Several Condition Assessments of Prestressed Concrete Cylinder Pipe used at Energy Generation Facilities

Todd Stong PE¹, Ron R. Jorgenson², and Jacob Sauer³

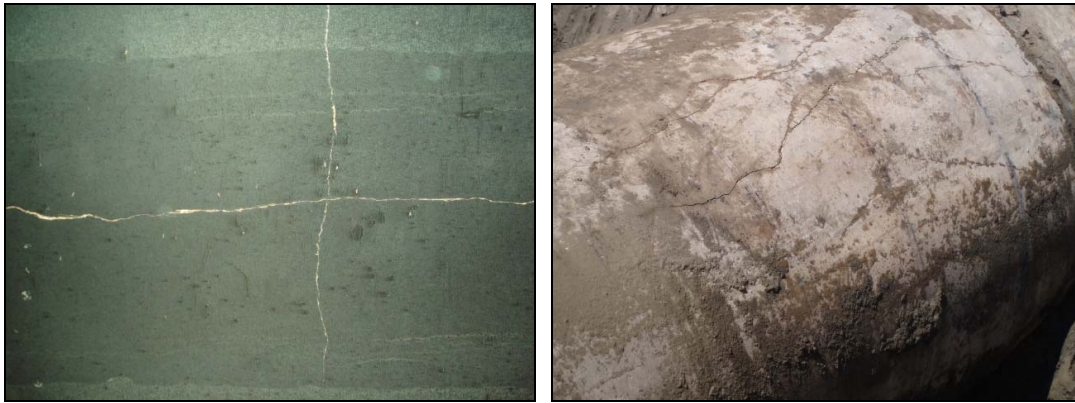
The physical evaluation found the supply line to be in good condition with limited visual signs of distress and only three of 53 pipes identified with potential wire breaks (all with less than 50 estimated wire breaks). Portions of the return line however were found to be in poor condition with three pipes having internal and external longitudinal cracking and hollows (Figure 2), and 38 of 102 pipes identified with potential wire breaks with up to 230 wire breaks estimated in a single pipe section. The majority of this distress was identified in a 1,000 foot section of the return line adjacent to the cooling towers.

Figure 2 - Longitudinal cracks on pipe R329 (internal and external)

- Installation of emergency repairs on three pipe sections consisting of external steel bands (Figure 4);
- Implementation of plant controls to limit pressure surges within the system;
- Development of an emergency repair plan including purchase of emergency repair sections;

- Future physical evaluation on a 5-year interval; and
- Repair or replacement of the 1,000 foot section of the return line.

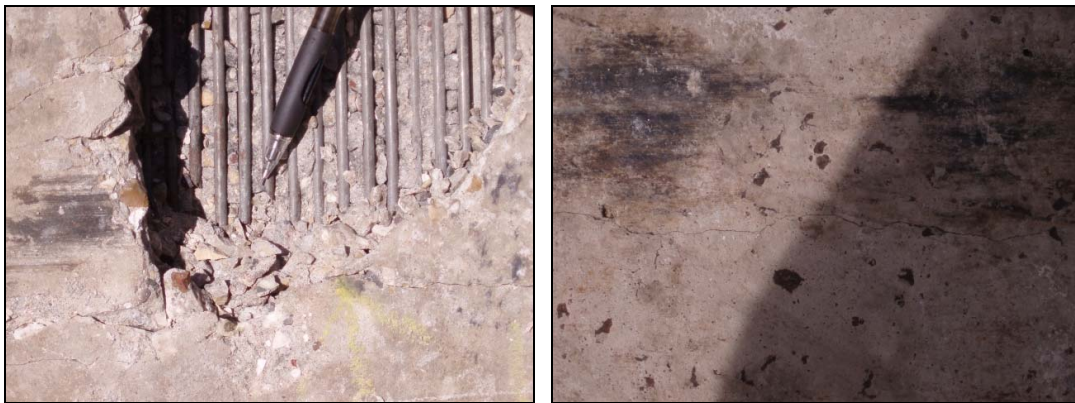
Observations of the prestressing wires in the distressed pipes identified clean wire breaks with limited signs of corrosion or necking (Figure 3). This brittle type failure suggests that hydrogen embrittlement of the prestressing wires has occurred due to the significant stray currents in the vicinity of the cooling towers and the higher risk of embrittlement associated with the Class IV wire used.

Figure 3- Broken prestressing wires and external longitudinal crack on pipe R332

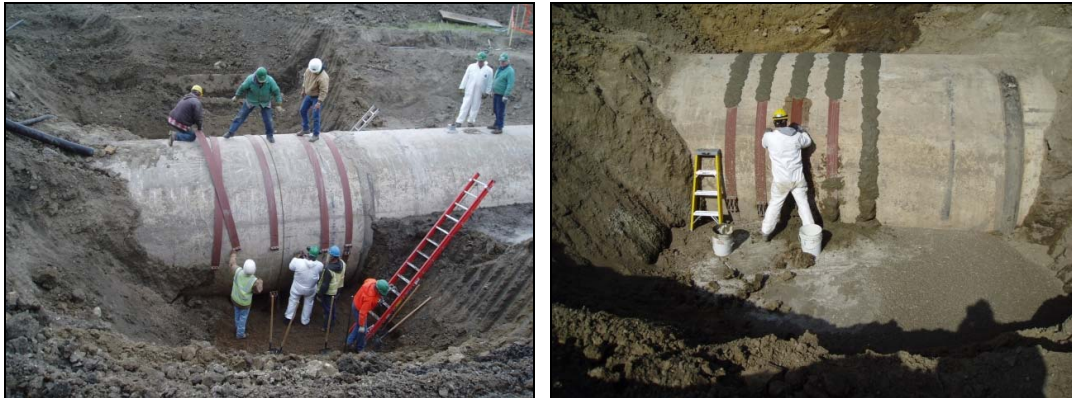
Figure 4- Steel support band installation

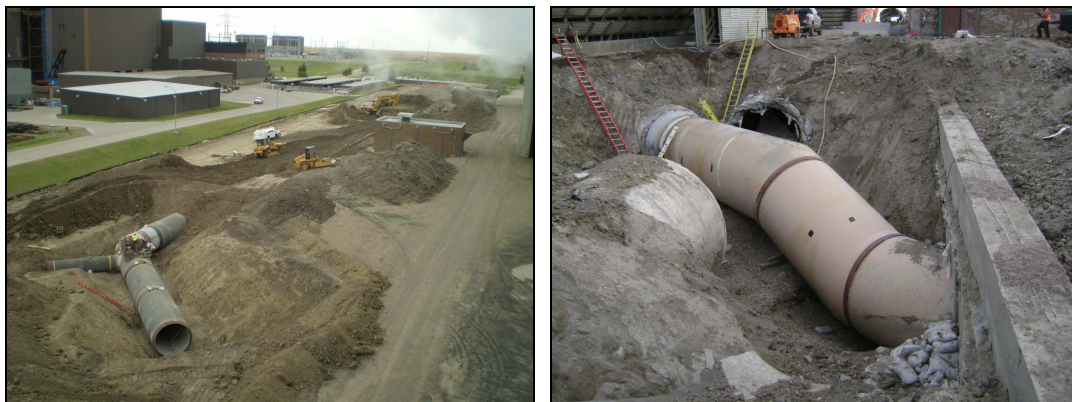
Figure 5 – New Line Installation

Several repair and replacement options for the distressed section of the return line were evaluate. Replacement of the distressed portion of the return line was chosen over repair due to the significant cost and planning associated with dual-unit outages and the plant personnel desire to have a more complete repair rather than a managed repair. A new pipelines was installed adjacent to the existing line in 2008 and tied-in to the existing cooling towers and return line during a 1-week outage in 2009 (Figure 5). The new line utilized a combination of mortar-lined steel and PCCP pipe and included the installation of a cathodic protection system.

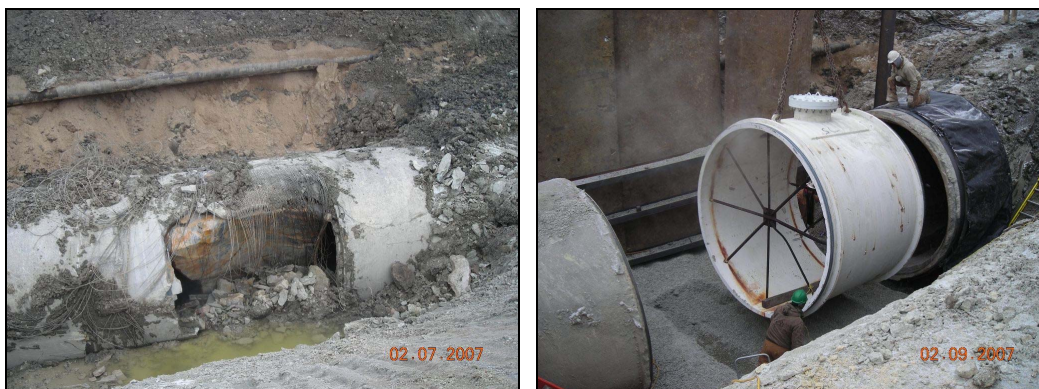
In 2007 a likely pressure surge in the system caused a rupture of a section of PCCP (Figure 7).

Figure 7 – Ruptured and repaired PCCP pipe

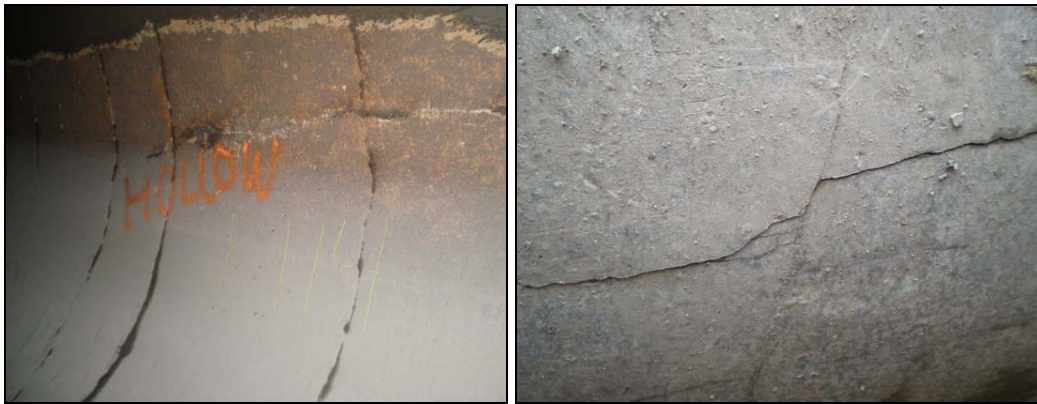
The physical evaluation found the supply line to be in generally good condition with limited visual signs of significant distress and only 12 of 77 pipes identified with potential wire breaks (all with less than 30 estimated wire breaks). The return line however was found to be in extremely poor condition with eleven pipes having longitudinal cracks and hollows (Figure 8), and 55 of 86 pipes identified with potential wire breaks. Seven pipes were estimated to have more than 200 estimated wire breaks (max estimate of 320 wire breaks for a single pipe section). The majority of the distress was identified in a 1,000-foot section of the return line.

Figure 8 – Internal and External Longitudinal Cracks and Hollows

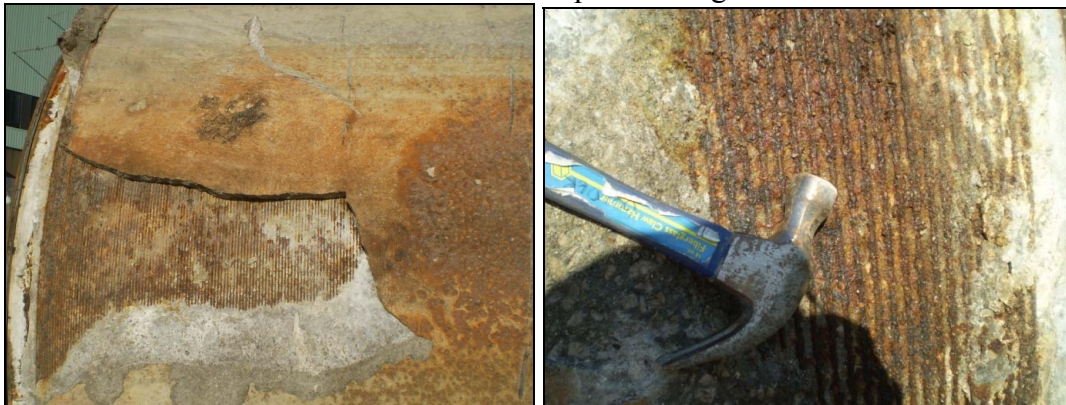
Observations of the distressed pipes identified external cracking, delamination of the mortar coating and significant corrosion of the prestressing wires (Figure 9). Further, the soils around the pipe were heterogeneous and ponding water above the pipe appears to have created wet/dry cycles across the pipe. The primary failure mechanism was identified as corrosion of the prestressing wires.

Figure 9 – Corrosion of Prestressing Wires

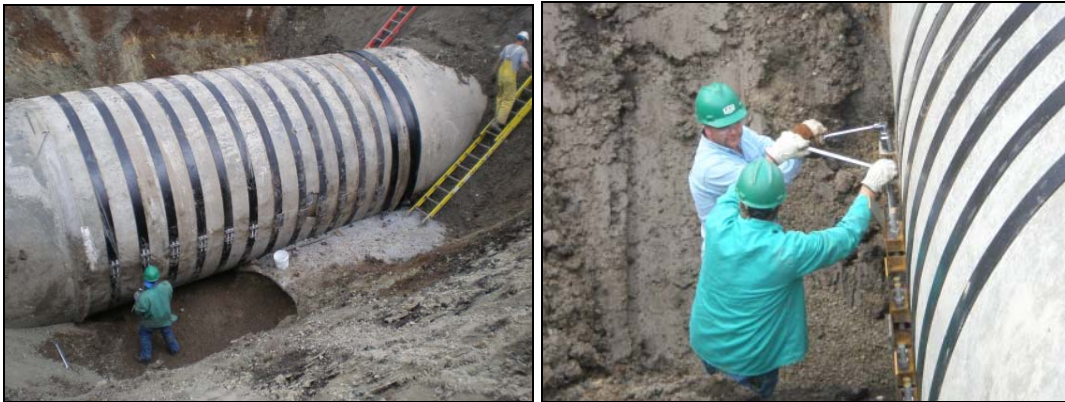
Figure 10 - Steel support band installation

- Installation of repair bands on 14 pipe sections consisting of external steel bands (Figure 10);
- Implementation of plant controls to limit pressure surges within the system;
- Development of an emergency repair plan including purchase of emergency repair sections;
- Future physical evaluation on a 5-year interval;
- Regrading of soil over the pipeline to promote drainage and reduce ponded water and infiltration to the PCCP; and
- Repair or replacement of the 1,000 foot distressed section of the return line.

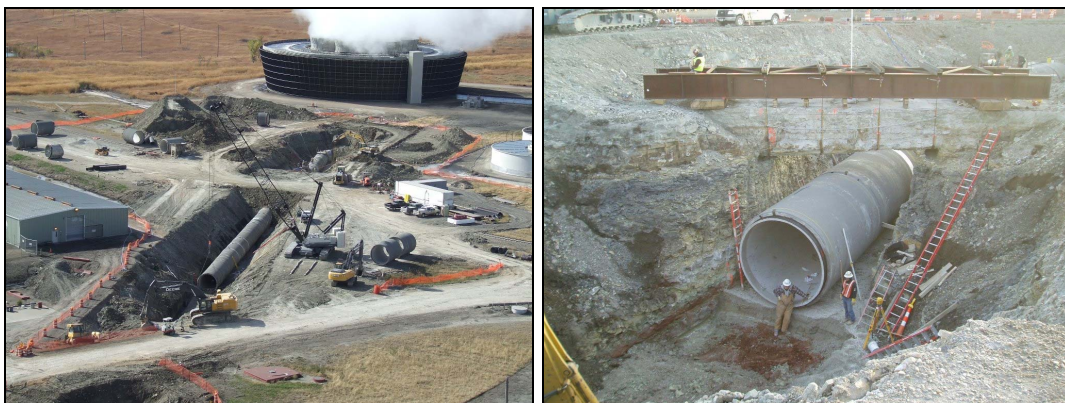
Figure 11 – New Line Installation

Several repair and replacement options were evaluated, but replacement of the distressed portion of the return line was chosen over repair based on the significant number of pipe sections distressed and the cost benefit comparison of repair versus replacement. The new pipeline was installed adjacent to the existing line in 2007 and tied-in to the existing return line during a planned outage in 2008 (Figure 11). The new line was constructed with PCCP and included the installation of a cathodic protection system.

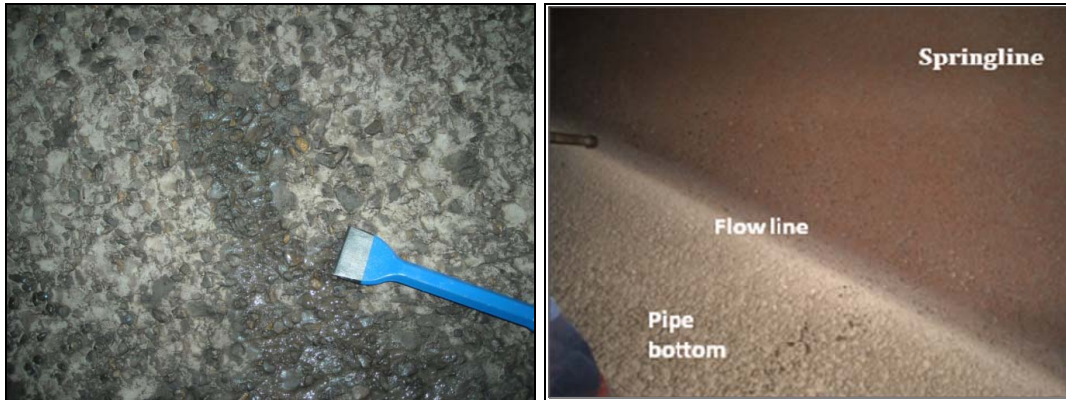
The physical evaluation found no longitudinal cracking or hollows within the effluent lines; suggesting little pipe distress. The Unit 1 effluent line did show significant erosion of the concrete lining (Figure 13) due to the high velocities and sediment load from the River water. The most severe erosion occurred at the end of the line where the pipe transitions to gravity flow and only utilizes a portion of the pipe section increasing the velocity up to 40 fps.

Figure 13 – Erosion at the bottom of the PCCP

- Implementation of plant controls to limit pressure surges within the system;
- Future physical evaluation on a 5-year interval;
- Physical evaluation of the influent lines (requires dual-unit outage or valve repair); and
- Quantitatively assess the thickness of the concrete lining erosion and implement potential re-lining in the future as required.

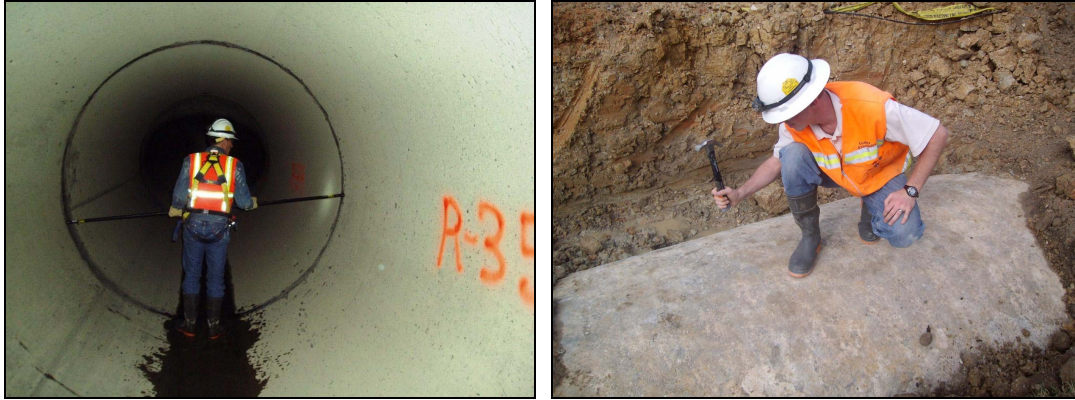
Figure 15 – Internal and External Visual and Sounding

The physical evaluation found no longitudinal cracking or hollows within the supply or return lines, and only 5 of 93 pipes were identified with potential wire breaks, with no pipes having more than 5 estimated wire breaks. These observations suggest that no significant distress in the pipe has occurred.

- Implementation of plant controls to limit pressure surges within the system;
- Future physical evaluation on a 7 to 10-year interval; and
- Regrading to promote positive site drainage away from the PCCP lines.
