Power Generation Case Study: Feasibility of Carbon Fiber and Alternate Repair Methods

Abstract

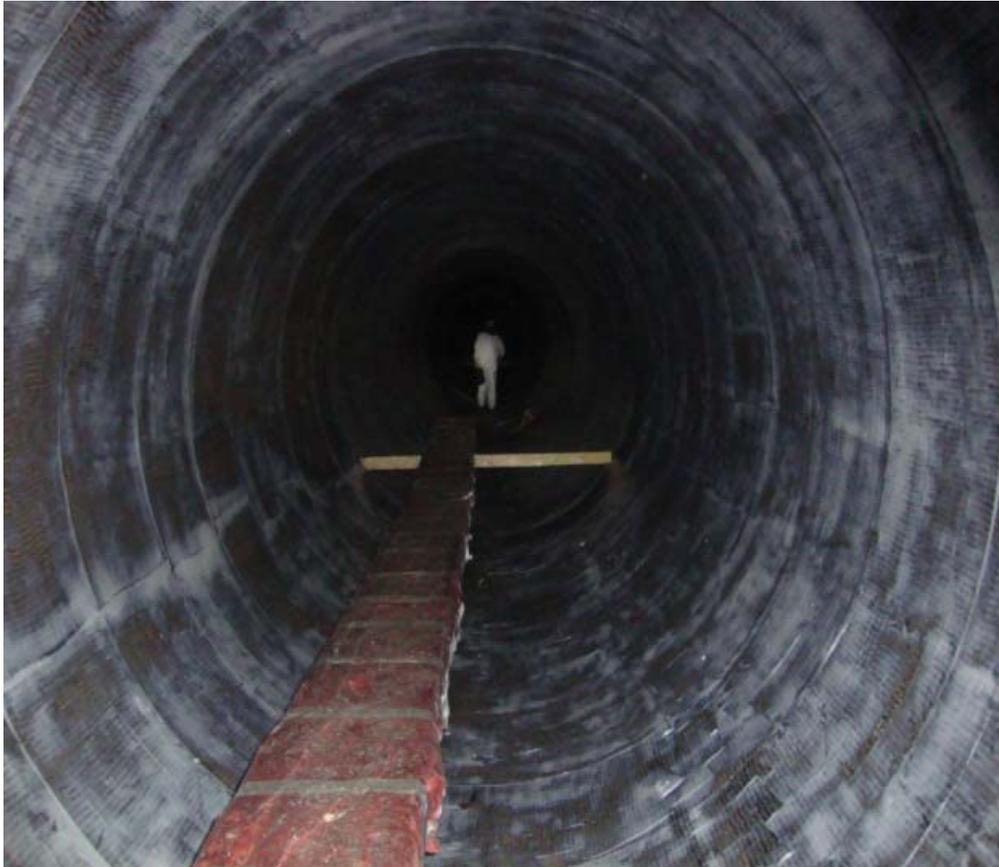
Figure 3. Completed CFRP installation

Over a period of 24 days, the Contractor completed the full retrofit of 55 – 20’ long sections of 102” diameter pipeline. With 10 days dedicated to the preparation of all surfaces, only 14 days were needed to complete 55 sections (surface preparation, Fiber Wrap layers and the top coat). The project was completed 6 days ahead of the very difficult work window and validated the idea that Fiber Wrap can be used as a cost-effective and time-efficient rehabilitation and strengthening material. In Figure 3, one can see the various stages of repair at the facility. The individual sections of pipe that are highlighted or boxed demonstrate the individual sectional repairs that took place from 2007 – 2010. The green sections of pipe highlighted all together represent the 55 sections, 1,100 lineal feet, of water circulating line rehabilitated.
