## **Rehabilitating a Life Line: Inspecting and Repairing the Hultman Aqueduct in Metropolitan Boston**

Paul Savard, PE<sup>1</sup>, Peter McGovern<sup>2</sup>

### **Abstract**

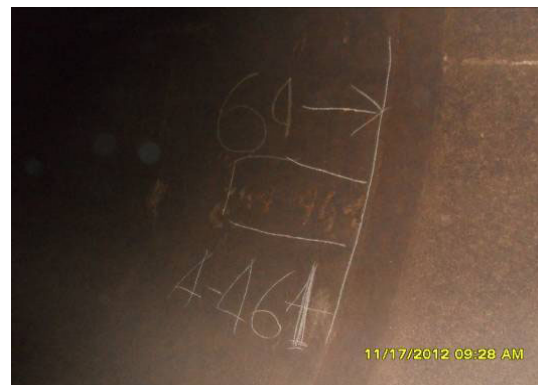
Figure 3 Internal pipe identification

drawings developed in the 1940's. The record drawings included a plan and profile view that documented the stationing for each 16-foot pipe segment, the invert at each joint, the pressure rating, and a unique pipe identification number. Figure 3 shows a photograph of the unique number identifier for pipe 4-464 that although over 60 years old remained visible during the inspection today and that was helpful in correlating locations of specific defects with as-built pipe segments. In addition, the record drawings provided stationing to locate each of the 14 blowoffs and 62 manways and air release valve connections, and six smaller diameter connections to pump stations along the way. The records also indicated the day, month, and year that the specific pipe segment was installed. Records of concrete cradles, culvert crossings, and other features installed during construction are also detailed on the record drawings. These records were invaluable in all phases of the project to locate specific features inside the Aqueduct prior to beginning the inspection and during repair.

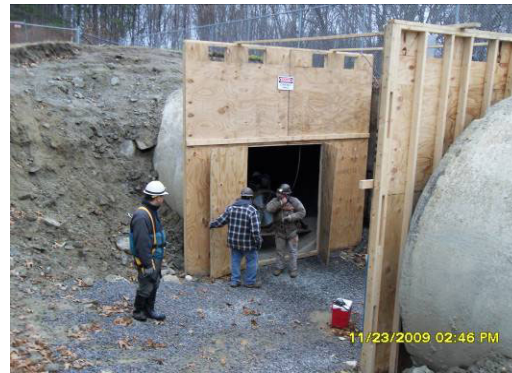
Figure 4 – Access Point (Transition from Segment D and E)

Figure 4 shows one of the access points provided by removing one 16 foot section of the Aqueduct. At the completion of the inspection and repair work, a new reinforced steel pipe segment was replaced and the pipe backfilled to pre-existing conditions.

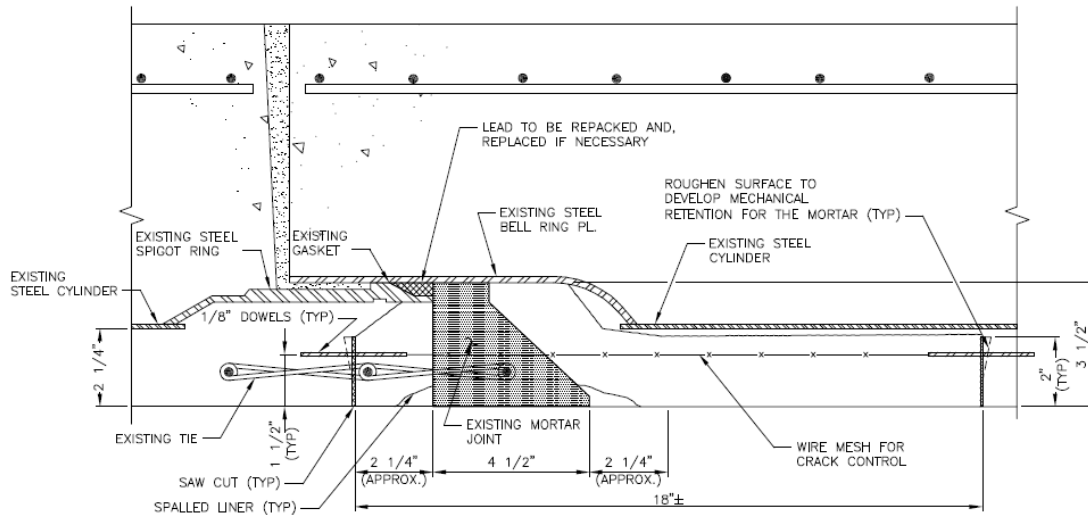
Figure 7

In areas with spalled or cracked concrete liner where repair was required, the concrete was saw cut beyond the defective limits and removed by power chipper and hand tools when nearing the steel liner to avoid damage. After preparing the edges to be perpendicular to the steel liner, the steel liner and lead gasket was cleaned by non-mechanical means and inspected. The inspection was to observe any visual evidence of leakage through visible deterioration, gaps, or evident rust. A standard detail developed to represent repair of this type of defect is shown in Figure 7.

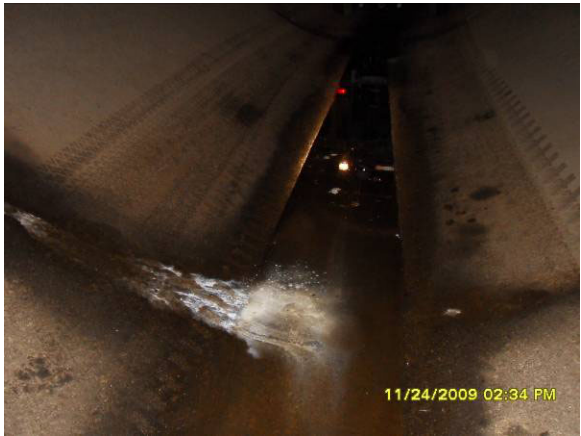
The figures that follow show a typical joint selected for repair, the removed mortar at the joint can be seen followed by the repacking of the lead joint and observations for continued leakage in a progression showing the various stages of the repair in Figures 8 through 13.

Figure 8 - Active Infiltration Defect

If leakage through the gasket was observed, the limits to be repacked were agreed to between the contractor's field personnel and the owner's on-site representatives. It was then hand packed to eliminate the leakage before the mortar repair proceeded. The mortar repair was paid as a unit price based on the length of the repair. Because the amount of gasket repair could not be quantified until it was uncovered and observed for evident leakage, this activity was reimbursed on a time and materials basis with the Owner's inspection personnel recording the extent of the work.

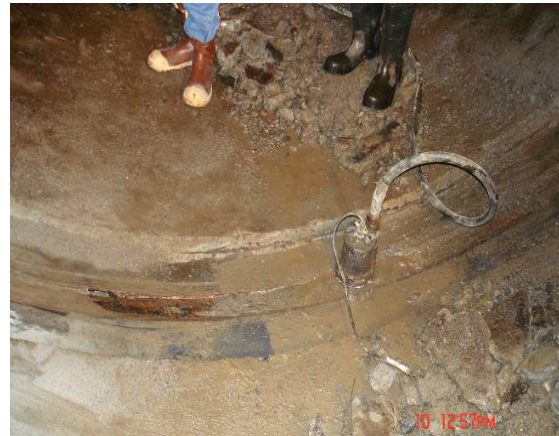
Figure 9 - Mortar Liner Removed

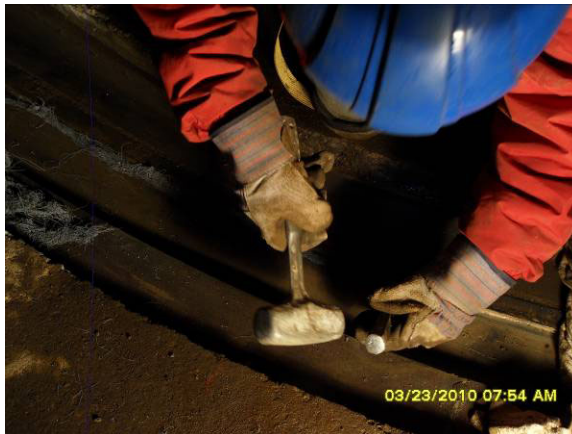
Figure 10 - Lead joint repacking

In other cases the type of repair was not as anticipated. For example, in lieu of welding steel plate to eliminate corroded sections of the steel liner, no such cases were encountered. Instead, repacking of the lead was found to be a more productive and cost effective means of cutting off water infiltration. The contractor was required to provide training for personnel performing repacking the lead gasket by an individual with a minimum of 15 years experience on lead gasket repacking for water lines in at least 10 projects totaling over 75 lead gaskets repacked.

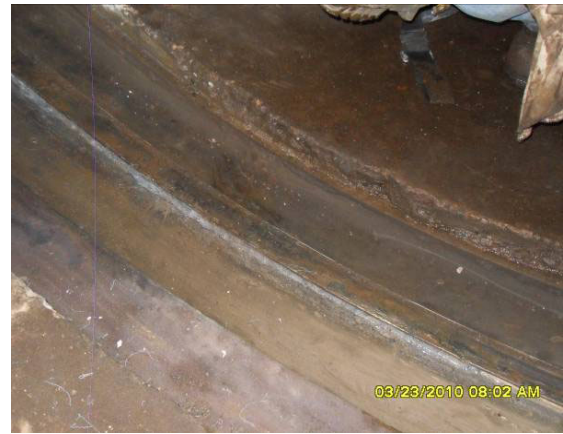
Figure 11 - Observation for Leakage before Mortar Repair

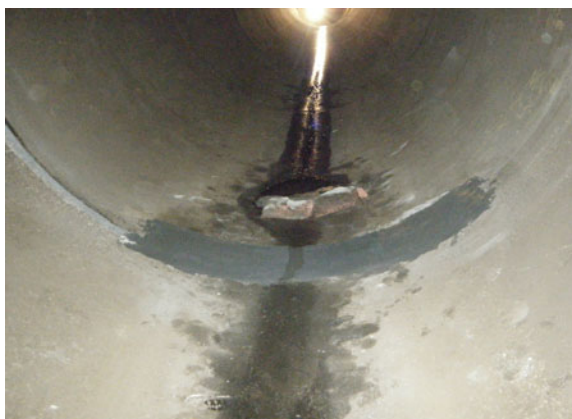
Figure 12 - Complete Repair

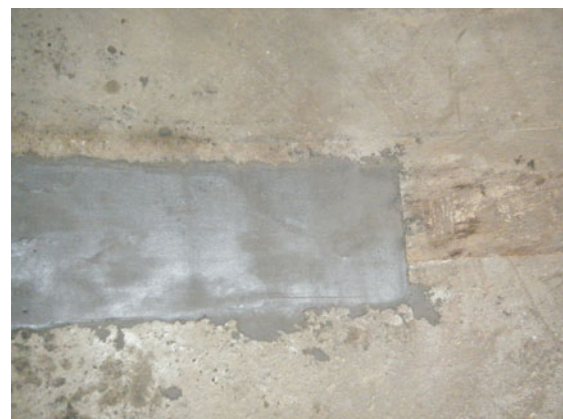
Figure 13 - Mortar repair and original mortar interface
