## **Rehabilitating a Life Line: Inspecting and Repairing the Hultman Aqueduct in Metropolitan Boston**

Paul Savard, PE<sup>1</sup>, Peter McGovern<sup>2</sup>

### **Abstract**

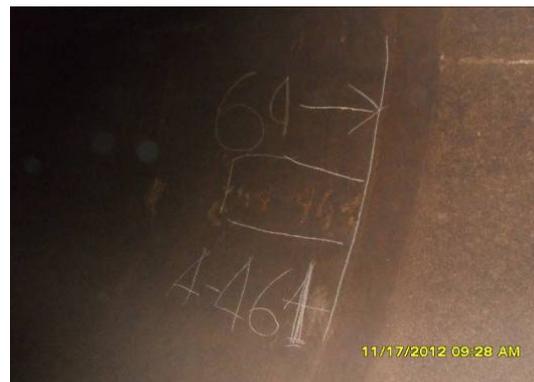
Figure 3 Internal pipe identification

drawings developed in the 1940's. The record drawings included a plan and profile view that documented the stationing for each 16-foot pipe segment, the invert at each joint, the pressure rating, and a unique pipe identification number. Figure 3 shows a photograph of the unique number identifier for pipe 4-464 that although over 60 years old remained visible during the inspection today and that was helpful in correlating locations of specific defects with as-built pipe segments. In addition, the record drawings provided stationing to locate each of the 14 blowoffs and 62 manways and air release valve connections, and six smaller diameter connections to pump stations along the way. The records also indicated the day, month, and year that the specific pipe segment was installed. Records of concrete cradles, culvert crossings, and other features installed during construction are also detailed on the record drawings. These records were invaluable in all phases of the project to locate specific features inside the Aqueduct prior to beginning the inspection and during repair.

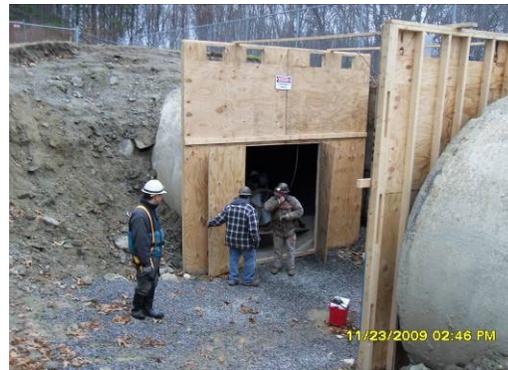
Figure 4 shows one of the access points provided by removing one 16 foot section of the Aqueduct. At the completion of the inspection and repair work, a new reinforced steel pipe segment was replaced and the pipe backfilled to pre-existing conditions.

Figure 4 – Access Point (Transition from Segment D and E)

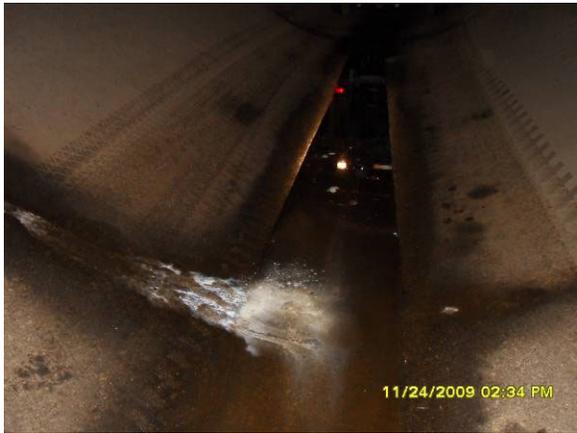
Figure 8 - Active Infiltration Defect

The figures that follow show a typical joint selected for repair, the removed mortar at the joint can be seen followed by the repacking of the lead joint and observations for continued leakage in a progression showing the various stages of the repair in Figures 8 through 13.

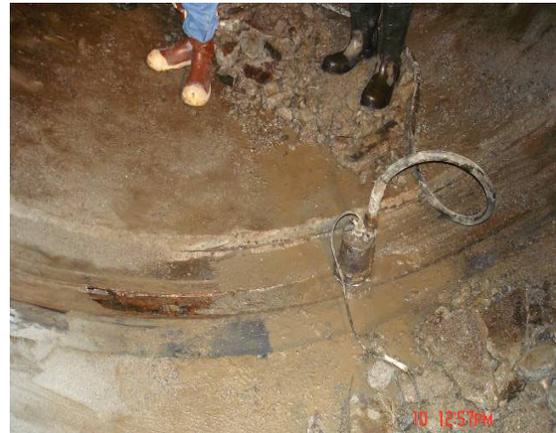
Figure 9 - Mortar Liner Removed

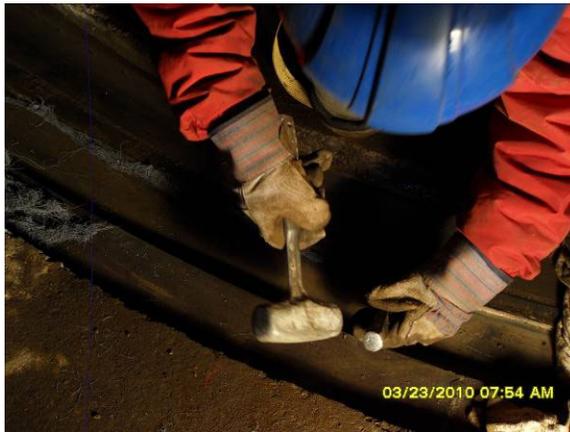
Figure 10 - Lead joint repacking

In other cases the type of repair was not as anticipated. For example, in lieu of welding steel plate to eliminate corroded sections of the steel liner, no such cases were encountered. Instead, repacking of the lead was found to be a more productive and cost effective means of cutting off water infiltration. The contractor was required to provide training for personnel performing repacking the lead gasket by an individual with a minimum of 15 years experience on lead gasket repacking for water lines in at least 10 projects totaling over 75 lead gaskets repacked.

If leakage through the gasket was observed, the limits to be repacked were agreed to between the contractor’s field personnel and the owner’s on-site representatives. It was then hand packed to eliminate the leakage before the mortar repair proceeded. The mortar repair was paid as a unit price based on the length of the repair. Because the amount of gasket repair could not be quantified until it was uncovered and observed for evident leakage, this activity was reimbursed on a time and materials basis with the Owner’s inspection personnel recording the extent of the work.

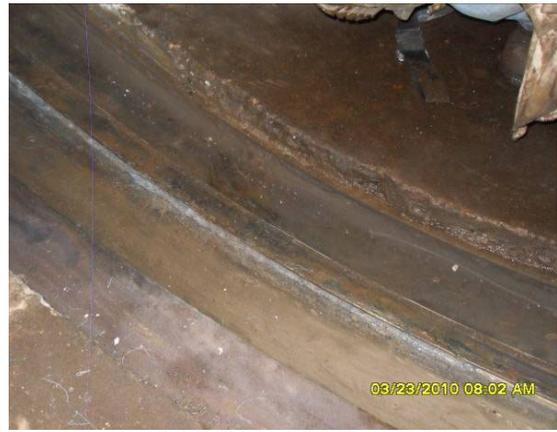
Figure 11 - Observation for Leakage before Mortar Repair

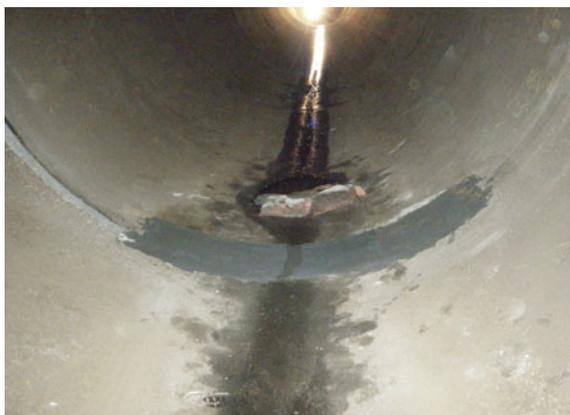
Figure 12 - Complete Repair

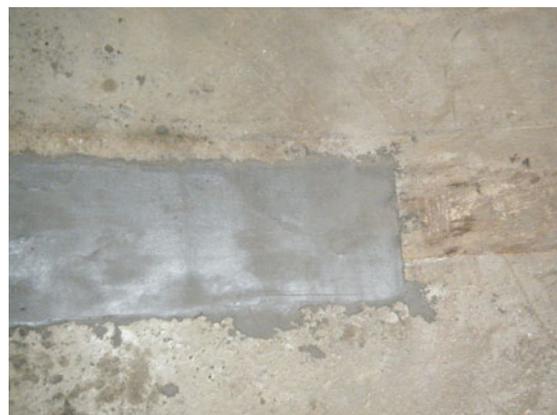
Figure 13 - Mortar repair and original mortar interface
