CONCRETE REPAIR BULLETIN

As seen in the
March/April 2010 issue

TRENCHLESS EMERGENCY REPAIR OF MILE-LONG PENSTOCK WITH FRP

BY MO EHSANI AND CARLOS PEÑA

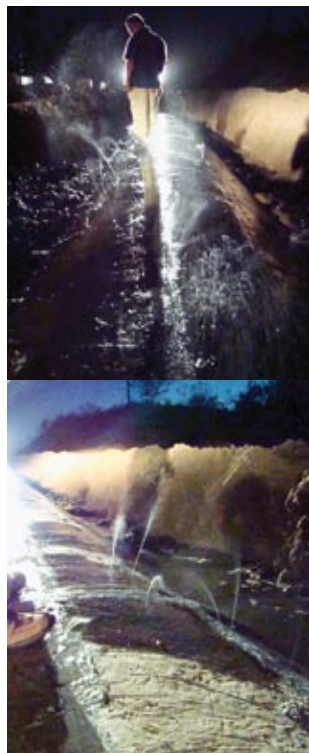
Although the structural design had properly addressed the strength requirements of the pipeline and accounted for the design pressure and hydrodynamic loads, the pipeline's serviceability requirements were overlooked. The pipeline exhibited significant longitudinal and transverse cracking during a pressurized test and, as a result, as much as 20% of the flow was lost due to leaks.

The pipeline was drained and all visible cracks were sealed using typical repair materials. When the pipeline was pressurized for a second time, the repaired cracks leaked again. The leaking

at the repaired cracks was most likely due to the increase in the crack width due to the deformations of the pipeline caused by the increase in internal pressure. Given the relative rigidity of most crack sealing materials, full deformation compatibility between the repair material and the surrounding concrete could not be achieved, degrading the integrity of the seal and allowing leaks to reoccur. Figure 2 illustrates typical leaks occurring along the length of the pipeline during tests conducted at maximum operational pressure.

Fig. 2: Leaking after conventional crack sealing

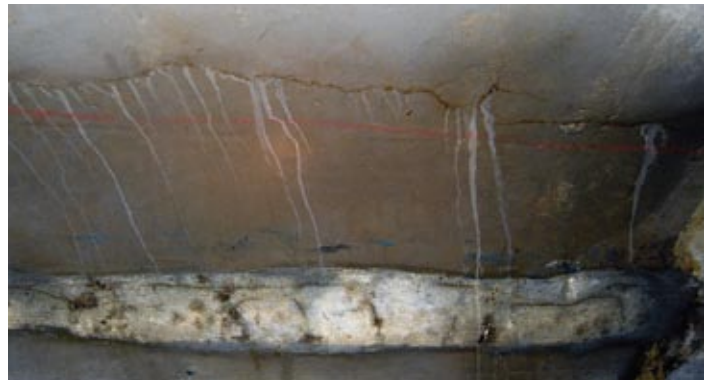
Fig. 3: Water seeping into pipeline

the constant tropical rains. Because most of the pipeline is buried underground, water draining down the mountains keeps the surrounding soil constantly saturated, which generates seepage pressures. In fact, with the pipeline empty, seepage water was observed draining through some of the longitudinal cracks (Fig. 3).

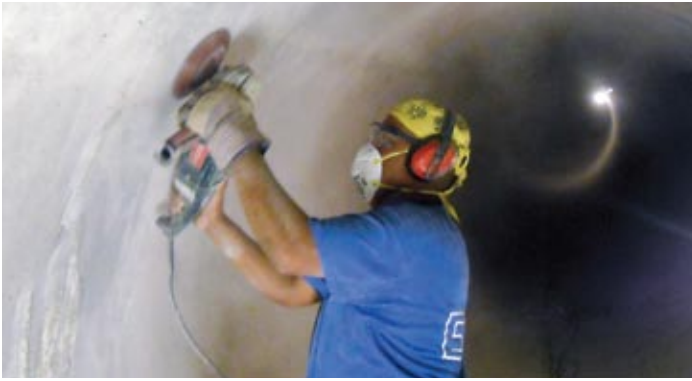
Fig. 4: Preparation work prior to installation of FRP lining

The application of FRP linings requires a certain amount of preliminary work to the pipe surface to maximize contact and bond strength between the substrate and the FRP. Therefore, pressure washing and/or sandblasting, as well as some patching and/or grinding, must take place in the areas targeted for lining with FRP. In the case of the El Encanto pipeline, the amount of surface prep work was atypically large because the cast-in-place construction process caused significantly more surface irregularities than those associated with the more traditional precast pipes, such as prestressed concrete cylinder pipe (PCCP). Evidence of cast-in-place procedures such as construction joints and formwork fins was visible in the pipeline. The pipeline was pressure washed with 7000 psi (48.3 MPa) machines to remove any scour, sediment, curing compounds, and any other substance that could hinder the bond between the FRP and the pipe surface. Figure 4 shows grinding of protrusions on the interior surface of the pipeline.

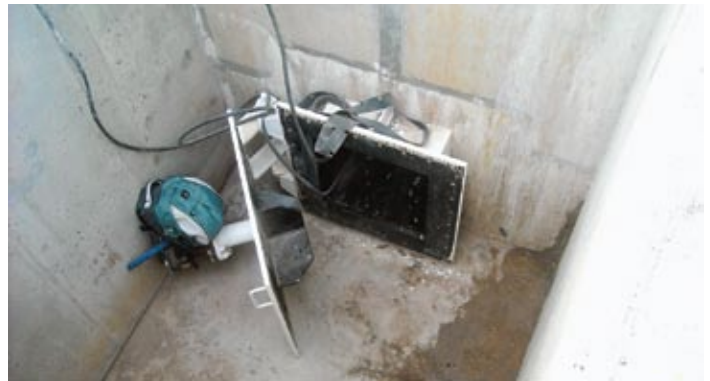
Fig. 5: Typical 2 ft. x 2 ft. access point

The 5742 ft (1750 m) long penstock had four lateral access points at the locations of relief valves, with spacing ranging from 1000 to 1500 ft (305 to 457 m). These 24 x 24 in. (810 x 610 mm) access points were used by the crew to supply FRP materials, tools, and equipment to four installation stations inside the pipeline. (Fig. 5)

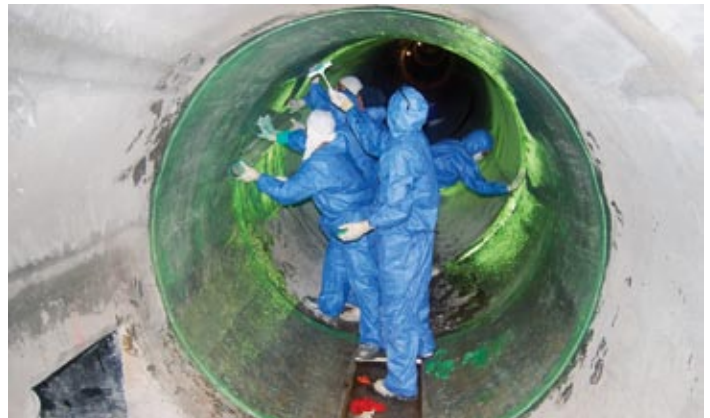
Fig. 6: Installation of FRP sheets on the interior surface of the pipeline

An epoxy paste was applied to the top half of the pipeline; the main purpose of the paste is to prevent peeling due to self weight of the saturated FRP fabric and to seal the surface to prevent excessive absorption by the dry concrete surface of the epoxy resin from the saturated FRP fabric. Figure 6 shows the installation of the first roll of FRP lining material at one of the installation stations. The access point is clearly visible on the lower left portion of the figure. No epoxy paste was used in the lower half of the pipe. Because gravity forces in this area tend to hold the FRP fabric in place, only a seal coat of epoxy resin was used to prevent excessive absorption by the dry concrete surface of epoxy resin from the saturated fabric. The edges of the 50 in. (1270 mm) wide bands of fabric were adequately overlapped in the hoop and longitudinal directions to

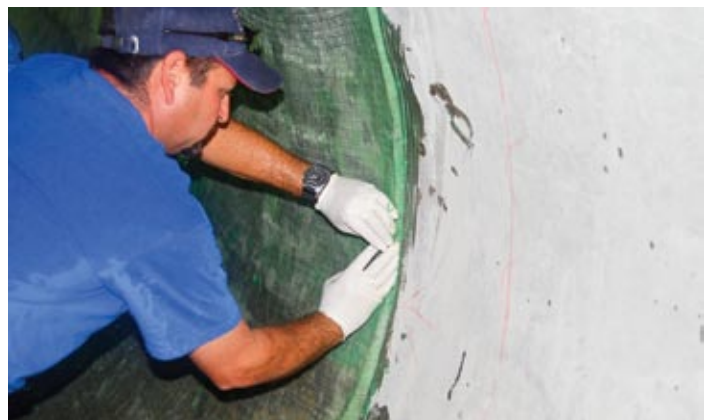
Fig. 7: Construction joint of FRP lining

Specially designed construction joints were prepared at the starting point of each installation run, which also became the end points of the installation front that started at a downstream access point. The joint was later sealed with an epoxy paste (Fig. 7). Nowhere in the 5742 ft (1750 m) length of the pipeline were FRP lining edges left exposed to peeling from water flow, maximizing the water tightness of the installation.

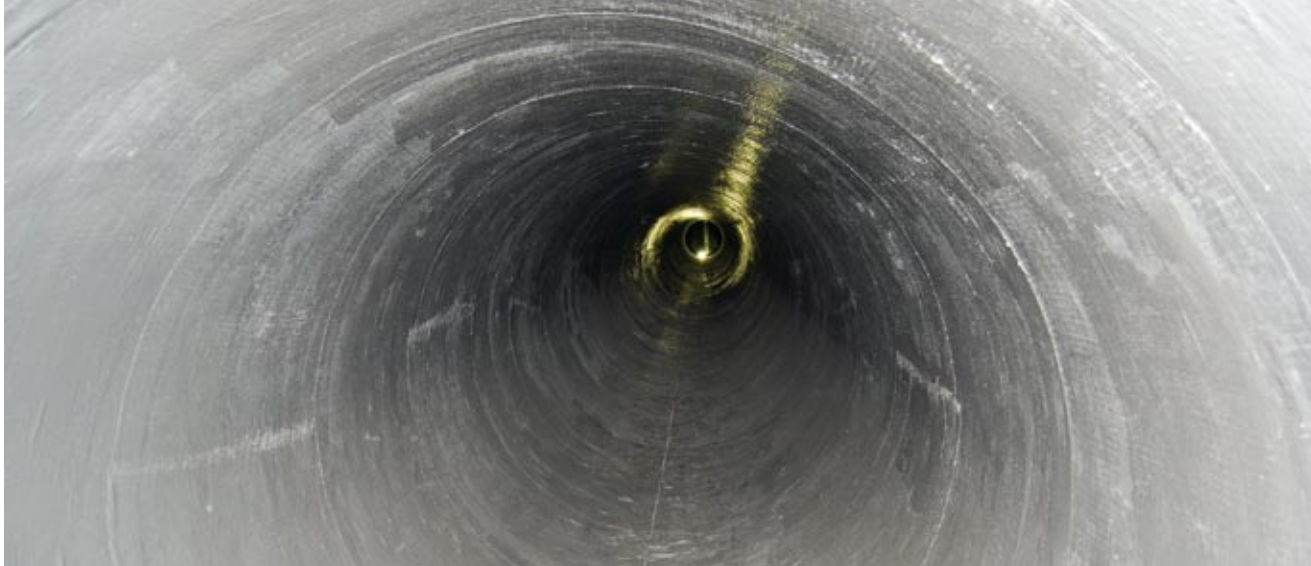
Fig. 8: Completed segment of pipeline prior to testing

The FRP lining installation was completed on July 8, 2009, and pressurized test runs were successfully completed on July 15. Figure 8 shows a completed lining installation prior to testing.
