Multiple Records Broken in Emergency Repair of Mile-Long Pipeline

Mo Ehsani, Ph.D., P.E., S.E. and Carlos Peña, M.S., P.E.

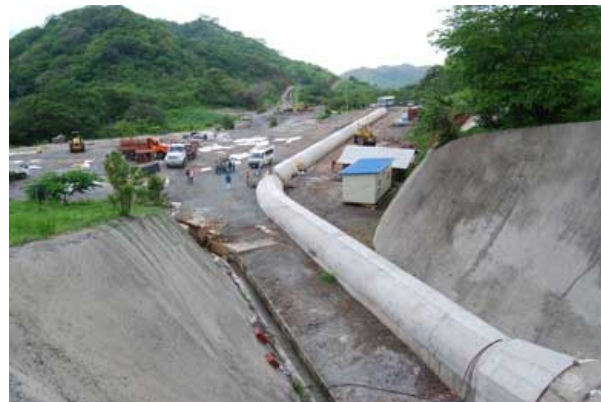
Figure 1: Above ground segment of the “El Encanto” pipeline

downstream. The pipeline is built of cast in place reinforced concrete, has an inner diameter of 7 ft, and a total length of 5,742 ft. The water flows by gravity, but because of the elevation difference between the dam and turbine complex, as well as the continuous changes in the vertical and horizontal alignment of the pipeline required to conform to the mountainous topography, the water flow is pressurized.

Although the structural design had properly addressed the strength requirements of the pipeline and accounted for the design pressure and hydrodynamic loads, the pipeline's serviceability requirements were overlooked. The pipeline exhibited significant longitudinal and transverse cracking during a pressurized test and as a result, as much as 20% of the flow was lost due to leaks.

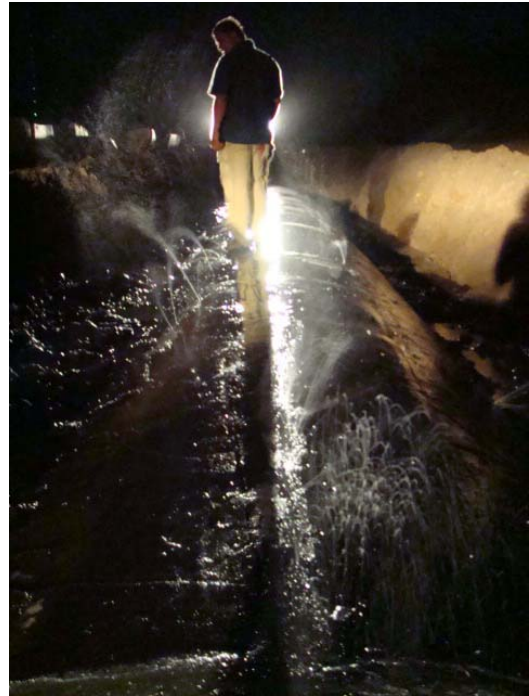
The pipeline was drained and all visible cracks were sealed using typical repair materials available locally. When the pipeline was pressurized for a second time, the repaired cracks leaked again. The leaking at the repaired cracks was most likely due to the increase in the crack width due to the deformations of the pipeline caused by the increase in internal pressure. Given the relative rigidity of most crack sealing materials, full deformation compatibility between the repair material and the surrounding concrete could not be achieved, degrading the integrity of the seal and allowing leaks to reoccur. Figure 2 illustrates typical leaks occurring along the length of the pipeline during tests conducted at maximum operational pressure.

Figure 2: Leaking after conventional crack sealing

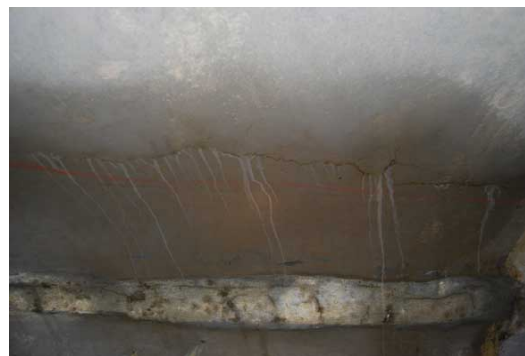
Moreover, the cracks generated multiple paths for humidity intrusion that reached the steel reinforcement of the pipeline, allowing for corrosion problems that, if not properly addressed, could compromise the structural integrity of the pipeline in the future. Complicating the problem even further was the combination of mountainous topography and the constant tropical rains. Since most of the pipeline is buried underground, water draining down the mountains keeps the surrounding soil constantly saturated which generates seepage pressures. In fact, with the pipeline empty, seepage water was observed draining through some of the longitudinal cracks (Fig. 3).

Figure 3: Water seeping into pipeline

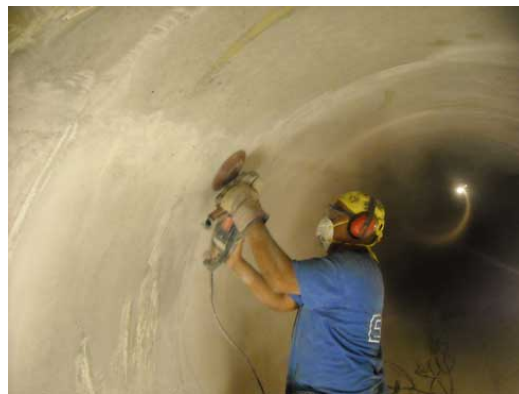
Figure 4: Prep work prior to installation of FRP lining

The application of FRP linings requires a certain amount of preliminary work to the pipe surface in order to maximize contact and bond strength between the substrate and the FRP. Therefore, pressure washing and/or sandblasting, as well as some patching and/or grinding must take place in the areas targeted for lining with FRP. In the case of the El Encanto pipeline, the amount of preliminary work was atypically large, since the cast in place construction process caused significantly more surface irregularities than those associated with the more traditional precast pipes, such as Prestressed Concrete Cylinder Pipe (PCCP). Evidence of cast in place procedures such as construction joints, formwork fins, etc. was visible in the pipeline. The pipeline was pressure washed with 7,000 psi machines to remove any scour, sediment, curing compounds, and any other substance that could hinder the bond between the FRP and the pipe surface. Figure 4 shows grinding of protrusions on the interior surface of the pipeline.

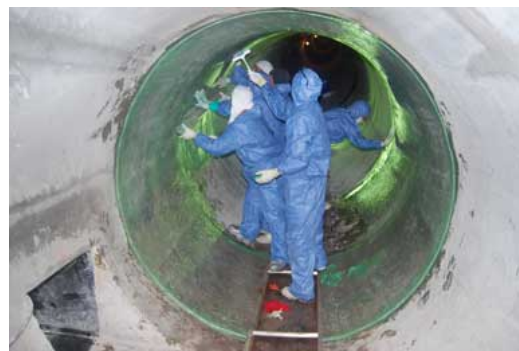
Figure 5: Installation of FRP sheets on the interior surface of the pipeline.

An epoxy paste was applied to the top half of the pipeline; the main purpose of the paste is to prevent peeling due to self weight of the saturated FRP fabric, and to seal the surface to prevent excessive absorption by the dry concrete surface of the epoxy resin from the saturated FRP fabric. Figure 5 shows the installation of the first roll of FRP lining material at one of the installation stations. The access point is clearly visible on the lower left portion of the figure. No epoxy paste was used in the lower half of the pipe. Since gravity forces in this area tend to hold the FRP fabric in place, only a seal coat of epoxy resin was used to prevent excessive absorption by the dry concrete surface of epoxy resin from the saturated fabric. The edges of the 50-inch wide bands of fabric were adequately overlapped in the hoop and longitudinal directions to

achieve full continuity of the FRP. The edges of the overlaps were feathered with epoxy paste and/or epoxy resin to secure in place the overlaps in the lining.

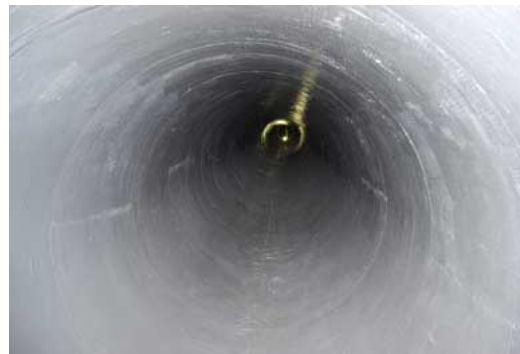
Figure 6: Completed segment of pipeline prior to testing.

The FRP lining installation was completed on July 8th, 2009, and pressurized test runs were successfully completed on July 15th. Figure 6 shows a completed lining installation prior to testing.
