Chicago, Illinois
May 2-7, 2010

Paper A-4-02

REHAB OF 100-YEAR-OLD LARGE SIZE CIRCULAR AND NON-CIRCULAR SEWERS

Michael I. Spero, P.E.¹, and Datta Shirodkar²

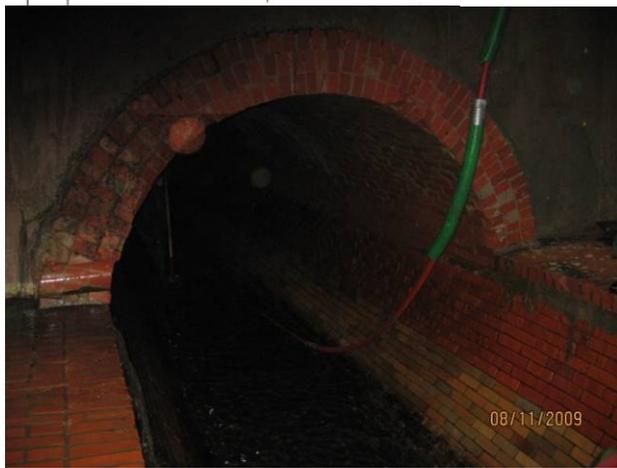
3. Even medium size rains could cause the pipe to fill up with storm water with only 10-15 minutes warning.
4. There were no plans of the existing sewer but a limited inspection determined that the sewer was in relatively good condition and the curve had a Radius = 125± feet. The curve was partially a smooth radius and partially made of chords with angle points.

Figure 3. Existing Brick Sewer

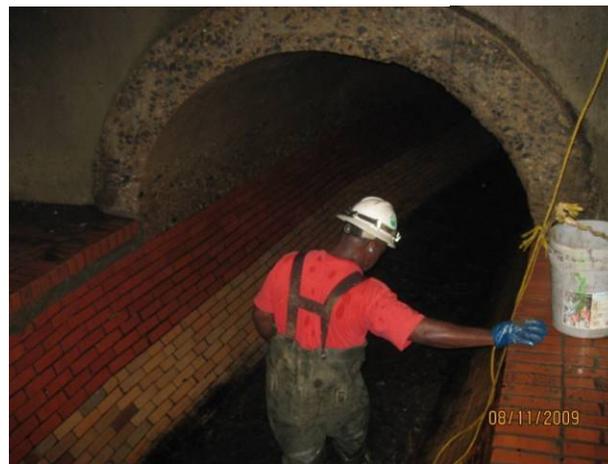
Figure 4. Exist. Brick & Unreinforced Conc. Sewer

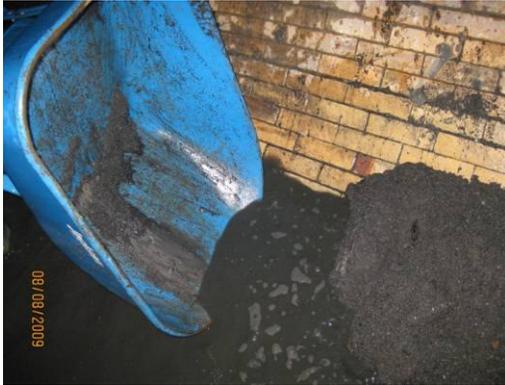
After the river backwater and pipe base flow were under control and the ventilation system established cleaning of the sewer was accomplished. The debris in the pipe was mostly sand and silt with an occasional brick or piece of concrete dislodged during the installation of lateral pipes. About half the debris was removed manually using wheel barrows [Figure 5]. The remaining debris was removed using a jet rodder and vacator truck. In preparation for the lining, the walls of the sewer were cleaning using a high pressure water blast of 6,000 psi [Figure 6]. This removed any dirt, oil, grease, loose mortar, concrete, aggregates, laitance, or other contaminants. What remains is clean competent brick and concrete. There were 8 abandoned services and 1 groundwater leak that were plugged. Twice during the cleaning operation there were rain storms. Crews and equipment had to be quickly removed from the sewer and the downstream plug deflated. These events stopped the sewer cleaning for 6 days.

Figure 5. Debris Removal

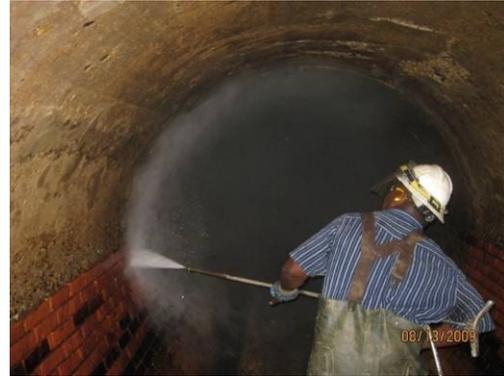
Figure 6. High Pressure Water Blast

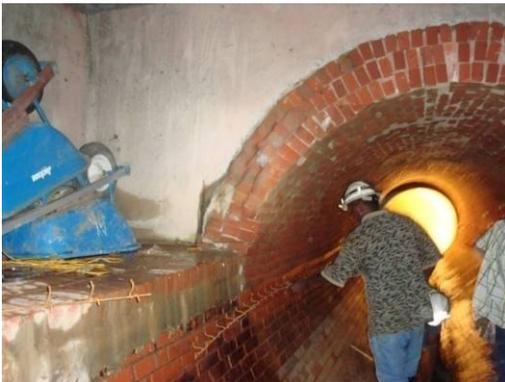
Figure 7. Bolster/Spacer Installation

In order to maintain the 3 inch minimum grout thickness, steel spacers (bolsters) are mounted on the pipe wall [Figure 7]. The 12-inch wide PVC panels come in 300 foot long coils. The liner is fed into the pipe through the manhole then pulled into position. The panels are spiral wound by connecting the adjacent panels with a Joiner Strip. The Joiner Strip is installed using a pneumatic Palm Hammer [Figure 8]. The end of the next coil is connected to the previous one with an “H” Strip splice. A steel buoyancy restraint angle is anchored at the bottom of the liner. Grout bulkheads are placed about every 400 feet using hydraulic cement. During the liner installation there were several times when storms necessitated evacuating the sewer and delayed the completion of the lining by almost 2 weeks.

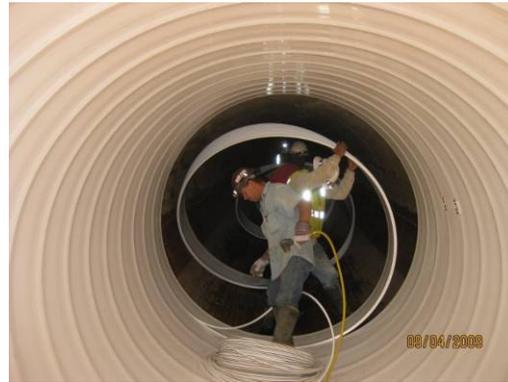
Figure 8. Spiral Wound Liner & Joiner Strips

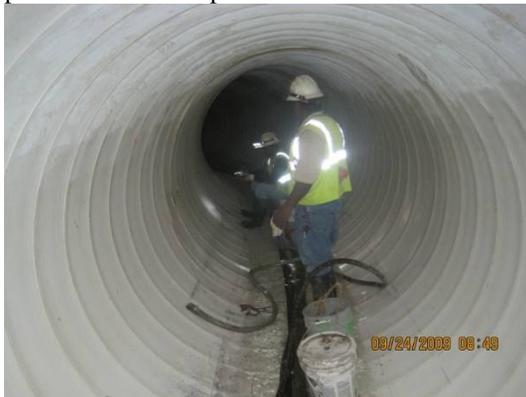
Figure 9. Grout Injection

The liner is grouted in 8 lifts of about 12- inches each. Grout and vent holes are drilled in the liner about every 20 feet. The grout hose discharges into the grout hole and the mixture flows by gravity into the annular space between the liner panels and the host pipe [Figure 9]. When grout starts flowing out of the vent hole, the hole is plugged and the hose is move to the next grout hole [Figure 10]. The next grout lift is placed a minimum of 12 hours after the previous lift is completed.

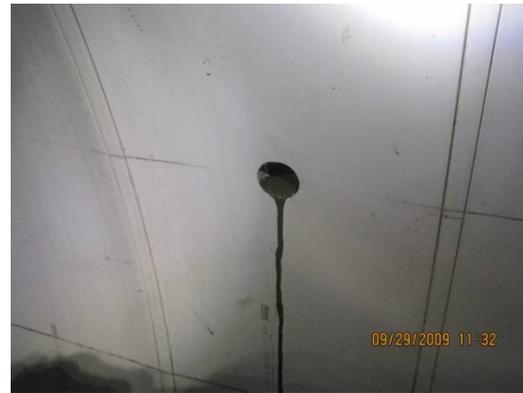
Figure 10. Grout Vent Hole

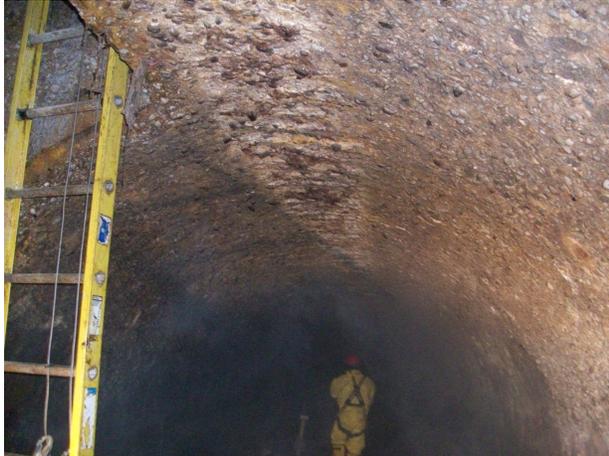
This project is a structural rehabilitation of mostly 70-75 year old sewers that are in relatively good condition considering their many years of service. There is some interior surface deterioration of the concrete and some corrosion of the existing steel reinforcement, primarily at the crown of the sewer. However there is no evidence of structural distress or failure, no extensive cracking, and no displacement at cold joints. The bottom portion of the sewer shows essentially no deterioration which is common for most sanitary sewer systems.

Figure 13. Deteriorated Crown

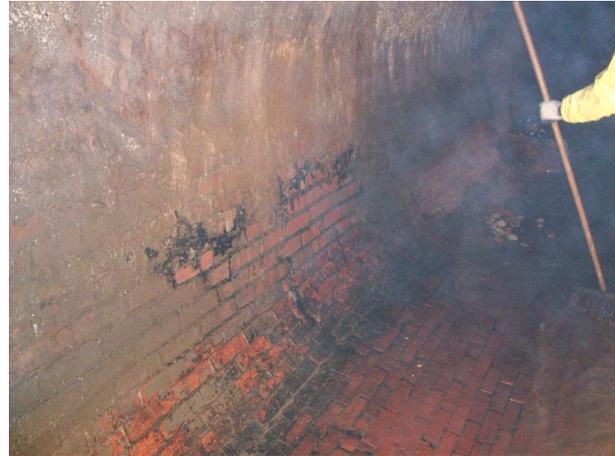
Figure 14. Brick Below Springline

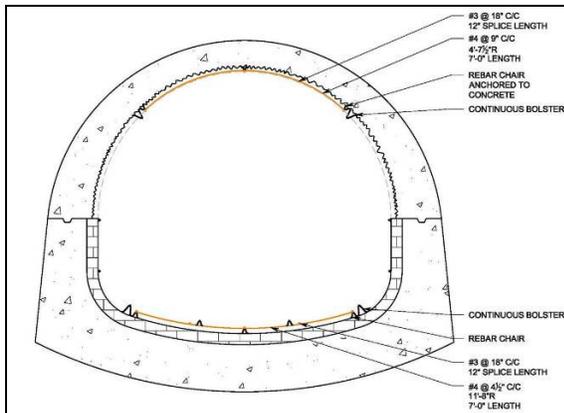
Fig.15. Install Reinforcement And Bolsters

- Install bolsters/spacers to ensure the minimum grout thickness as per the design calculations. [Figure 15]
- Install reinforcement, only if required by the design calculations. [Figure 15]
- Install bottom panel and the curved corner strips. [Figure 16]
- Install buoyancy restraint angles for bottom panel. [Figure 17]
- Grout bottom panel and curved corner strip. [Figure 18]
- Install the top panel and bracing system for the top panel. [Figure 19]
- Grout top panel in lifts. [Figure 20]

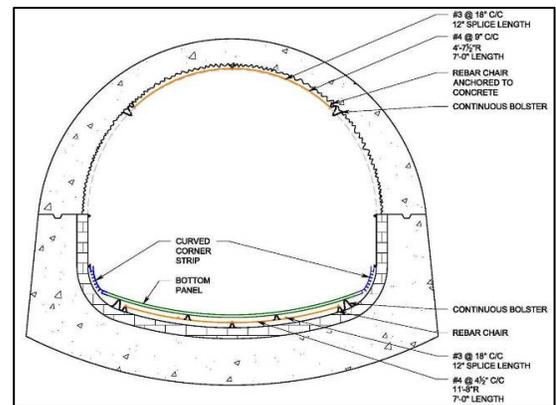
Fig. 16. Install Bottom Panel & Curved Corner Strips

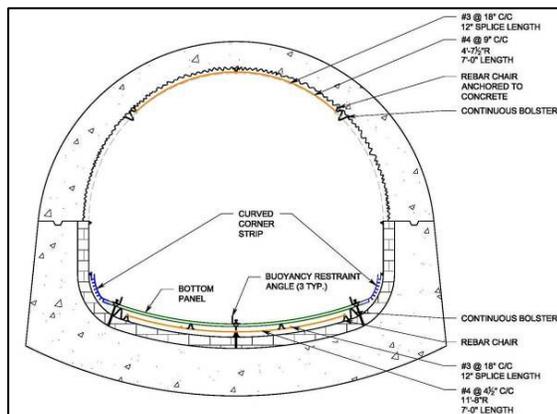
Fig. 17. Installation of Buoyancy Restraint Angles

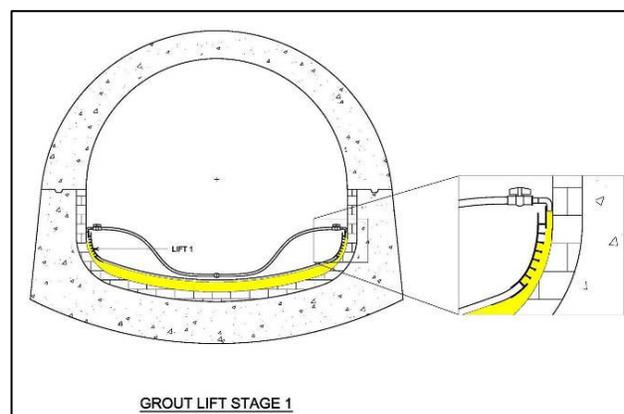
Fig. 18. Grouting Bottom Panel

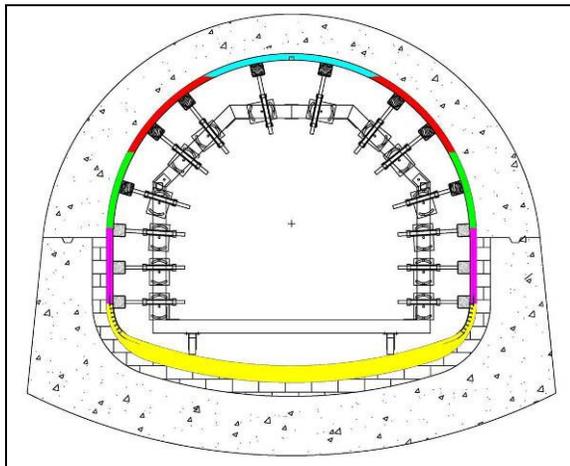
Fig. 19 – Installation of Top Panel Installation Of Bracing System

The bracing system is installed to prevent the deflection/buckling of the liner due to the hydraulic pressure of the grout. The bracing will prevent the liner from deflection for more than 1/8” in the longitudinal and traverse direction. Figure 19, shows the conceptual bracing system that is planned to be use on this project.

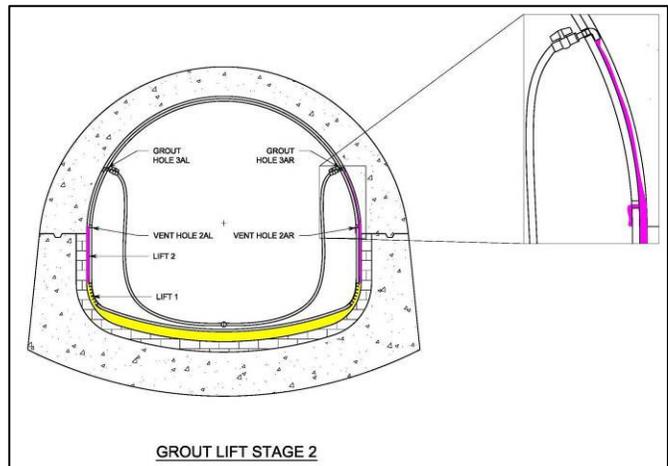
Fig. 20 – Grouting Second Lift

Hydraulic cement bulkheads are placed every 300 - 400 ft. The distance between the bulkheads is determined by the volume of grout that can be mixed and pumped in a day using the colloidal mixers. As shown in Figure 20 grout and vent holes are drilled in the liner every 20 feet. The grout hose discharges into the grout hole and the mixture flows by gravity into the annular space between the liner panels and the host pipe. When grout starts flowing out of the vent hole, the hole is plugged and the hose is move to the next grout hole. The mixed grout is very fluid (low viscosity) but will set up in 4-5 hours. Within 24 hours the grout will have a compressive strength of 2000-3000 psi and be ready to place the next lift. The next grout lift is placed a minimum of 12 hours after the previous lift is completed. As shown in Figure 20 grout and vent valves are used for the top lift instead of grout and vent holes.
