QuakeWrap Inc.

Construction Summary

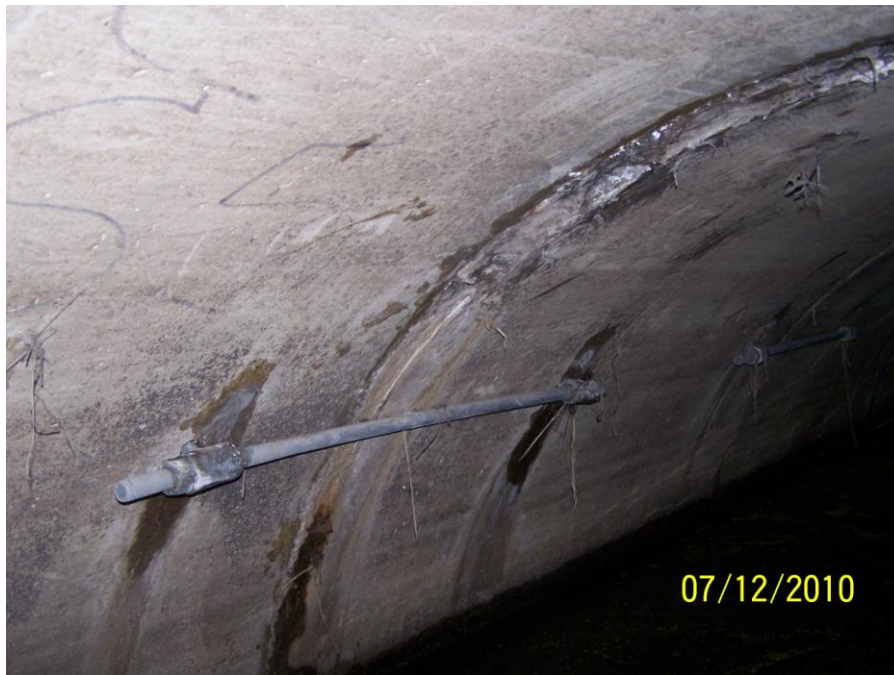
Photo 141: Internal pipe tie installed.

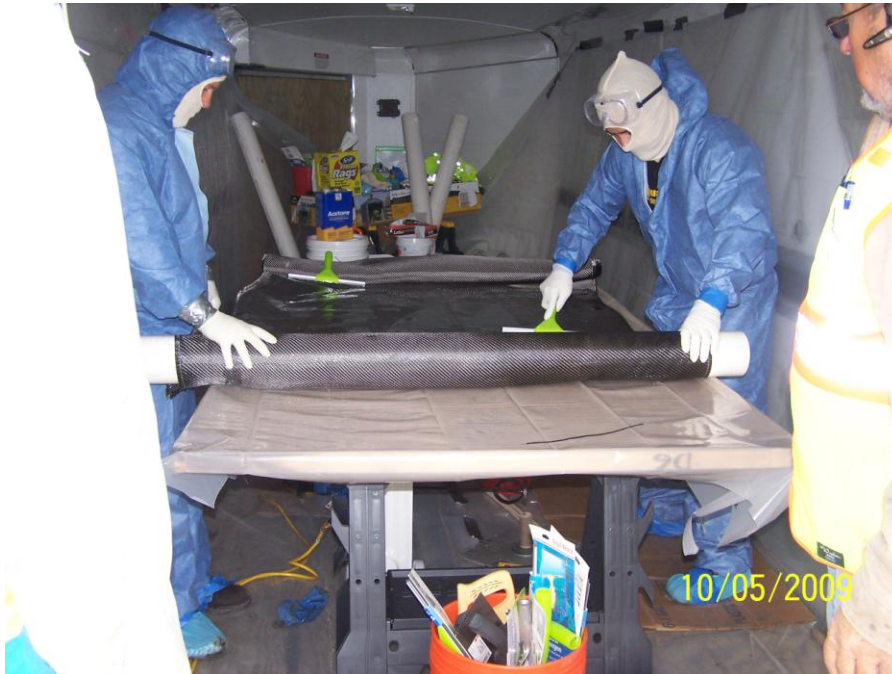
Photo 142: QuakeWrap being saturated before installation

The fabric saturating process was done in an onsite job trailer. Resin was also placed on the top of the fabric. Squeegees were then used to spread the Resin and obtain complete saturation. The saturated piece of fabric was placed onto a PVC pipe to transport the saturated fabric into the pipe for installation.

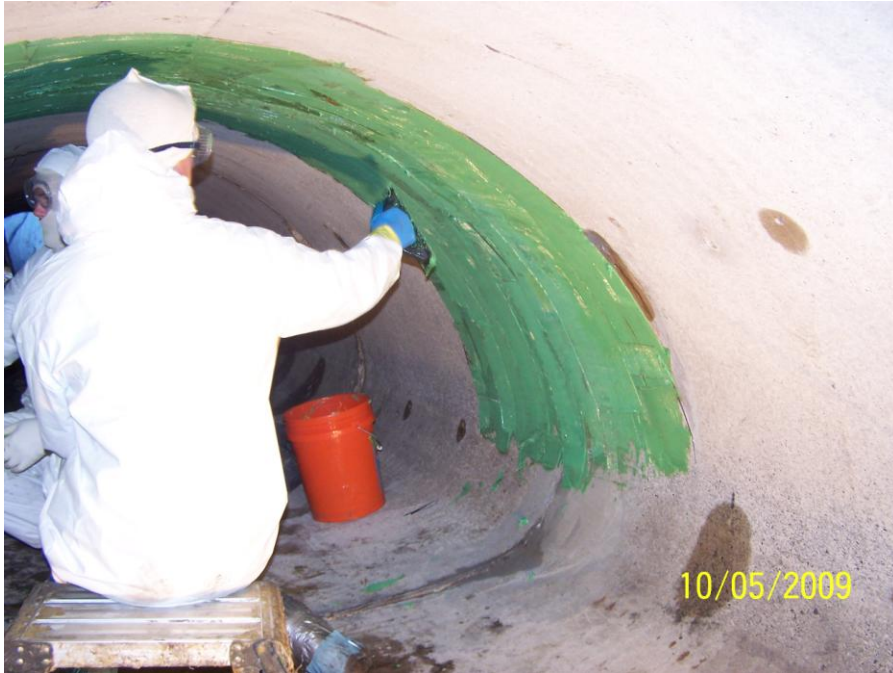
Photo 143: QuakeBond™ J201TC Tack Coat being installed. Does not need to be placed on the bottom.

Inside the pipe a tack coat called QuakeBond™ J201TC was placed on the sides and top to hold the fabric up. The saturated fabric was then placed around the pipe. Workers used squeegees to get any wrinkles out of the material. Two layers of fabric were placed on each joint.

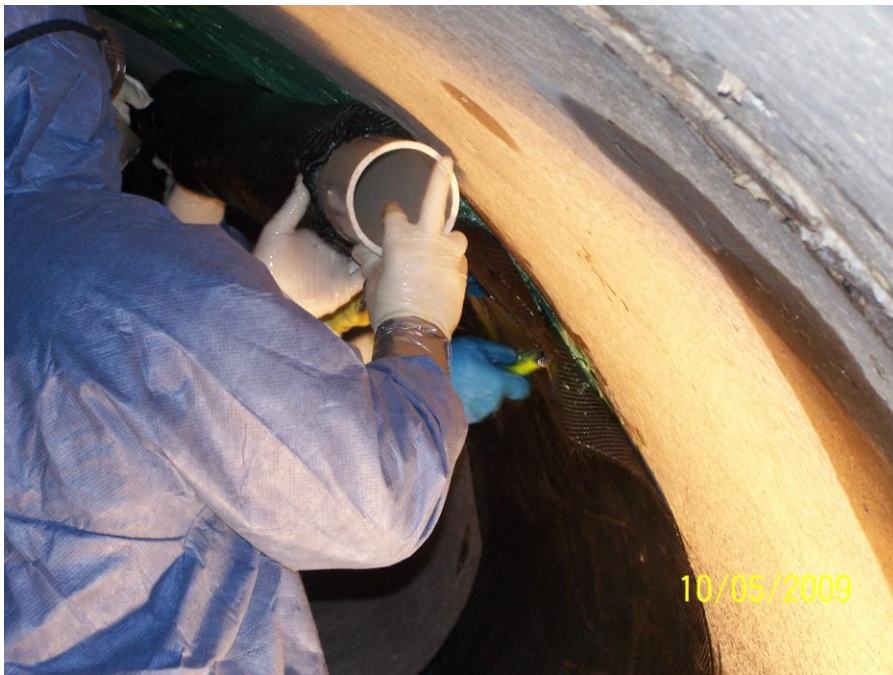
Photo 144: QuakeWrap™ TB20C Carbon Fabric being installed

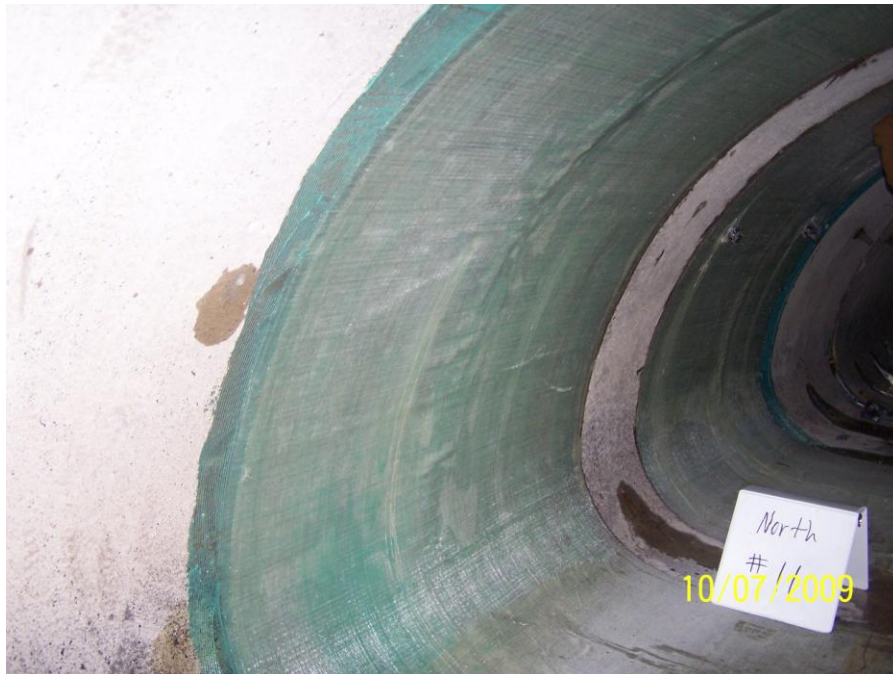
Photo 145: QuakeWrap™ VB26G Glass Fabric installed

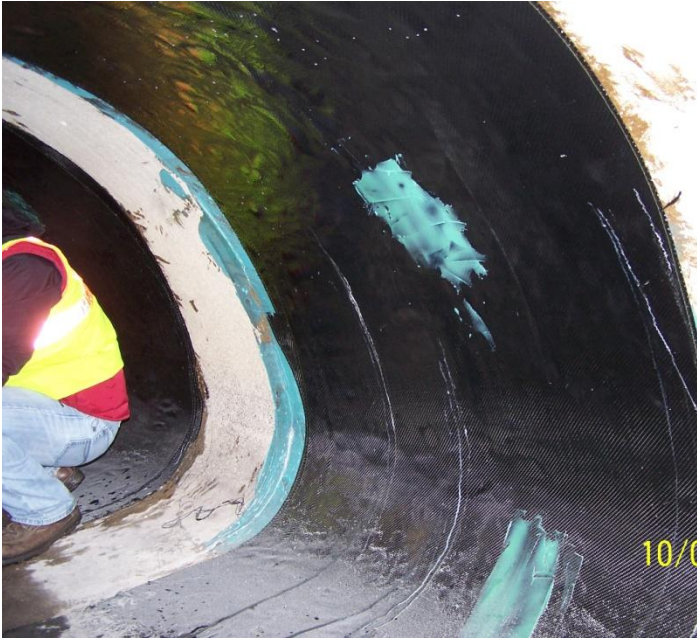
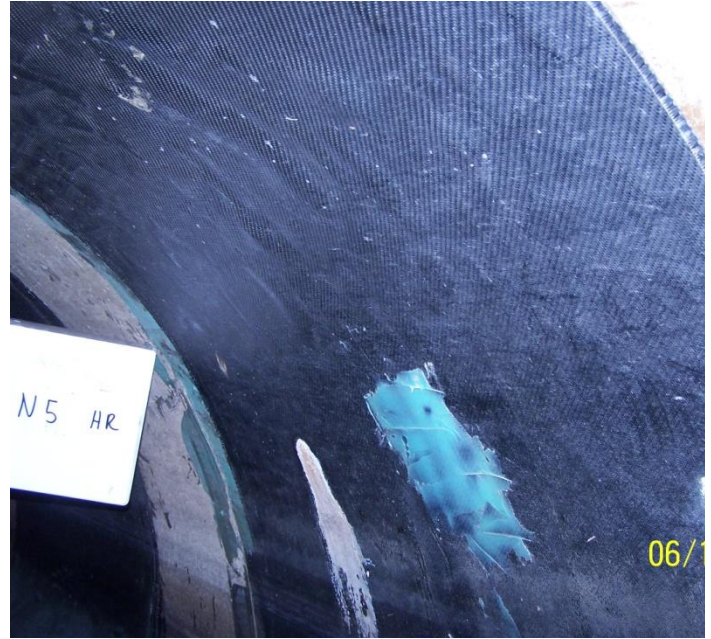
Photo 157: Carbon Fiber in 2009

Photo 158: Carbon Fiber in 2011

The QuakeWrap (Carbon Fiber and Fiberglass) bonded to the concrete very well and those joints remained sealed and didn't show any signs of movement.

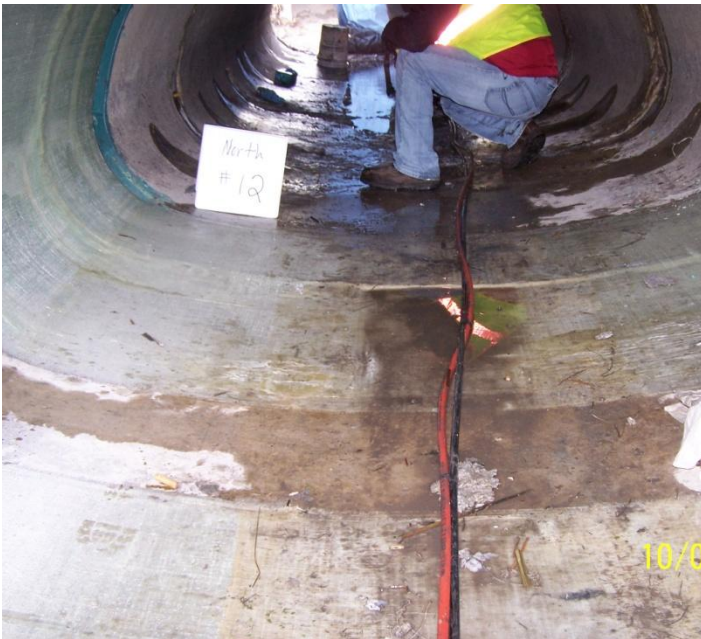
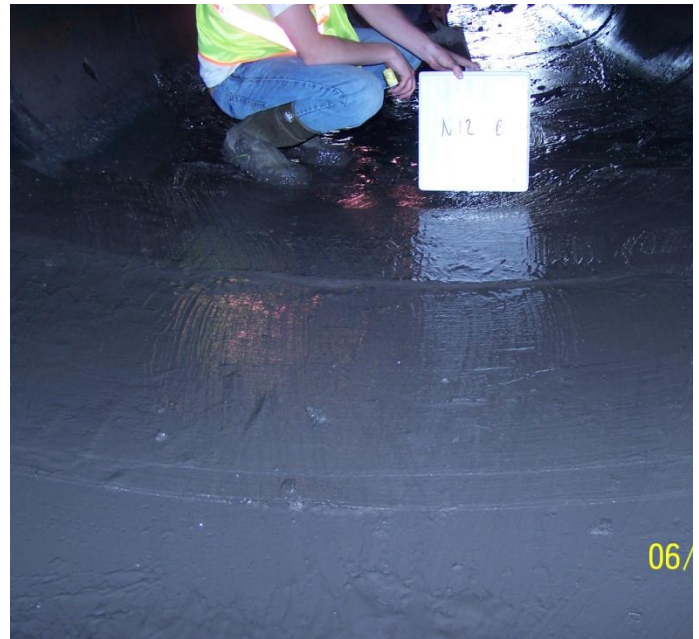
Photo 159: Fiberglass in 2009

Photo 160: Fiberglass in 2011
