Fiber-Reinforced Polymer Pipe Lining

Emergency repair to penstock allows power plant to enter service

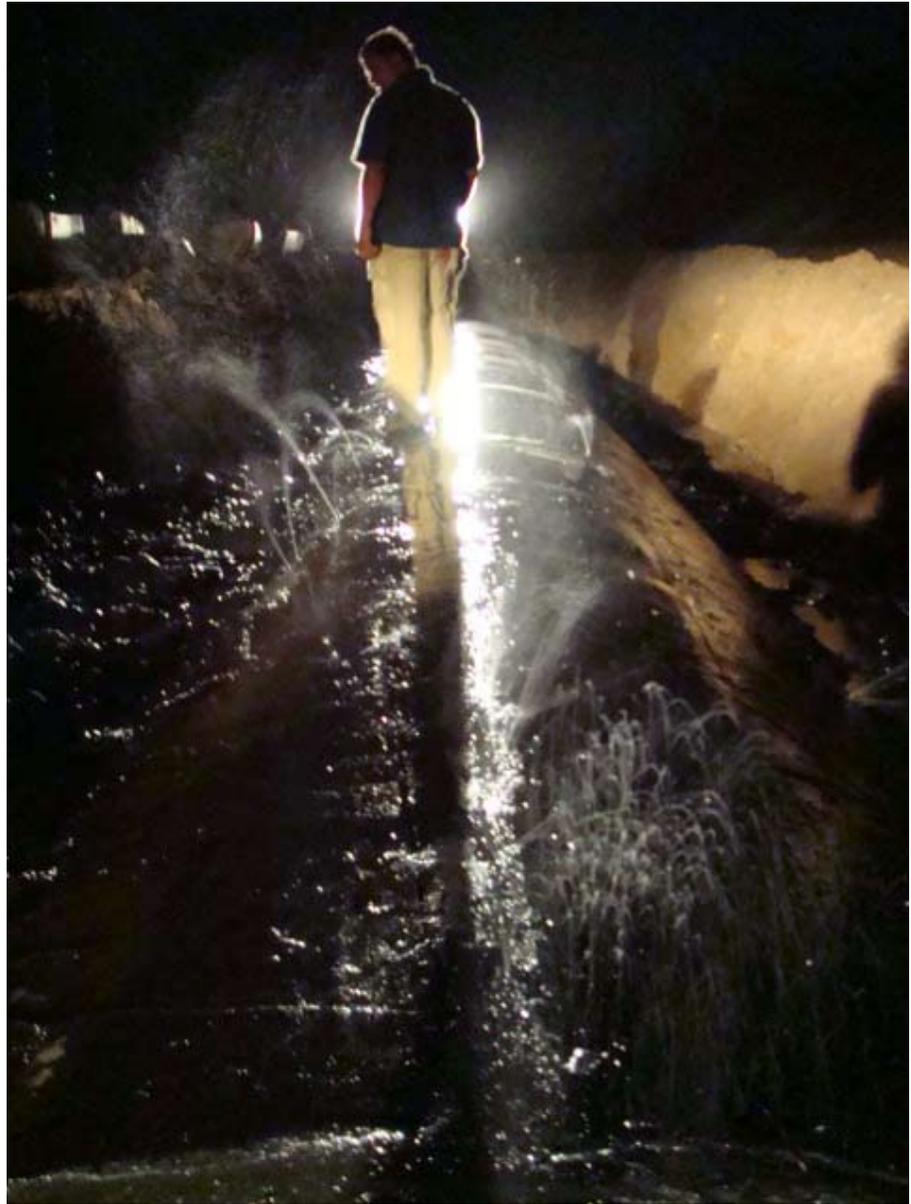
Before it was placed in service, a pressure test showed that the pipe had significant longitudinal and transverse cracking. As a result, as much as 20% of the flow was lost due to leaks. The penstock was drained and all visible cracks were sealed using locally available repair materials; but when it was pressurized for a second time, the repaired cracks continued to leak (Fig. 2).

Fig. 2: After conventional crack sealing, the penstock failed to pass a second pressure test.

We were then contacted to engineer repairs. After inspection of the cracks (Fig. 3), review of the structural plans, and consideration of the engineering reports pertinent to the leak issues, we determined that an FRP lining would provide a solution.

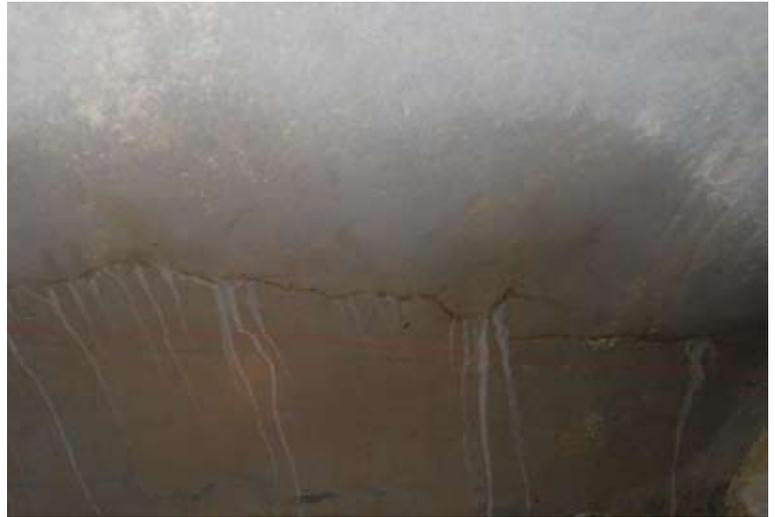
Fig. 3: A typical crack in the pipe wall

The FRP lining was designed to bridge cracks in the concrete, provide a moisture barrier, and supply additional hoop strength to compensate for future loss of circumferential steel due to corrosion. We designed the adhered FRP laminate to achieve full deformation compatibility with the pipe during pressurization, and we specified bidirectional glass fibers in the fabric to ensure that existing or future cracks are intercepted in orthogonal directions. It should be noted, however, that although the laminate will prevent water from leaking from or into the pipe, corrosion of the steel reinforcement will not be slowed significantly in this case due to the constant presence of seepage water in the cracks.

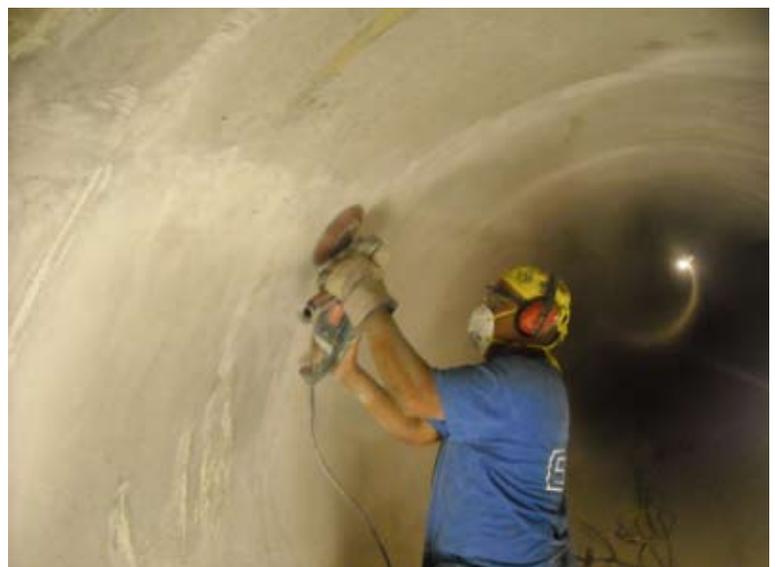
Fig. 4: Prior to installation of the FRP lining, surface preparation included grinding

Before an FRP lining can be applied, the substrate must be prepared to maximize contact and bond strength. The inside of the pipe was pressure washed with 7,000 psi (50 MPa) machines to remove scour, sediment, curing compounds, and any other substance that could hinder the bond between the FRP and the pipe surface; surface irregularities (such as roughness at construction joints and fins at formwork joints) were ground smooth (Fig. 4).

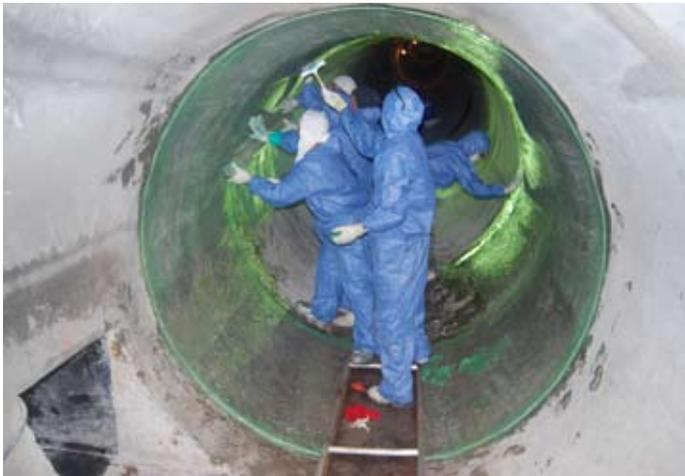
Fig. 5: Installation of FRP sheets on the interior surface of the pipe. An access point is visible at the lower left

To help prevent the joints in the lining from being lifted by the water flow, the installation direction was opposite to the flow direction. An installation crew initially applied an epoxy paste to the top half of the penstock. This not only sealed the surface of the concrete to prevent the dry concrete from absorbing excessive resin from the saturated fabric but also prevented peeling of the saturated FRP fabric before the resin cured. Figure 5 shows the installation of the first roll of FRP lining material at one of the installation stations. After they were saturated with resin, 50 in. (1,270 mm) wide bands of fabric were rolled onto the prepared surface—much as one would install wallpaper.

Because gravity helped to hold the FRP fabric in place, only a seal coat of epoxy resin was used to prevent the dry concrete from absorbing excessive resin from the fabric in the lower half of the pipe. The edges of the fabric bands were lapped in the circumferential and longitudinal directions to achieve full continuity of the FRP. To help prevent delamination, the edges of the laps were feathered with epoxy paste or resin.

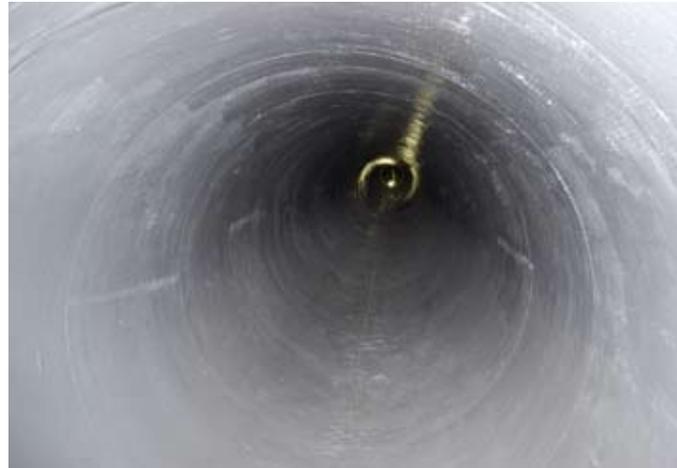
Fig. 6: Completed lining, including gray top coat, prior to testing

The final step involved installation of an epoxy top coat as a cover for all the installed FRP. This coat was designed to protect the laminate against abrasion caused by sediment carried by the river water as well as to cover possible pinholes in the FRP lining. The coating has a concrete gray color to facilitate quality control by providing a visual indication that the light green-colored FRP lining was fully covered. The top coat application took place before the lining was fully cured (the lining surface was tacky on contact) to ensure maximum bond.

The average rate of production of each of the four installation stations was 2,500 ft.² (230 m²) of FRP lining installed in an average 8-hour work day. The operation continued 7 days a week, allowing the complete installation of approximately 150,000 ft.² (14,000 m²) of the FRP lining system in 15 calendar days. This time included the application of the epoxy top coat. The FRP lining installation was completed on July 8, 2009 (Fig. 6), and pressurized test runs were successfully completed on July 15.
