Pipeline Rehabilitation amidst Environmentally Sensitive Location

Abstract

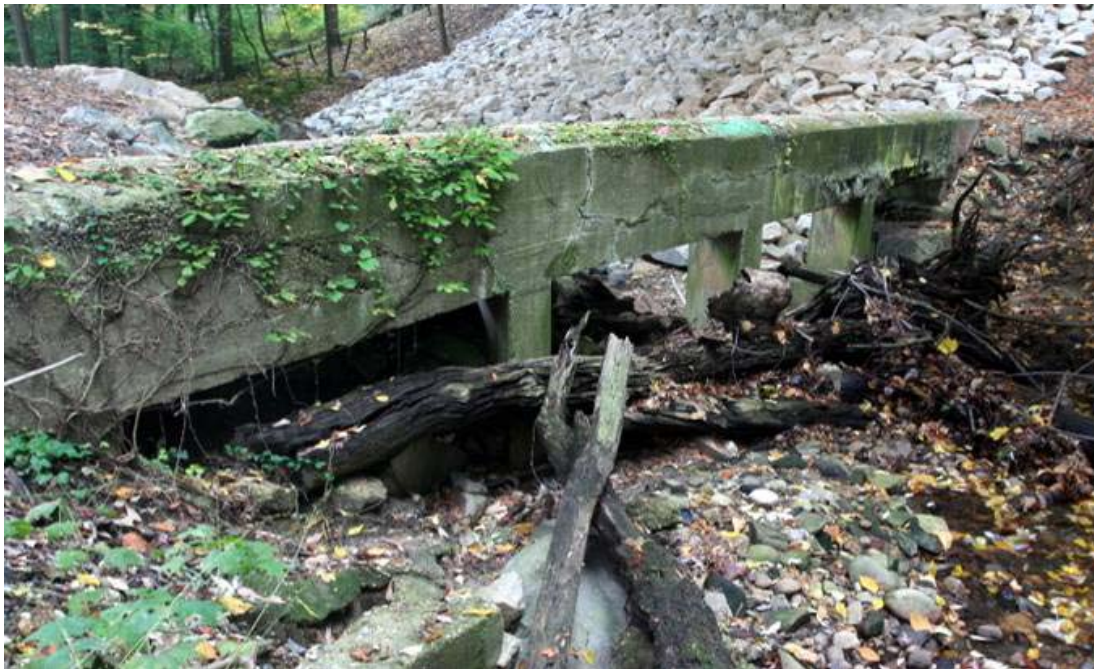
Figure 1. Original condition of the Klinge Creek aerial sewer

The crossing consists of an 18 inch pipeline which was encased in 30-in by 30-in concrete. The crossing is 40 ft in length and has four intermediate support piers along the length of the crossing as well as footings positioned on the banks of the creek. As shown in Figure 1, the original condition of the aerial sewer indicated substantial concrete cracking and spalling. Debris was blocking the stream creek, which altered the profile of the bank and had eroded the footings.

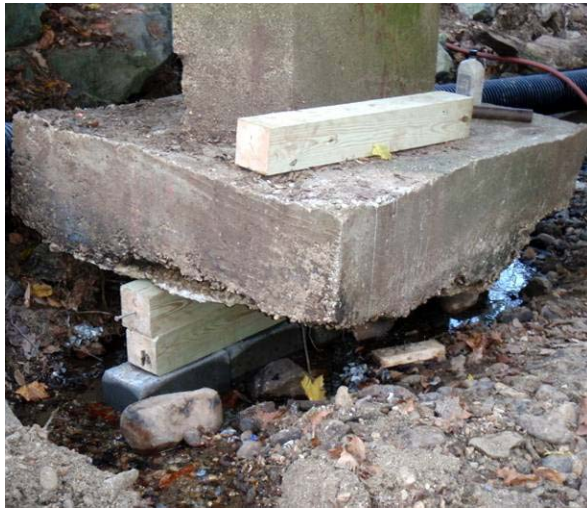
The soil adjacent to the two piers located within the path of the creek had undergone such extensive erosion that the piers were 100% suspended. One of the piers was suspended above the soil by approximately 24 inches, as shown in Figure 2 a. The other pier which was located within the path of the creek flow had separated from main structure on December 10, 2009 such that an approximately 6in gap exists between the pier and the aerial sewer crossing. This separation of the pier from the main structure occurred two days after bypass was started, so a potential spill was prevented, but the unrepaired aerial crossing provided substantial risk of failure. Because of the location within Klinge Creek of the National Park Services, any sewage spill would have resulted in steep fines and negative press.

a. Pier suspended approximately 24 in.

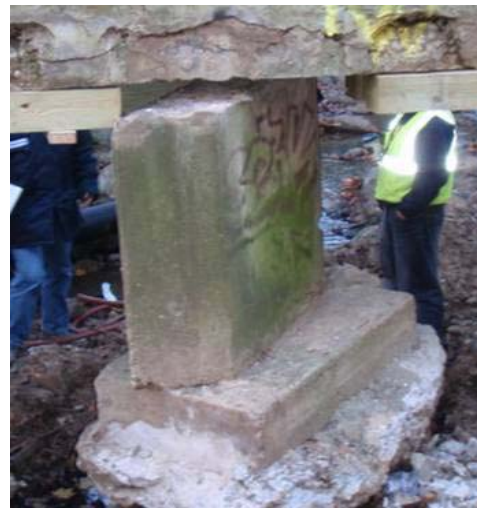
b. Pier separated from the main structure

Figure 2. Deteriorated condition of the existing abutments

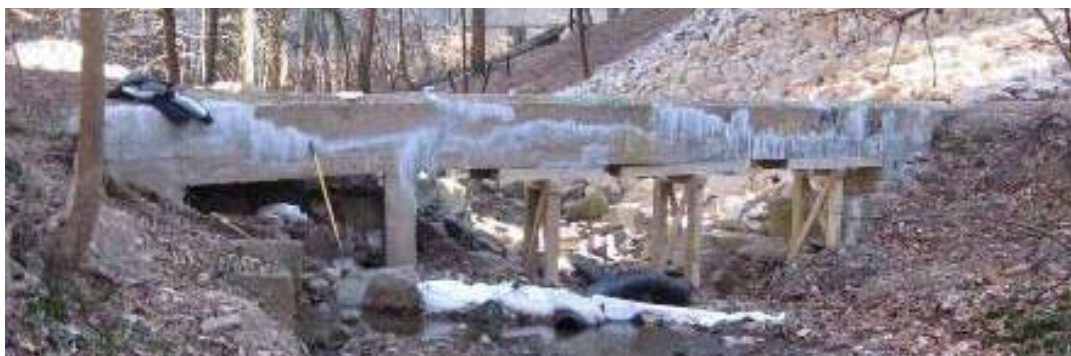
A field inspection performed by J.W. Marshall and Associates in January 2010 showed that the central two footings shown in Figure 2 had been completely removed and replaced with wooden temporary support structures as shown in Figure 3 (Marshall, 2010).

Figure 3. Temporary support structures observed at time of Jan 2010 inspection

An investigation of the footings indicated inadequate footing size and concerns regarding their capacity and stability of the footings to safely support the aerial sewer crossing (Marshall, 2010). Recommendations for action provided by J.W. Marshall to DC Water included foundation improvement, measures to increase the abutment size, and riprap placed around the footings to manage future erosion. These recommendations were implemented by DC Water and the capacity increase provided to the footings in conjunction with carbon fiber wrap strengthening provided to the concrete encased pipeline allowed for the permanent removal of two central footings which were previously located in the direct path of the creek.

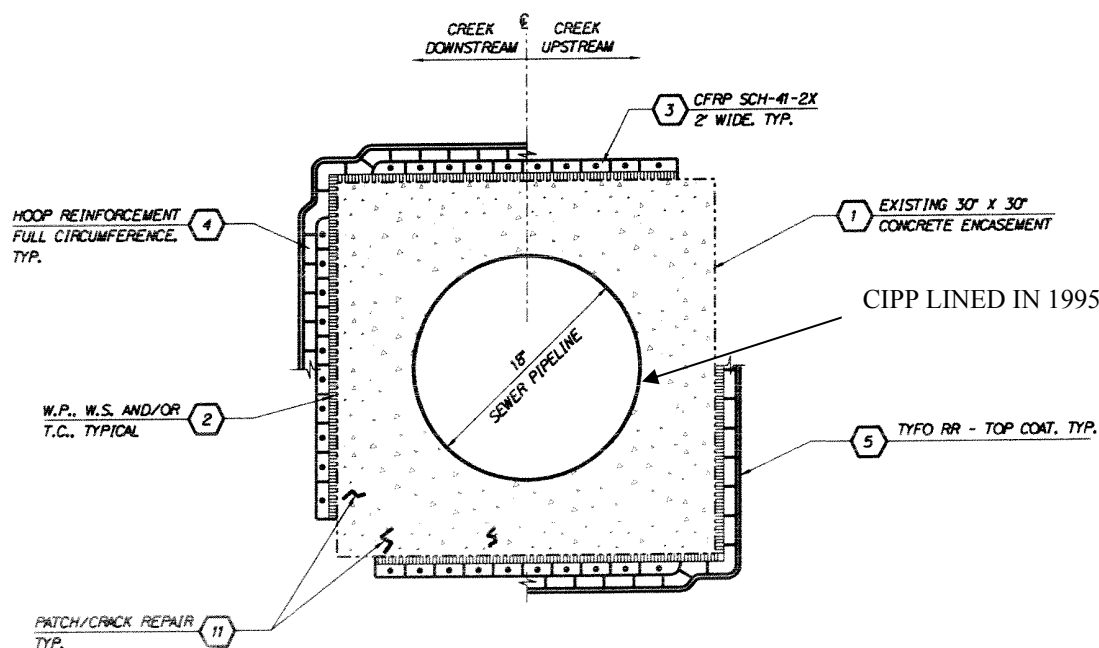
Figure 4. Typical Cross Section of Concrete Encasement (Analytical, 2010)

debris as well as storm flood water acting on the crossing up to the top of the encased sewer were also considered in the design (Bian, 2010). The design accounted for moments, shears, and allowable deflections in both the horizontal and vertical directions. In order to accomplish these strengthening objectives, Analytical Engineering provided a carbon fiber wrap design using Fyfe Company's Tyfo[®] Fibrwrap[®] System in to provide structural integrity in the longitudinal and circumferential direction for the crossing, as shown in Figure 4 and Figure 5.

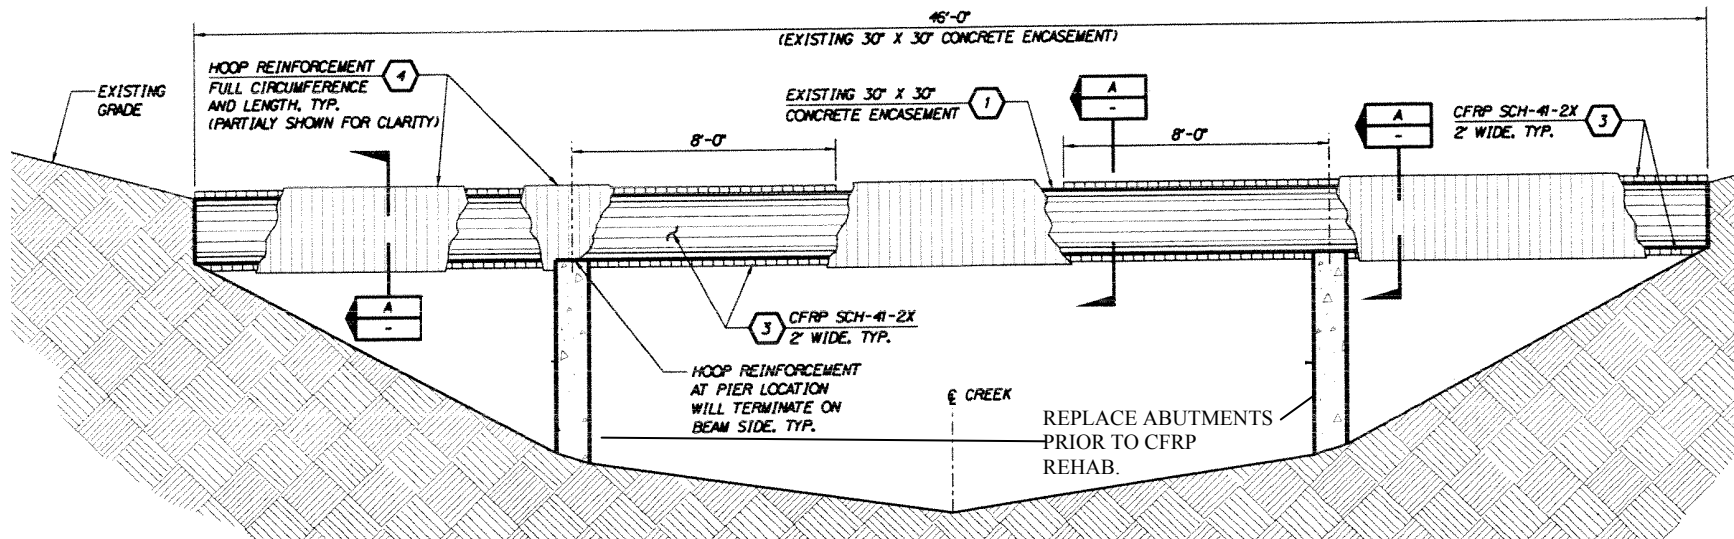
Figure 5. Profile of Existing 30-in x 30-in Concrete Encasement (Analytical, 2010)

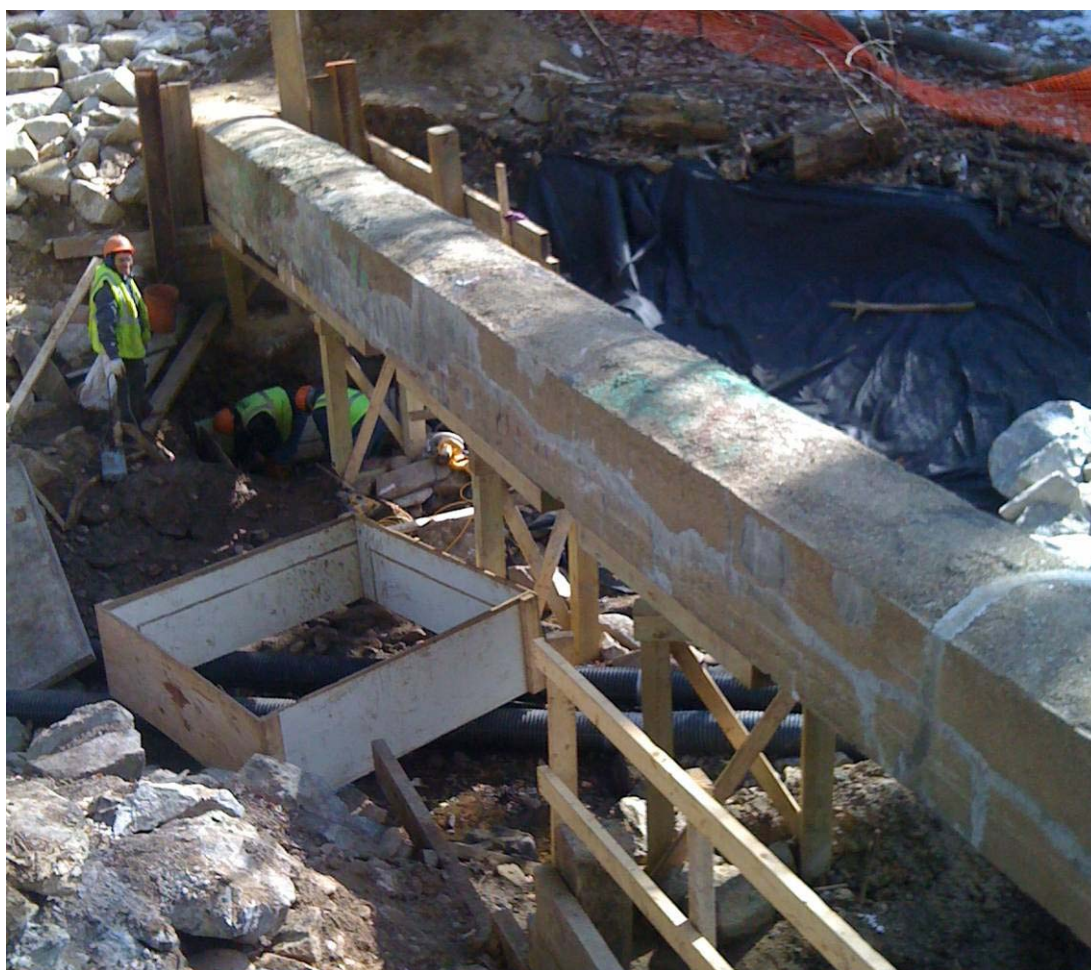
Figure 6. Aerial sewer under construction with supporting scaffolding

Prior to the executing the carbon fiber wrap portion of the scope of work, the repair of the footings and abutments recommended by J.W. Marshall and Associates were performed. While work was being performed on the crossing, the water from the creek was routed through bypass piping, as shown in Figure 6, to allow for a safe and dry construction site and to avoid potential for environmental contamination of the creek with construction debris.

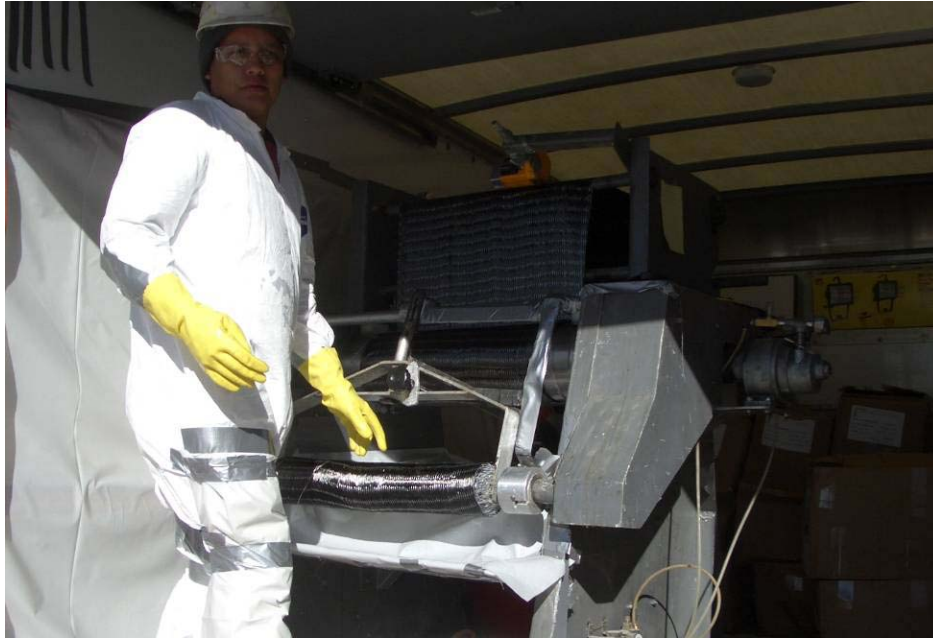
Figure 7. Carbon fiber sheet, impregnated with Tyfo[®] S epoxy

Once the surface preparation was completed, the carbon fiber fabric sheets were saturated with Tyfo[®] S epoxy resin system using the saturator machine shown in

Figure 7. The use of the saturator machine ensured full saturation of the carbon fiber wrap and allowed for tight quality control on the resin to fiber ratio provided for the carbon fiber composite system. Sheets of the Tyfo[®] Fibrwrap[®] carbon fabric were applied to the structure in the longitudinal and circumferential direction as shown in Figure 4 and Figure 5 in order to meet the project requirements.

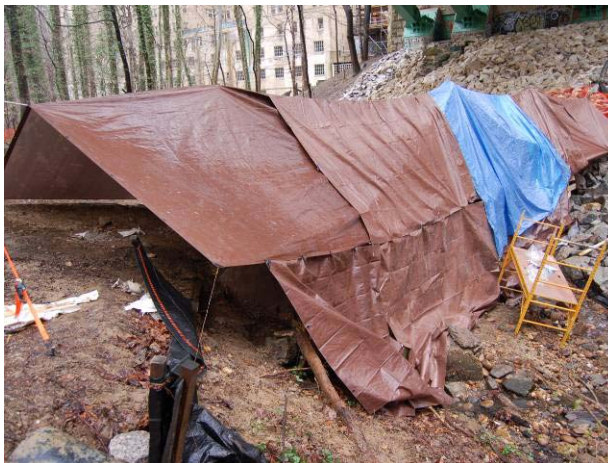
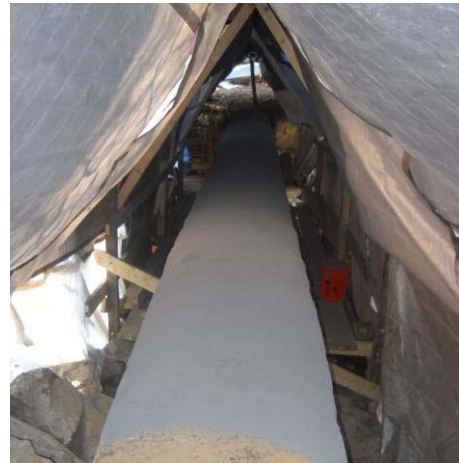
Figure 8. Tenting of project in order to provide environmental control

Since the carbon fiber strengthening operation was performed in March during varying weather conditions, the work area was tented as shown in Figure 8 such that the work area could be temperature controlled to allow for optimum curing conditions for the carbon fiber wrap system. A final top coat of the Tyfo[®] RR was applied as a UV and fire protection coating as well as an aesthetically pleasing finish to fit in with the surrounding setting at Klinge Creek of NPS.

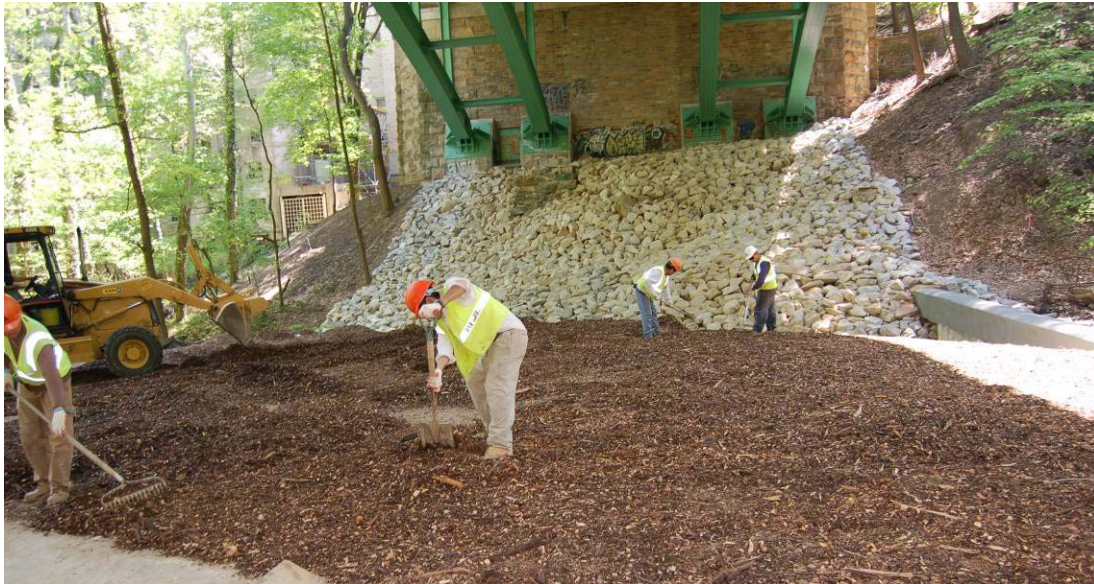
Figure 9. Environmental restoration of the surrounding area

Once Fibrwrap Construction's carbon fiber strengthening work was complete, the site along the stream and at the embankment was restored per the National Park Service's requirements as shown in Figure 9. The completed restoration of the Klinge Creek aerial sewer is shown in Figure 10.

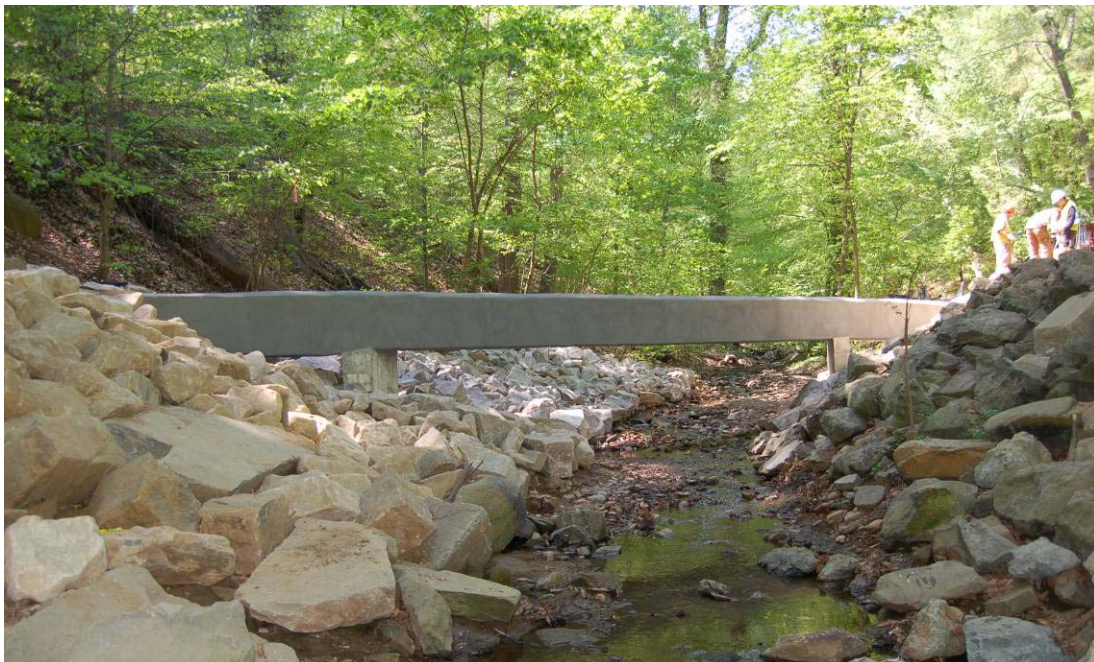
Figure 10. Completed restoration of the Klinge Creek aerial sewer
