WORLD'S LARGEST PROJECT ON PIPE RENOVATION WITH FRP COMPLETED AHEAD OF SCHEDULE

Mo Ehsani, Ph.D., P.E., S.E. & Carlos Peña, M.S., P.E.

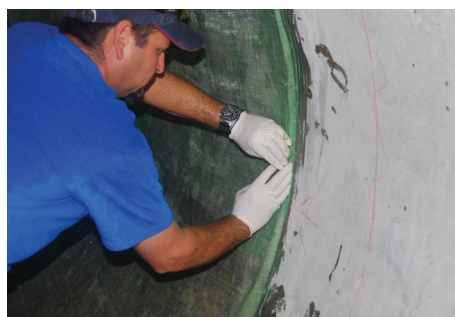
Figure 8: Construction joint of FRP lining

Specially designed construction joints (Figure 8) were prepared at the starting point of each installation run, which also became the end points of the installation front that started at a downstream access point. The joint was later sealed with an epoxy paste. Nowhere in the 5,742 ft. length of the pipeline were FRP lining edges left exposed to peeling from water

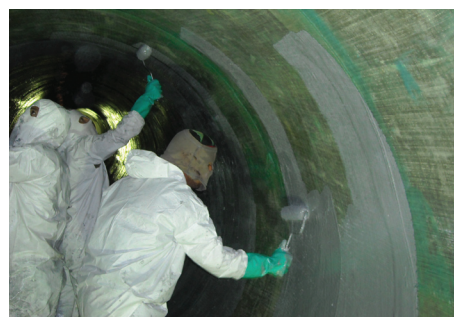
Figure 9: Application of epoxy top coat

viously, was used to provide abrasion protection for the FRP, as well as to seal any remaining pores in the installed FRP laminate. Figure 9 shows the application of the top coat. The application took place before the lining was fully cured (surface was still tacky on contact) to ensure maximum bond.

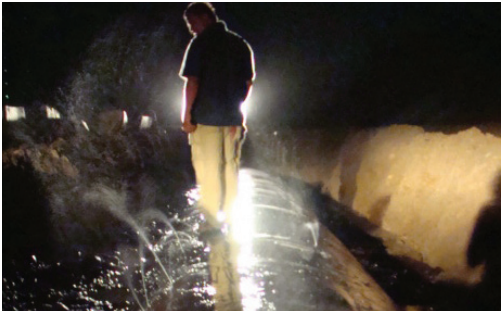
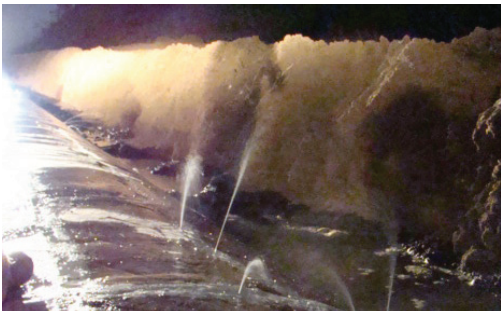
able locally. When the pipeline was pressurized again, the repaired cracks again leaked. The leaking at the repaired cracks was most likely due to the increase in the crack width due to the deformations of the pipeline caused by the increase in internal pressure. Given the rigidity of most crack sealing materials, full deformation compatibility between the repair material and concrete could not be achieved,

Figure 2: Leaking after conventional crack sealing

degrading the seal and allowing leaks to reoccur. Figure 2 illustrates typical leaks occurring at two locations along the length of the pipeline during tests conducted at maximum operational pressure.

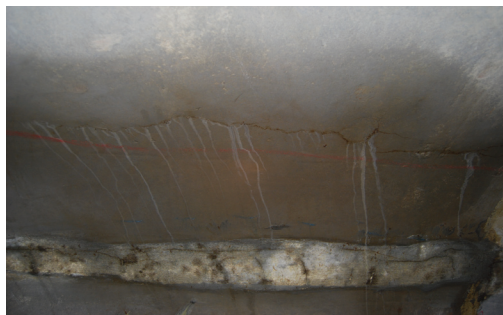
Figure 3: Seepage water draining into pipeline

water was observed draining through some of the longitudinal cracks (Figure 3). It was at this point that QuakeWrap's Mexico (QWM) office was contacted for engineering consultation to repair the longitudinal cracks. A site visit was quickly arranged for one of QWM's structural engineers. The engineer inspected the cracks, reviewed structural plans and available local engineering reports pertinent to the leak issues, and identified the main cause of the problem.

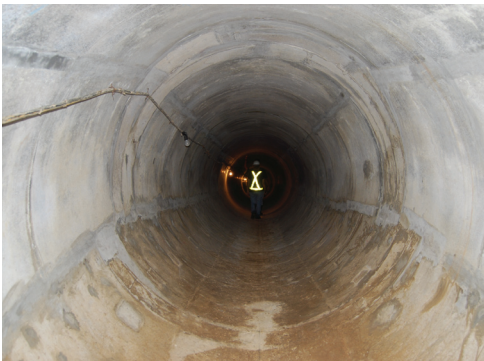
such as Prestressed Concrete Cylinder Pipe (PCCP). Figure 4 shows the typical condition of the interior surface of the pipeline prior to initiating prep work activities. Evidence of cast in place procedures can be observed, such as construction joints, formwork fins, etc. The pipeline was pressure washed with 7,000 psi (482 bar) machines to remove any scour, sediment, and curing compounds, or

Figure 4: Initial interior surface conditions of the pipeline

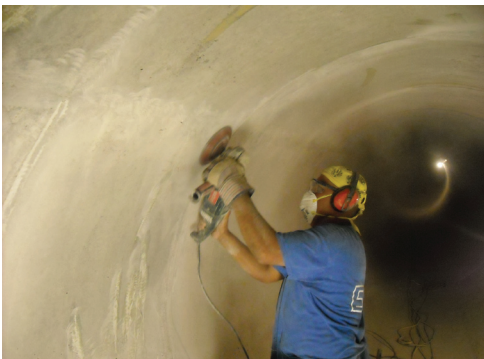
Figure 5: Prep work activities prior to installing FRP lining

any other substance that could hinder the bond between the FRP and the pipe surface. Figure 5 shows grinding of protrusions on the interior surface of the pipeline.

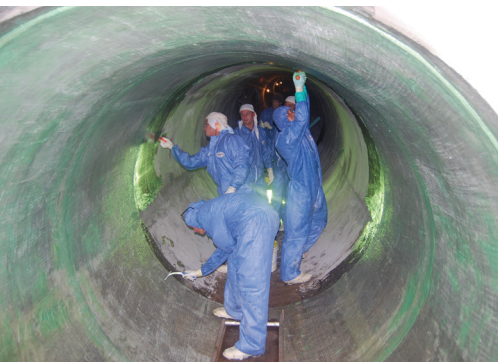
Figure 7(a): Epoxy paste installation on top half of pipeline

Figure 7a illustrates the application of an epoxy paste to the top half of the pipeline; the main purpose of the paste is to prevent peeling due to the weight of the saturated FRP fabric, and to seal the surface to prevent excessive absorption by the dry concrete surface of the epoxy resin from the saturated FRP fabric. Figure 7b shows the installation of the first roll of FRP lining material at one of the

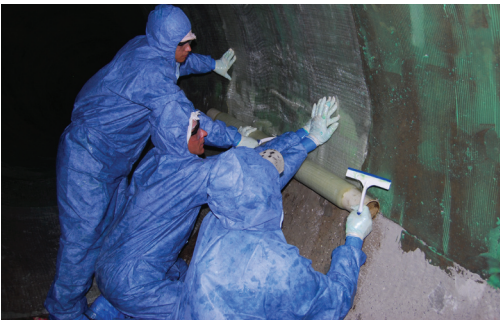
Figure 7(c) Transitions between top and bottom half installation

installation stations. The access point is clearly visible on the lower left portion of the figure. Figure 7c shows the transition between the top and bottom half installation. Notice that there is no epoxy paste used in the lower half. Since gravity effects in this area tend to hold the FRP fabric in place, only a seal coat of epoxy resin was used to prevent excessive absorption from the saturated fabric. Figure 7d illustrates overlap and fabric edge detailing. Detailing is done with epoxy paste and/or epoxy resin to feather down edge fibers, and to secure in place the overlaps in the lining.
