Pressure Testing of PipeMedic™ Laminate

Link-Pipe

Mo Ehsani, Ph.D., P.E., S.E.

This report summarizes a test of a PipeMedic™ laminate that was conducted at the offices of Link-Pipe in Richmond Hill, ON.

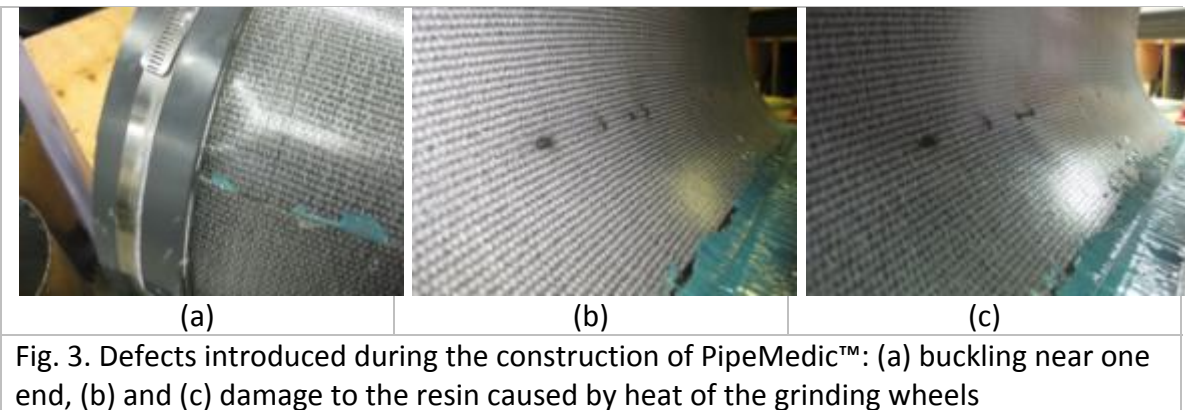
During the assembly of PipeMedic™, a small bulging (buckling) of the laminate developed at one end when the 2-inch wide end support rings were being bonded (Fig. 3a). This was caused by over-tightening of the hose clamps that were used to affix the end support rings to the PipeMedic™. Attempts to fix this were not successful and the defect remained. Additionally, three small areas where the bumps were intentionally introduced along the PipeMedic™ assembly (Figs. 3b and 3c) to simulate the protrusions that may be present in a damaged pipe or a pipe surface that has not been properly prepared or sandblasted.

It is interesting to note that the final failure of PipeMedic™ was not due to the defects that were introduced during its assembly, namely the buckled portion at one end and the burnt epoxy shown in Fig. 3.

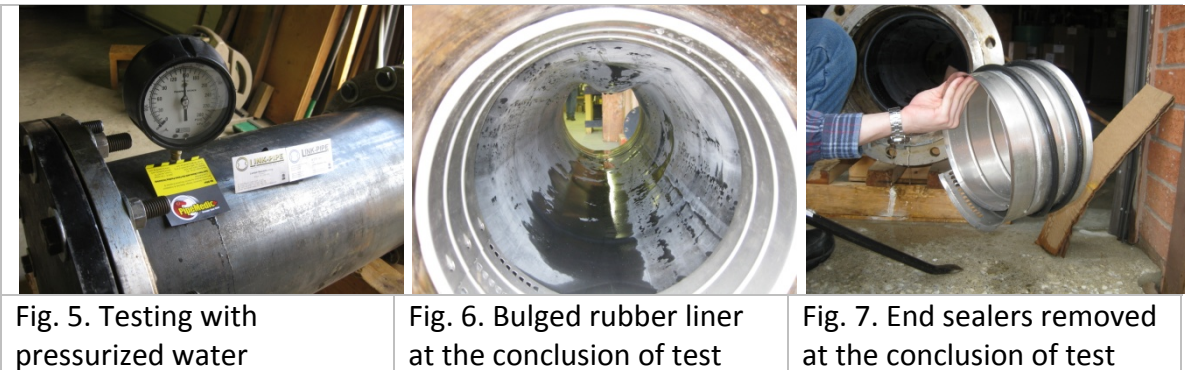
The pipe end caps were removed. Around the failure point in the middle point of the test assembly, a bulging of the rubber liner could be seen at the top (Fig. 6). The Link-Pipe end sealers and the rubber liner were taken out (Fig. 7). Inspection of the rubber liner showed a small tearing of about 3/4 inches near the bulged location at midspan. This hole had allowed the water to leak out of the system.

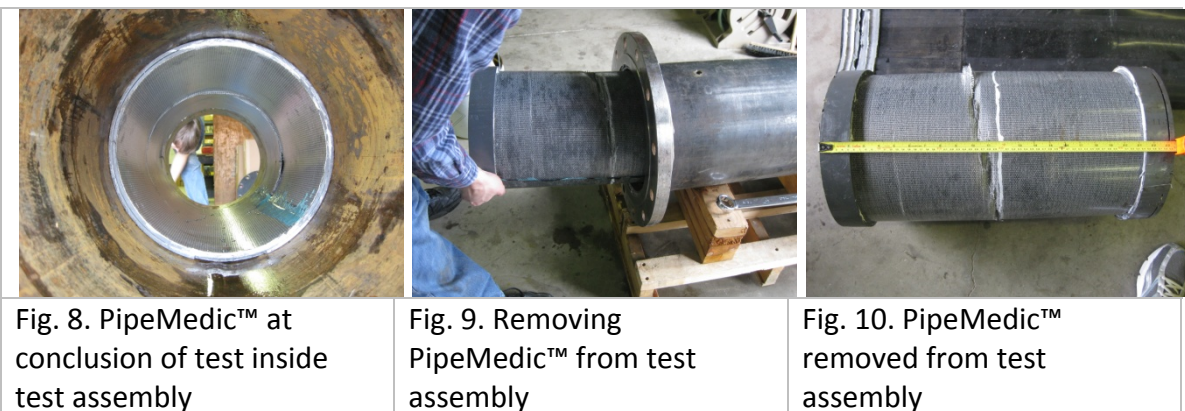
A view of the PipeMedic™ inside the test assembly showed tension failure in a semi-circular pattern near the midspan that extended over the single-ply region of PipeMedic™ (Fig. 8). Next, the PipeMedic™ assembly was taken out by hammering a wooden block on one end of it to force it move towards the other end of the assembly (Fig. 9). Figure 10 shows the PipeMedic™ assembly taken out of the test assembly.

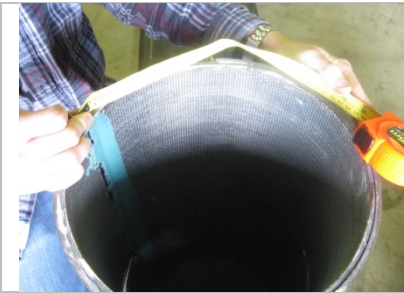
As seen in Fig. 11, the damage in PipeMedic™ was in the single-ply zone and the 14-inch region of the circumference where the PipeMedic™ was overlapped (two plies) was not damaged at all. Fig. 12 shows a close-up view of the failure zone and as highlighted in

Fig. 11. Overlap (two-ply) region of PipeMedic™

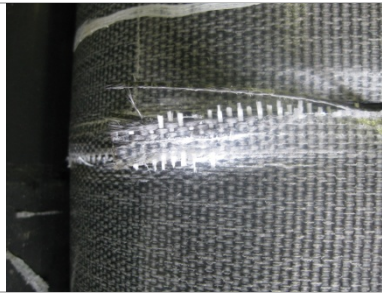
Fig. 12. Close up view of failure region

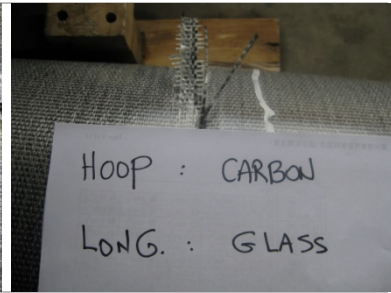
Fig. 13, the failure of PipeMedic™ at a pressure of 240 psi was due to axial tension failure of the small amount of glass fibers that were present in the longitudinal direction. If the more common PipeMedic™ product PC2.2, for example, were used this mode of failure could be avoided, resulting in significantly larger failure pressure.

Fig. 13. Close up view of the fibers in PipeMedic™
