Case Study: Repairing damaged manhole cover using QuakeWrap FRP

District of Columbia Water and Sewer Authority contracted QuakeWrap and FRP Construction to strengthen one of their manholes to withstand a backflow event. QuakeWrap engineers designed a retrofit plan increasing the manhole's tensile strength utilizing a combination of carbon and glass Fiber Reinforced Polymer (FRP).

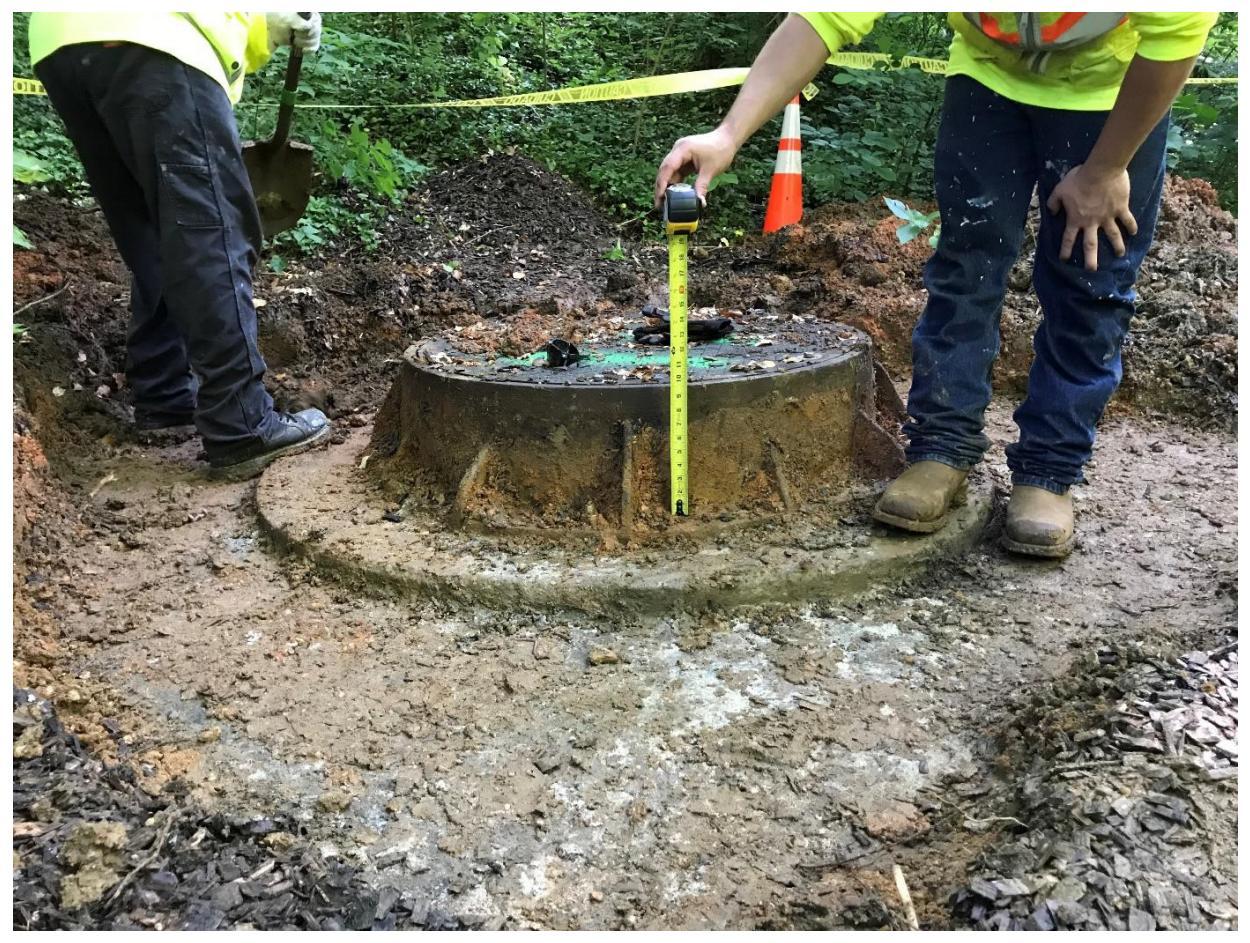
To accomplish this repair, specialty installers FRP Construction first exposed the foundation of the manhole (Fig. 1).

Fig. 1 Exposure of manhole for surface prep.

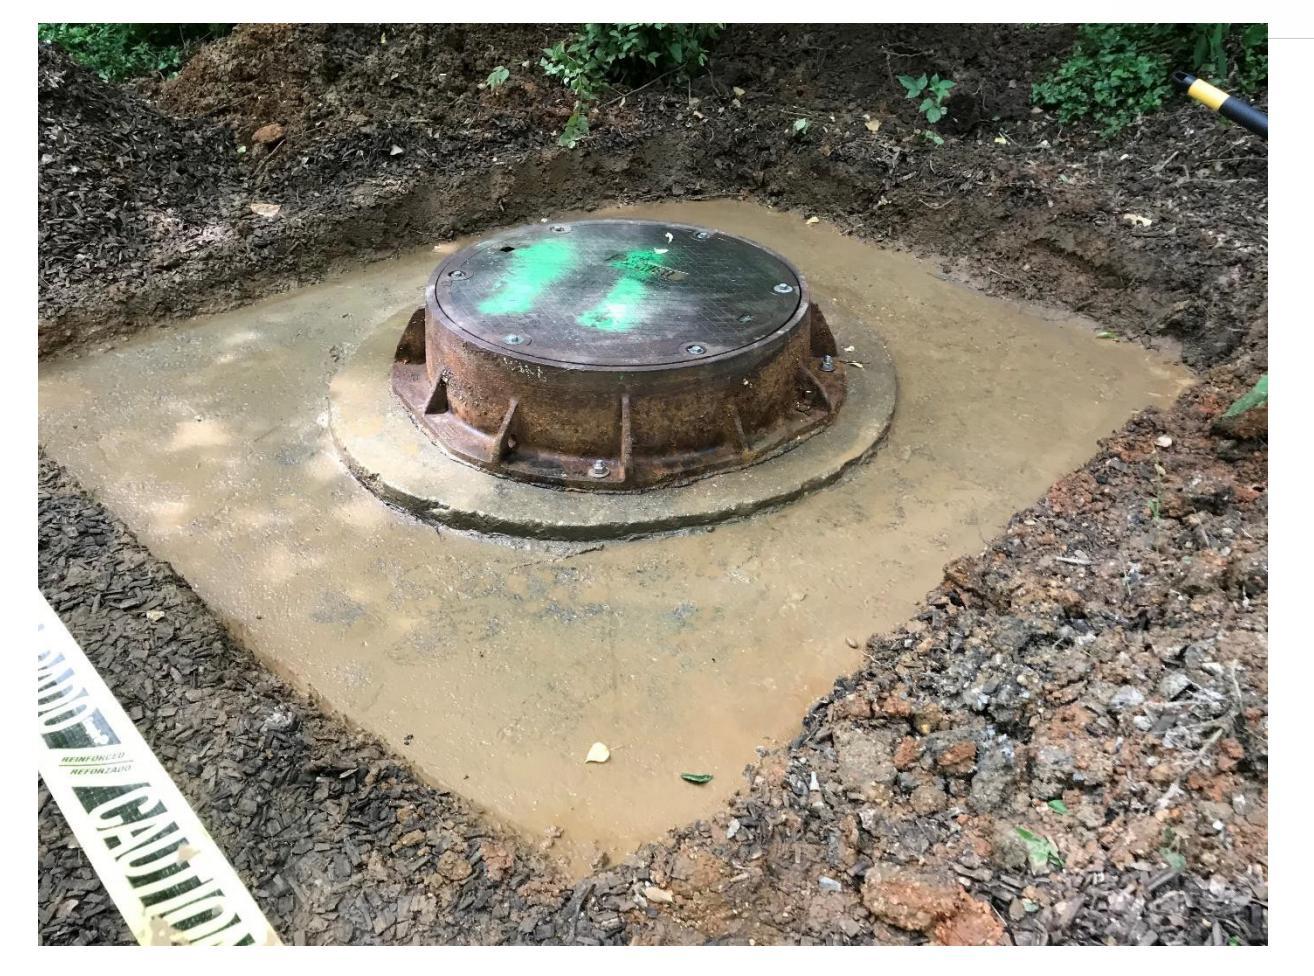
Next, the foundation and manhole were cleaned for installation of grout slope (Fig. 2).

Fig. 2 Foundation cleaned.

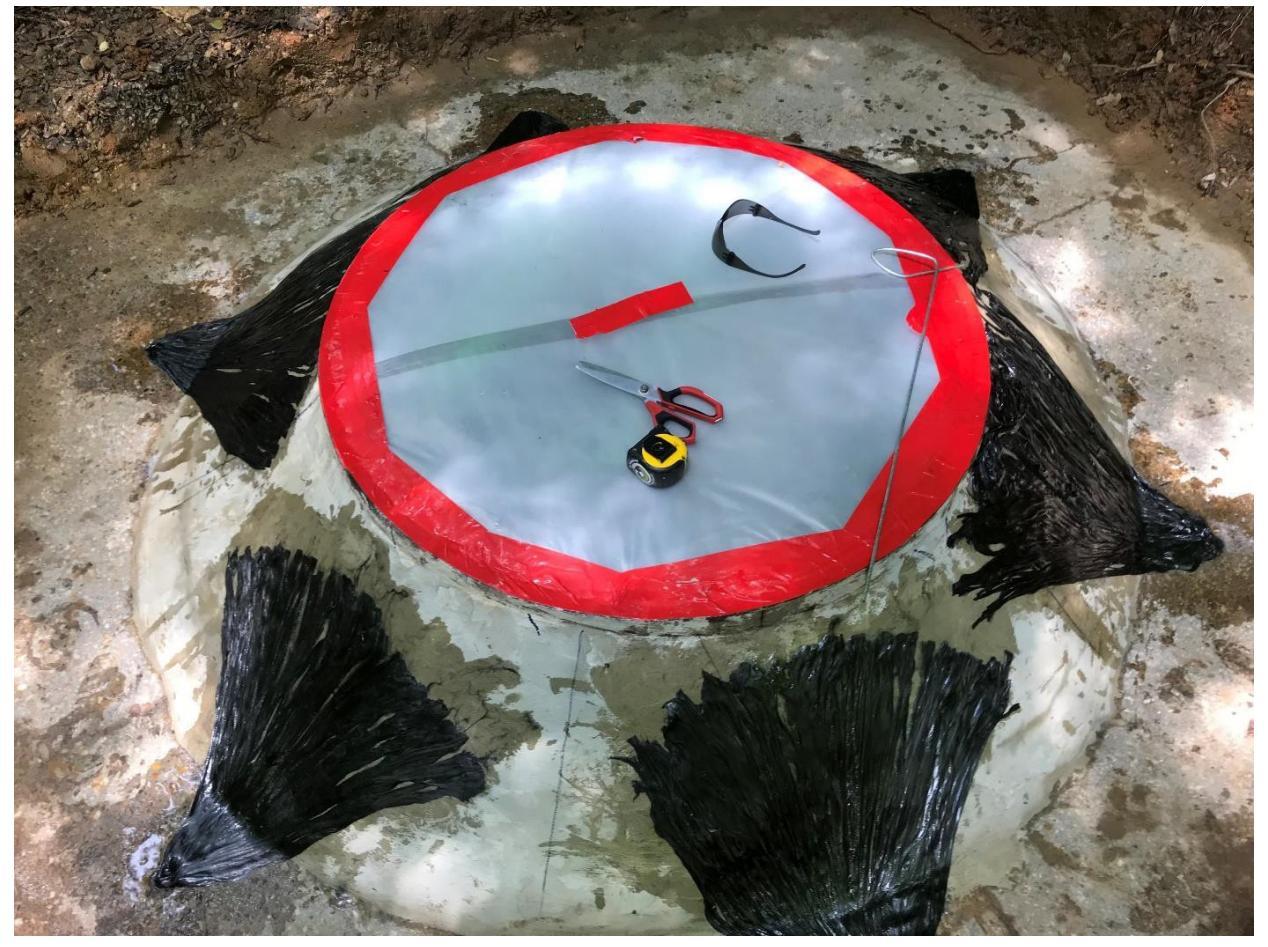
All exposed concrete was surface prepared for installation of FRP. The manhole was wrapped in containment plastic to protect it from epoxy (Fig. 4).

Fig. 4 Placement of Carbon FRP

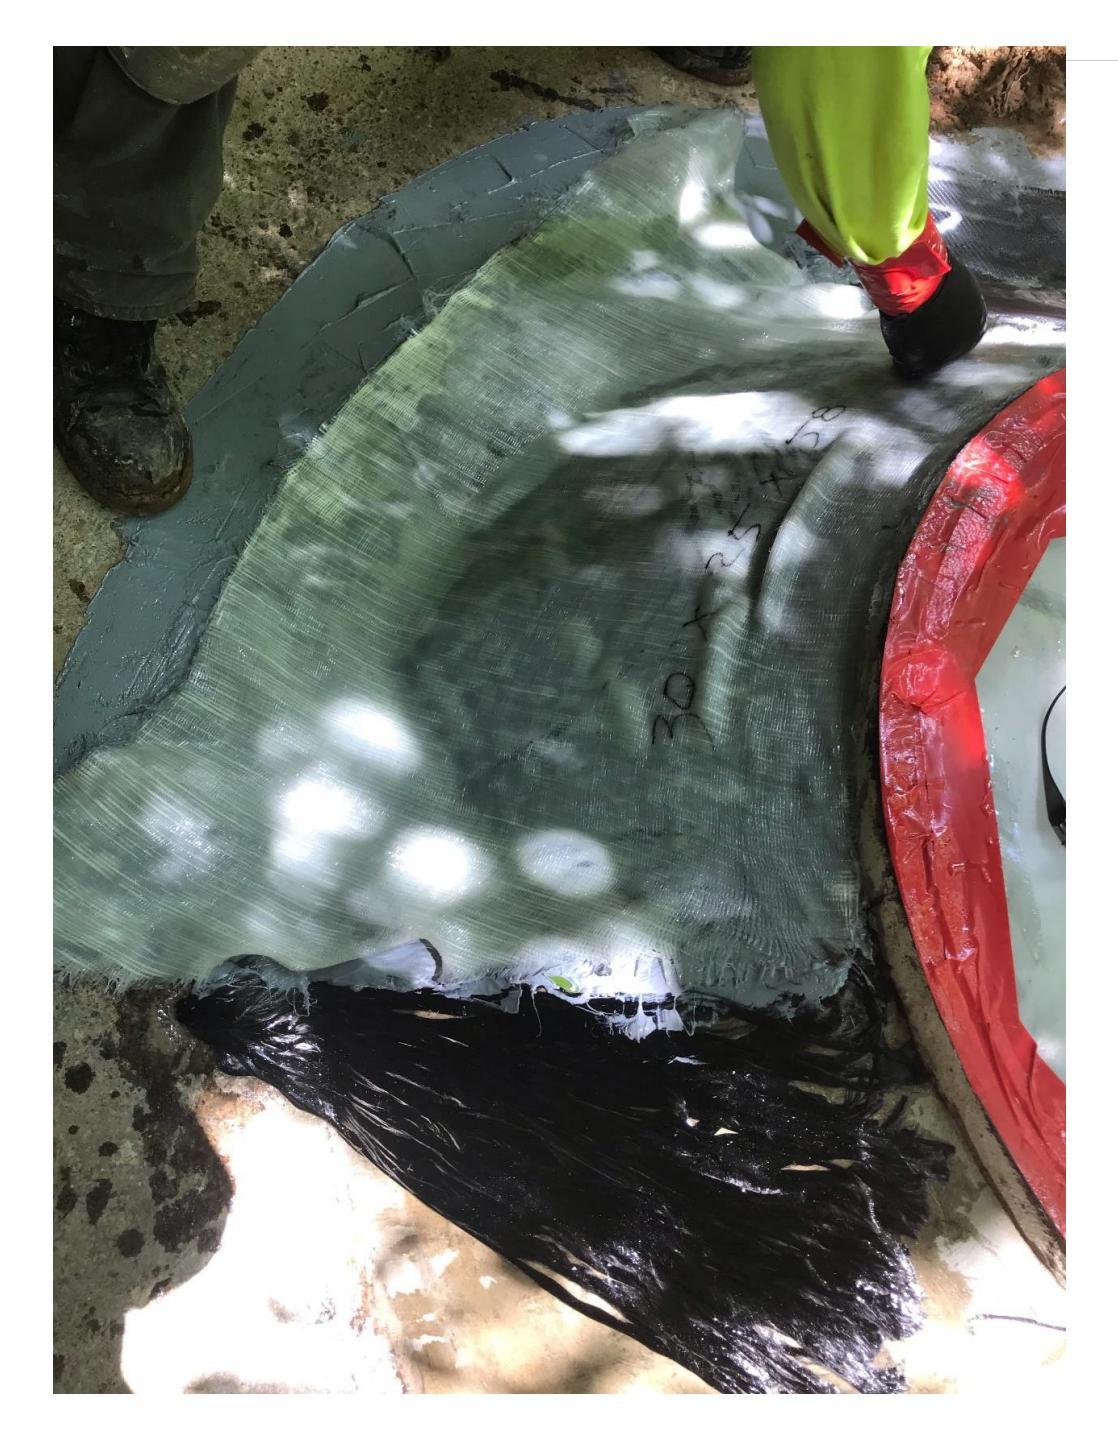
Glass fiber was then placed over the top of the carbon fiber anchors (Fig. 5).

Fig. 5 Placement of Glass FRP

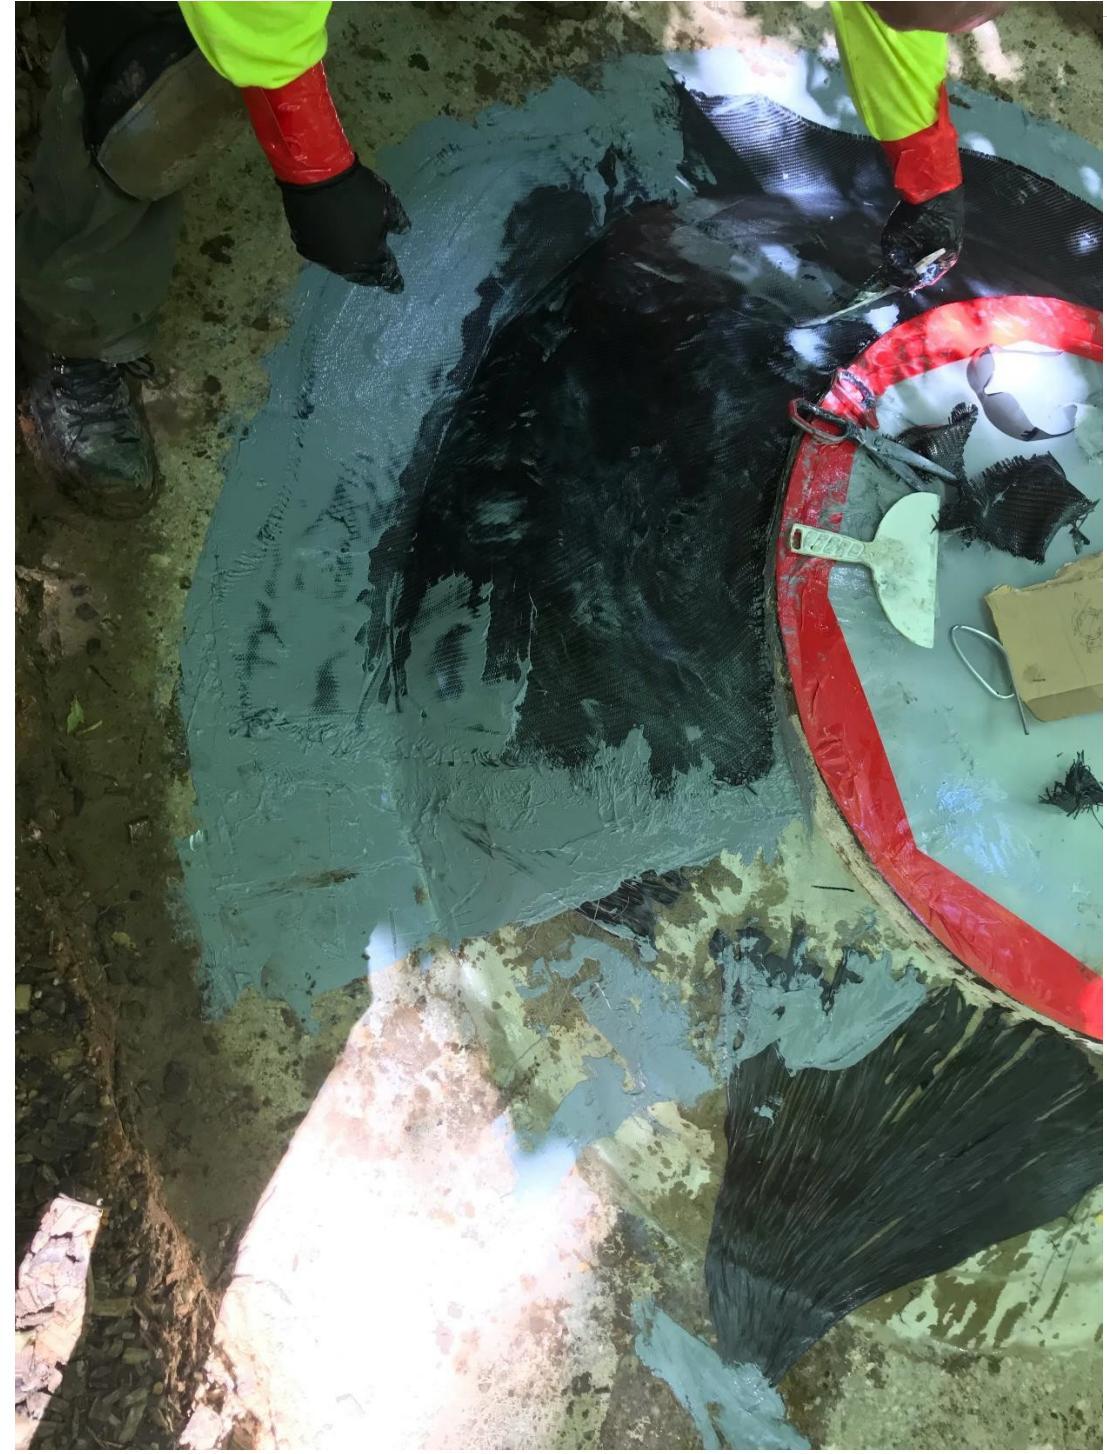
Carbon FRP was then placed over the top of the glass for tensile strengthening purposes (Fig. 6).

Fig. 6 Placement of Carbon FRP Over Glass FRP

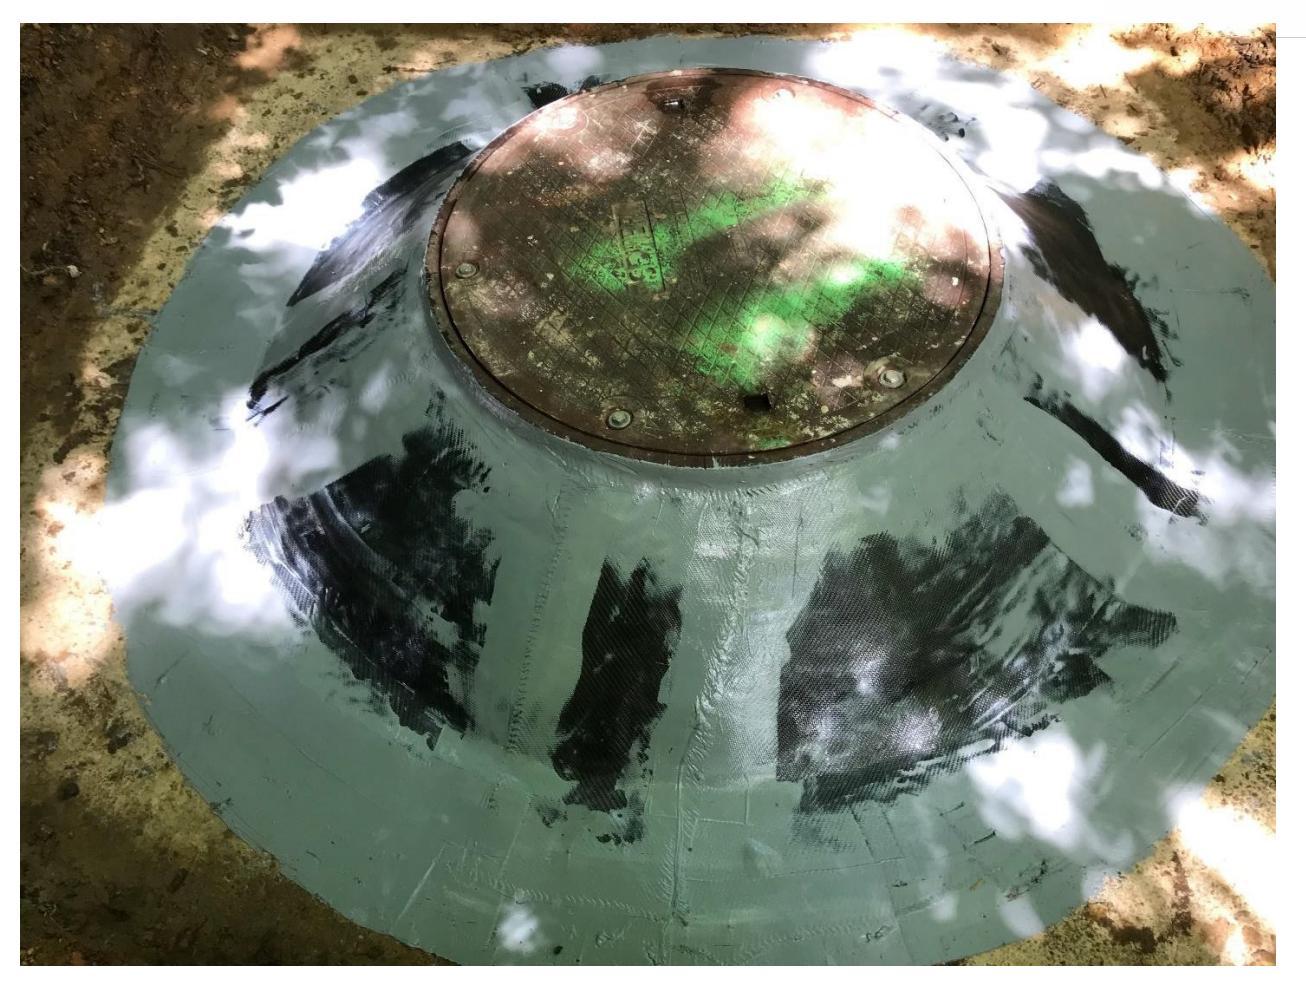
Seams of fabric were covered in thickened epoxy for protection of FRP installation (Fig. 7).

Fig. 7 All FRP installation areas and thickened epoxy were coated for final concrete gray finish.

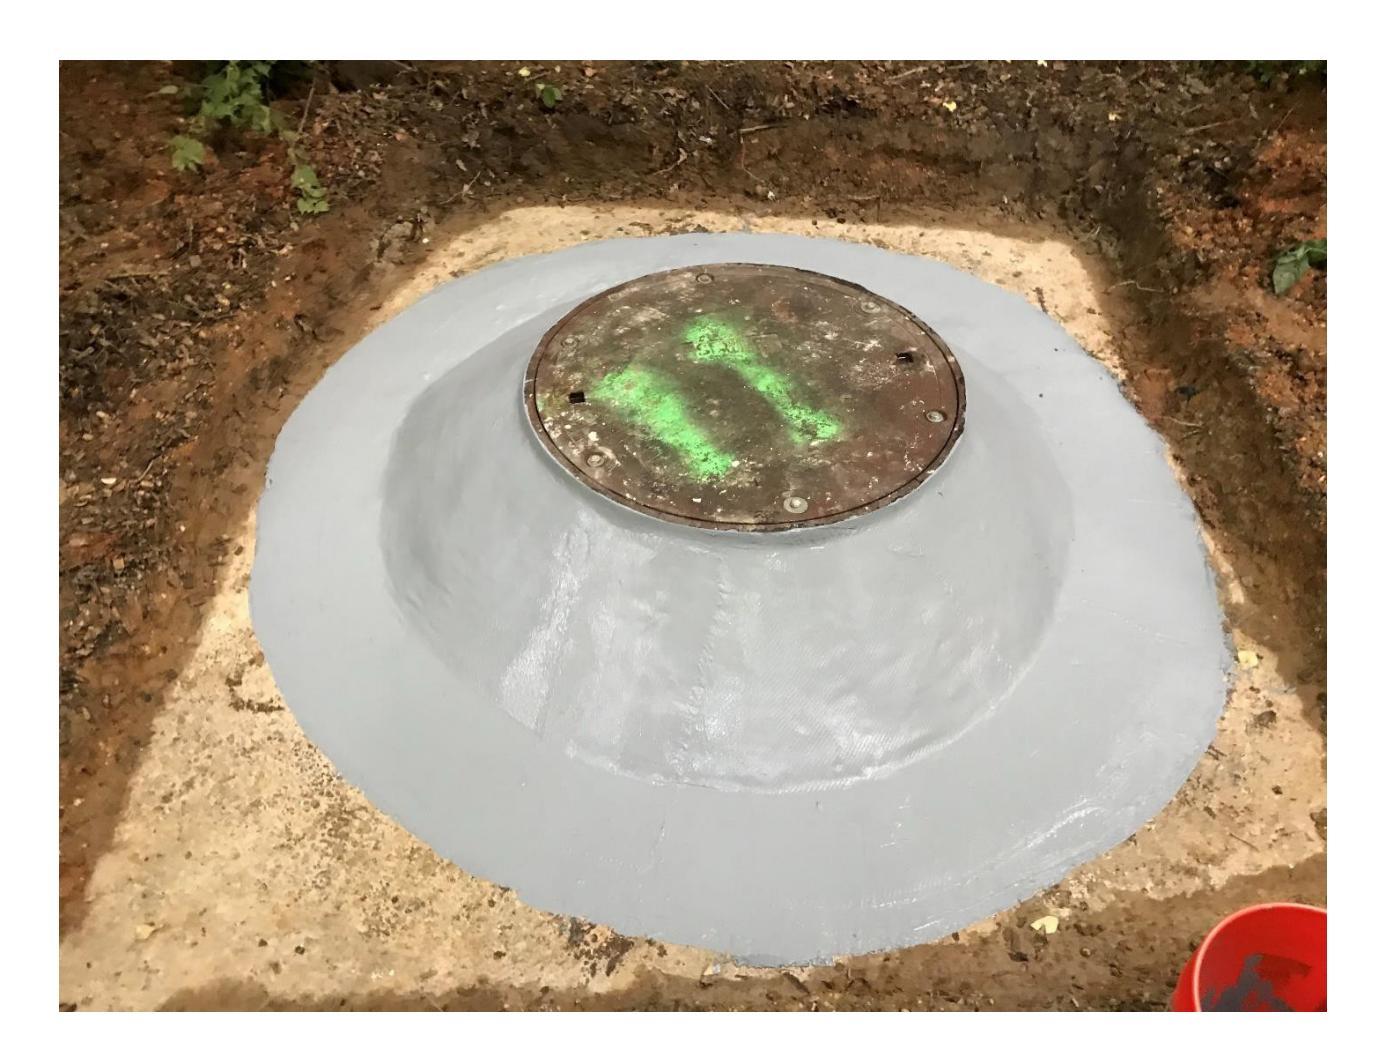
Fig. 8. Coating of Final Installation
