## Tests of Corroded Steel Pipes Externally Wrapped with QuakeWrap®

Client: PERTAMINA Technical Services

## **Testing Report**

Report No: 1374650367

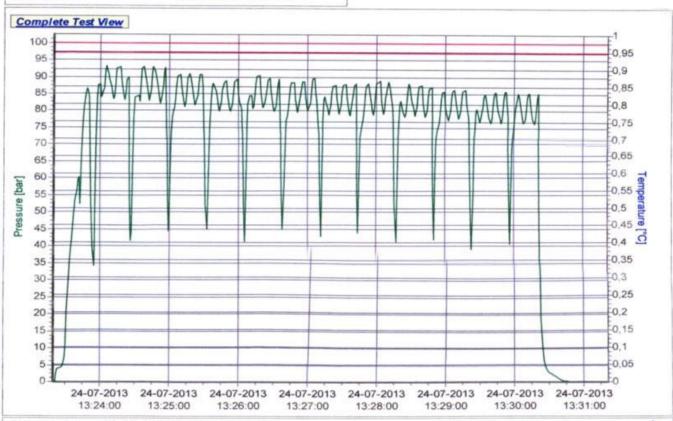
14. The pipe test pressure was set at 95 bar (1378 psi). The maximum pressure reached in the repaired pipe was 93.1 bar (1351 psi). The complete data collected during the test is shown on the next page.

Max. Pressure
 93,15 [bar]
