PROJECT PROFILE

Corroded Tank Repair using QuakeWrap FRP

Client: Copper Mining Operation

Project Location: Northwest Mexico

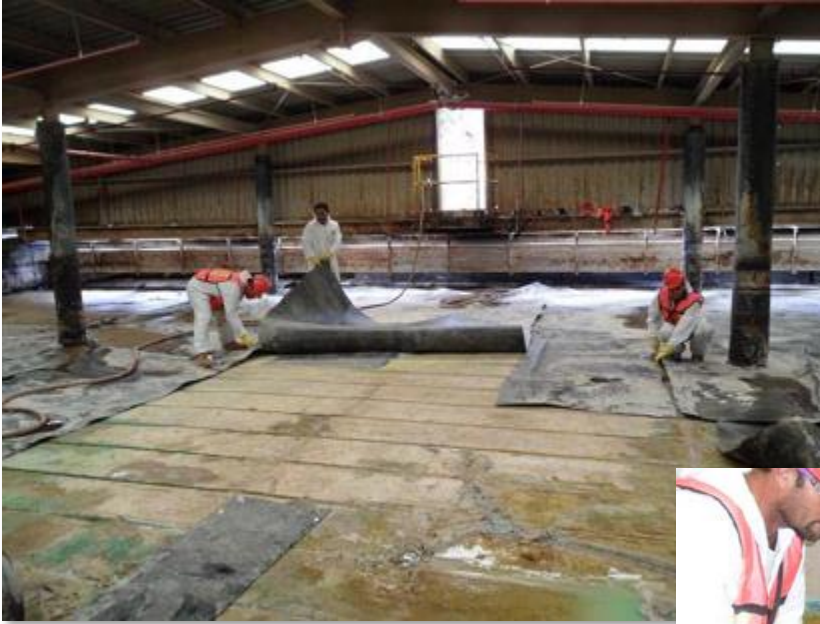
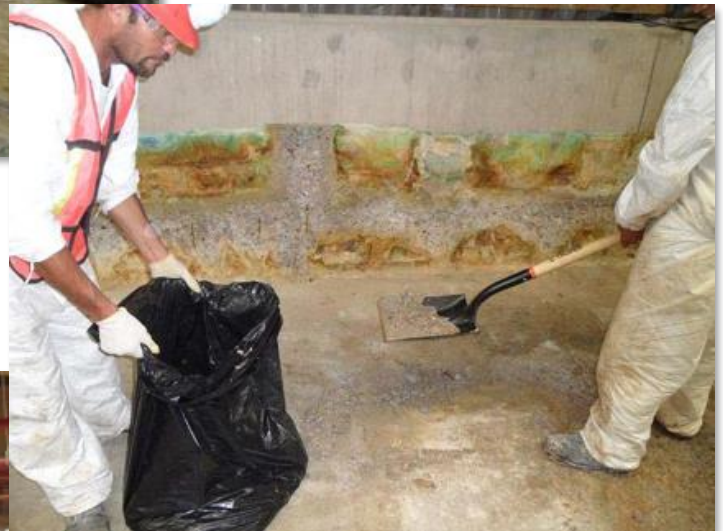
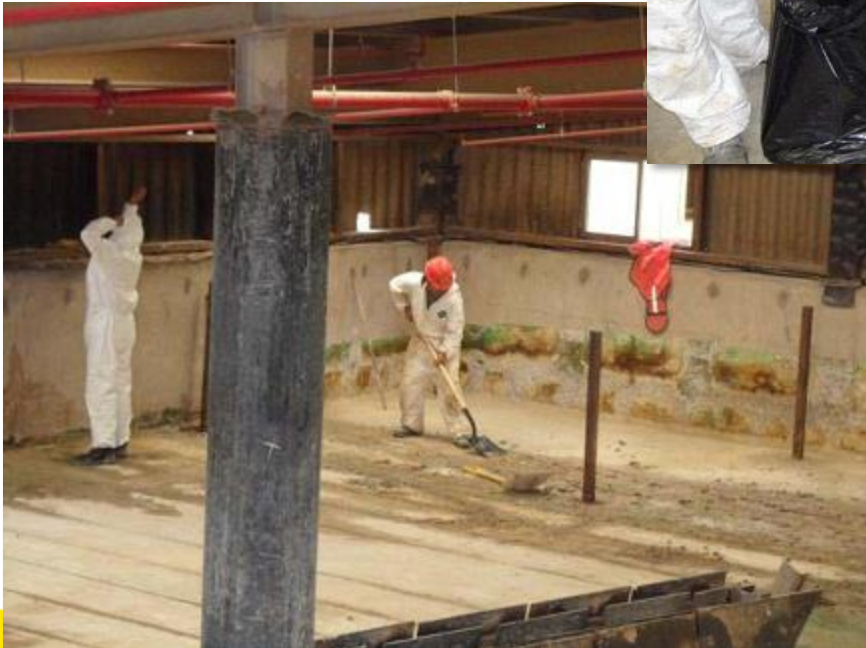
Project Photos: Before

- Tanks carry an electrolytic fluid and prior to repair were being protected with a semi-rigid liner bolted to the insides of the tanks
- A combination of chemical and age degradation caused multiple breaches in this liner, leading to subsequent damage to the concrete surface due to long term exposure to the electrolytic fluid.

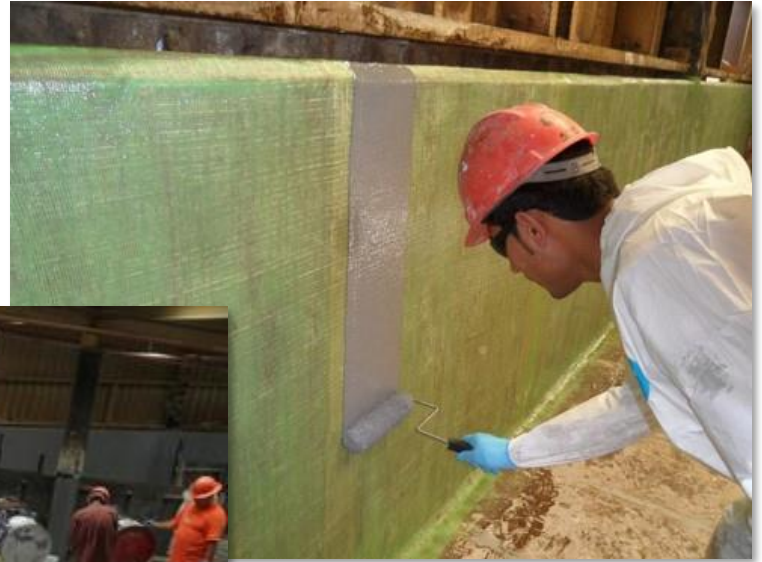
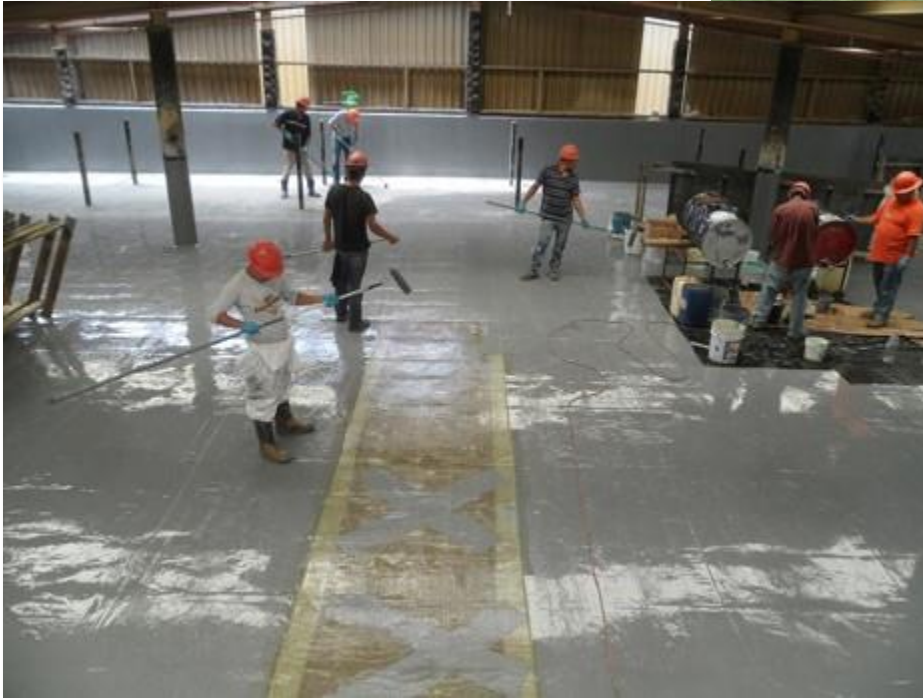
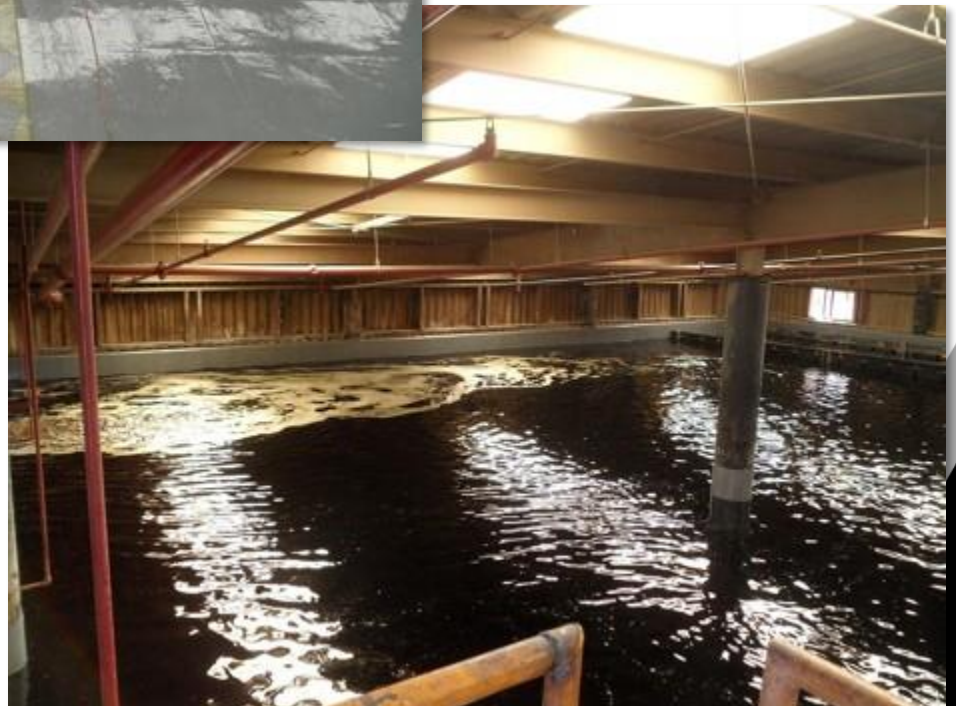
Project Photos: Finish and Operation

- Tanks have been in leak-free operation for over five years.

- An outer coat of QuakeBond epoxy was applied for long term chemical resistance for tanks
- The FRP lining was more cost effective than welded-in-place stainless steel linings [that the plant had used on an earlier repair](#)
