## CIPP of Leaking High-Pressure Gas Main

The challenges Progressive Pipeline Management (PPM) and Public Service Electric & Gas Co. (PSE&G) overcame, as well as those they prepared for, make the rehabilitation of this 16-inch, high-pressure gas main the 2011 *Trenchless Technology* Project of the Year.

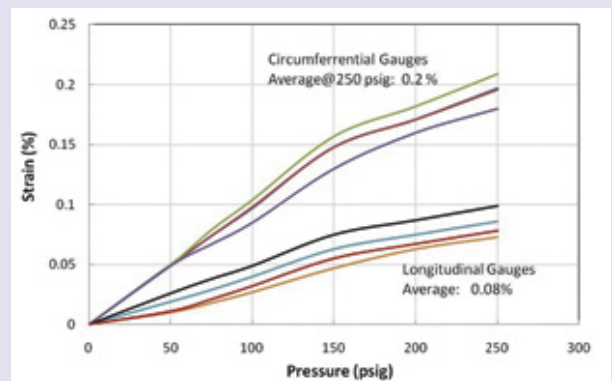
Circumferential and Longitudinal strain in PipeMedic™ laminate for the 16-inch pipe

The PipeMedic™-steel pipe system was lined with CIP, capped at both ends, thrust-restrained and connected to a hydraulic pressure system to apply controlled test pressures. Strain gages and displacement sensors were installed to monitor circumferential and longitudinal strains in PipeMedic™ during the loading.

is 60 psig. All pipe sections were tested under hydrostatic pressure that was increased every two hours by 50 psi up to the maximum pressure of 250 psi, more than four times the MAOP.

The measured strains in the laminate were about ¼ the ultimate values, indicating that the PipeMedic™ system could have resisted pressures as much as 900 psi. The loading imposed on the laminate causes a combination of hoop and longitudinal stress. This can be seen from the measured strains. The longitudinal gages that were positioned at four inches from the end of the laminate, recorded an average strain of 0.085% that is 43% of the average strain measured in the hoop direction. This clearly demonstrated the importance of PipeMedic™ laminates constructed with sufficient strength in longitudinal and transverse directions to resist the imposed loads.
