Paterson, N.J.

CIPP of Leaking High-Pressure Gas Main

Sharon M. Bueno — Oct 27, 2011

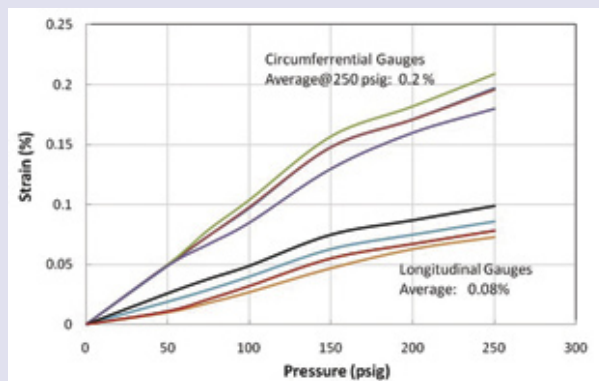
Circumferential and Longitudinal strain in PipeMedic™ laminate for the 16-inch pipe

The PipeMedic™-steel pipe system was lined with CIP, capped at both ends, thrust-restrained and connected to a hydraulic pressure system to apply controlled test pressures. Strain gages and displacement sensors were installed to monitor circumferential and longitudinal strains in PipeMedic™ during the loading.

is 60 psig. All pipe sections were tested under hydrostatic pressure that was increased every two hours by 50 psi up to the maximum pressure of 250 psi, more than four times the MAOP.

The measured strains in the laminate were about ¼ the ultimate values, indicating that the PipeMedic™ system could have resisted pressures as much as 900 psi. The loading imposed on the laminate causes a combination of hoop and longitudinal stress. This can be seen from the measured strains. The longitudinal gages that were positioned at four inches from the end of the laminate, recorded an average strain of 0.085% that is 43% of the average strain measured in the hoop direction. This clearly demonstrated the importance of PipeMedic™ laminates constructed with sufficient strength in longitudinal and transverse directions to resist the imposed loads.
