# A New Generation of FRP Laminates for Repair of Pipelines in Gas Industry

Mo Ehsani, PhD, PE, SE, F.ASCE

## ABSTRACT

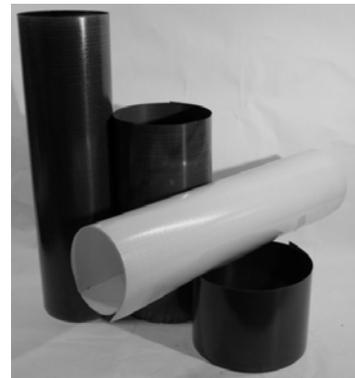
Figure 1. PipeMedic Laminates

The development of PipeMedic™ laminates began in 2008 (Ehsani, 2009; Figure 1). Using a special manufacturing process, these laminates are constructed with one or more layers of carbon or

glass fabric saturated with resin and pressed together to form a very thin solid sheet. The laminates are manufactured in rolls 4-ft wide x 150-ft long that can be easily cut to any size in the field. With a thickness of about 0.01-0.025 inches, the laminates are flexible enough to be coiled for insertion into pipes as small as 4 inches in diameter. The tensile strength of the laminates ranges between 60,000 – 145,000 psi.

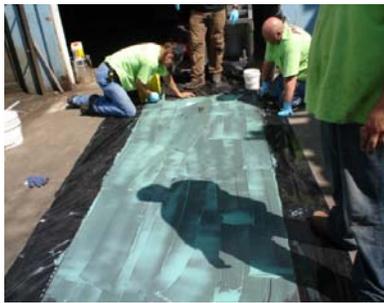
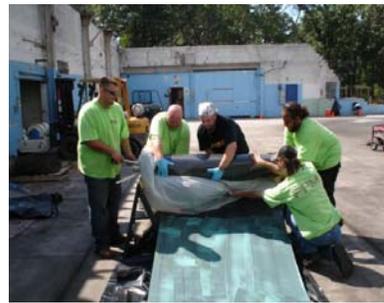
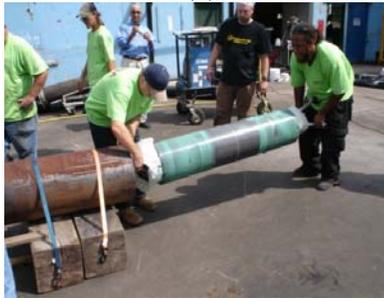
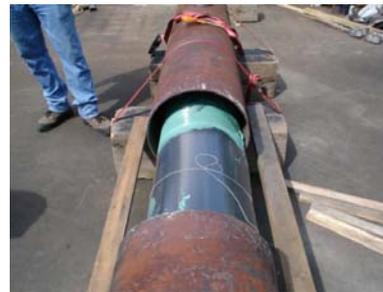
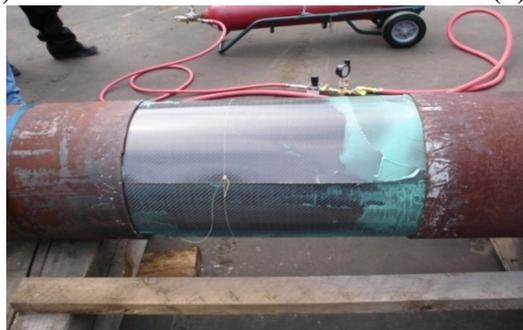
Figure 3. Steps in field demonstration: (a) apply epoxy to laminate, (b) wrap laminate around inflatable packer; (c) insert assembly into pipe, (d) position the assembly over gap that simulates drip pot location and inflate packer, and (e) completed installation.

1. Apply adhesive to the laminate (Figure 3a).
2. Wrap laminate around the inflatable bladder (Figure 3b).
3. Insert the bladder into the pipe (Figure 3c).
4. Inflate the bladder to expand laminate at simulated drip pot gap (Figure 3d).
5. PipeMedic™ laminate section bridging 24-inch gap and curing (Figure 3e).

Testing was performed by GTI personnel at the contractor's facility. The testing program included testing three pipe diameters. The first sample was the 16-inch diameter pipe that was constructed during the demonstration phase (Figure 3); that repair included 3 plies of a biaxial carbon laminate. In addition, two smaller samples with diameters of 6 and 12 inches, respectively, were constructed and tested. These two specimens were retrofitted with a biaxial glass laminate applied in two plies. All three specimens included a 24-inch free-standing laminate section, which extended an additional 12 inches into each side of the pipe.

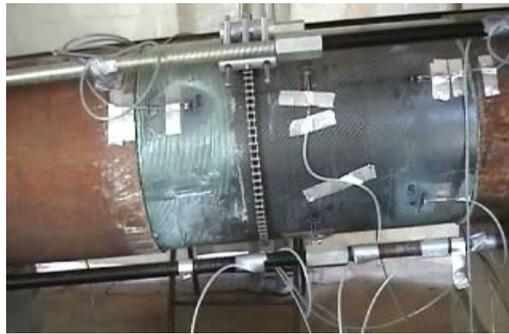
Figure 4. Instrumented laminate during test.

The laminate-steel pipe system was lined with CIP, capped at both ends, thrust-restrained and connected to a hydraulic pressure system to apply controlled test pressures. Strain gages and displacement sensors were installed as shown in Figure 4 to monitor circumferential and longitudinal strains in the laminate during the loading.

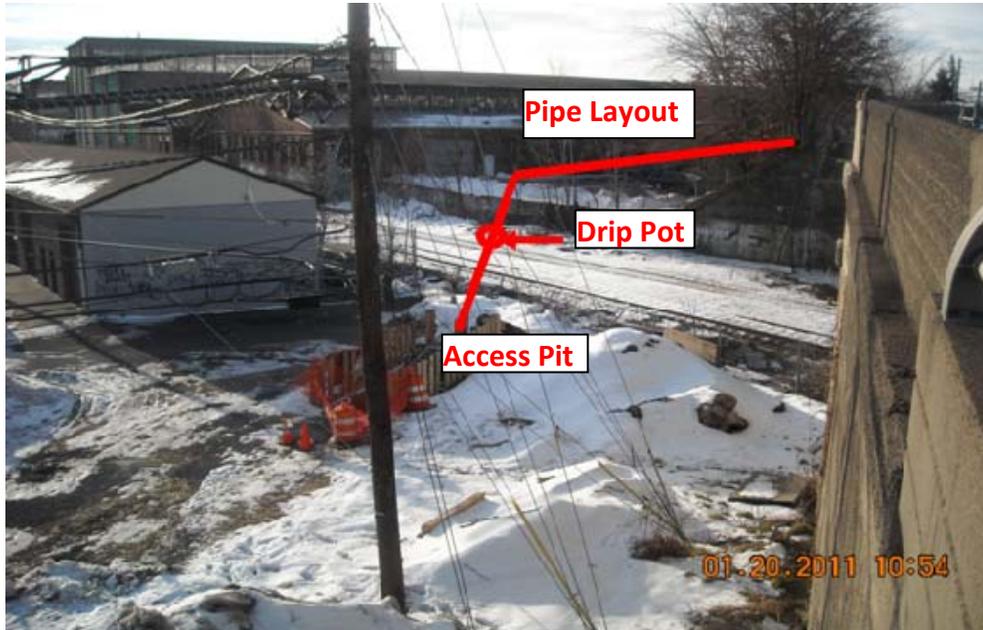
Figure 6. Project site showing the existing pipe layout and drip pot location under the railroad tracks.

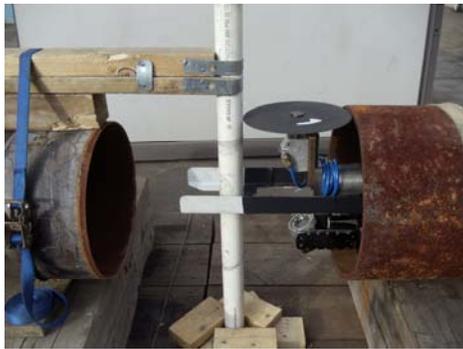
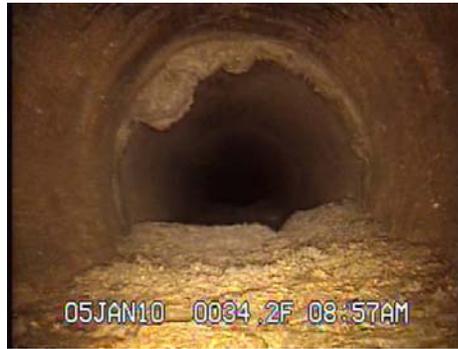
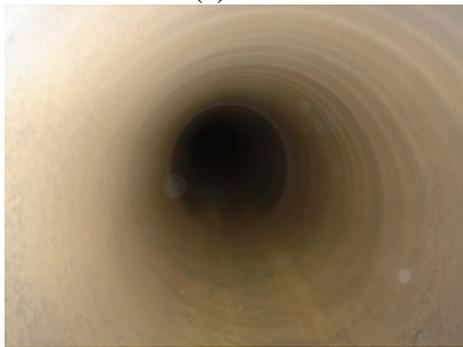
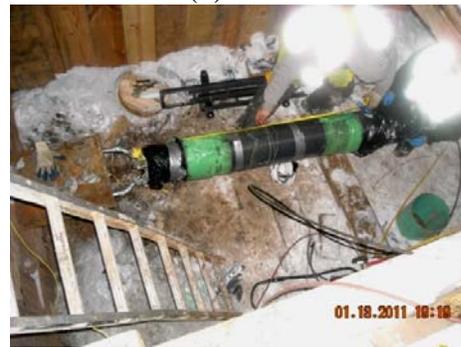
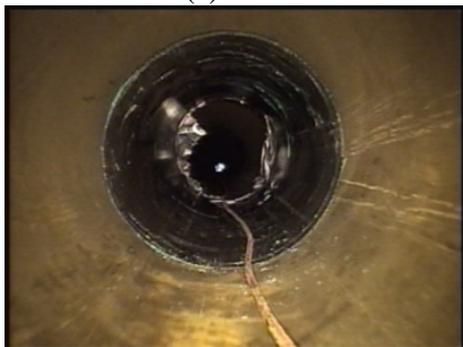
Figure 7. Field installation: (a) robot to cut the standpipe, (b) debris-laden pipe, (c) cleaned pipe, (d) laminate and packer assembly, (e) laminate installed across the drip pot, and (f) completed installation.

A closed circuit camera was used to locate the exact location of the drip pot and the installation followed the steps described in the demonstration project. In carrying such repairs, the standpipe inside the drip pot has to be removed. PPM developed a robotic arm to cut the ¾ inch steel standpipe that was obstructing the installation (Figure 7 a). The robot cut the standpipe in two locations (below the invert and above the crown) allowing the standpipe pieces to fall inside the drip pot. The pipe was also laden with debris (Figure 7b) that had to be blasted away to achieve a clean uniform surface (Figure 7c).

The bladder was also modified by adding a sled that would allow it to cross the 24-inch opening without falling into the drip pot. Figure 7d shows the laminate ready to be inserted into the pipe and Figure 7e shows the installed laminate. The next step was the lining of the complete 700-ft section with the CIP liner. As shown in Figure 7f, the small thickness of the laminate (nearly 0.1 inch) makes it virtually undetectable after the liner has been installed. The newly lined pipe is expected to
