Nashville, TN
March 11-15, 2012

Paper E-1-01

Winter Wonderland Does Wonders to CIPP Renewal of a High Pressure Gas Main in NJ

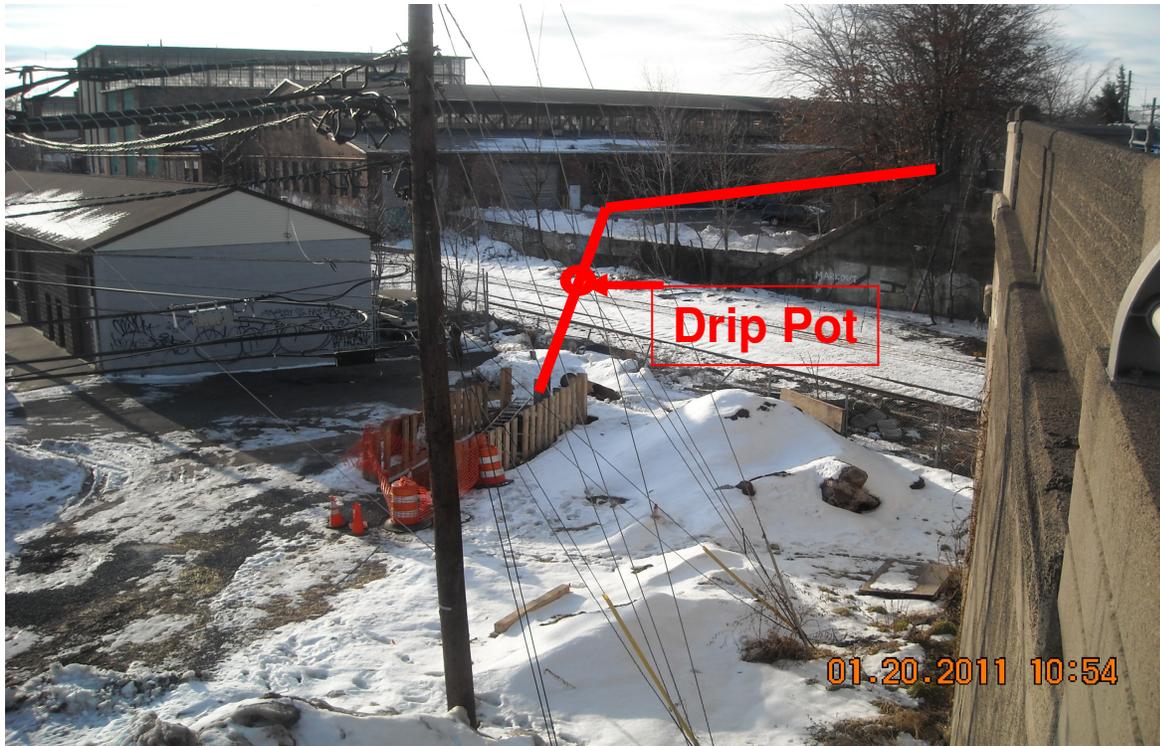
Figure 1. Overview of project area.

through an active truck dock loading/unloading area at a depth of approximately 24 feet. Then it follows under a set of railroad tracks to another private parking lot on the opposite side of the tracks, approximately 700 feet in length (Figure 1). The pipeline, according to the historic drawings circa 1900, has one 45 degree bend somewhere close to the center of the job and a drip pot that is located directly under the railroad tracks (Figure 2). The drip pot was used for collecting hydrocarbon fluids from the old gas manufacturing days and was a common fitting for that era. The 45 degree bend did not pose a problem from a lining perspective since liners are ideal for such applications/geometries, but the drip pot was a major obstacle and needed to be replaced with a section of straight pipe. This was necessary because the liner could not pass through the internal drip pot piping (standpipe) and negotiate the drip pot's 24-inch gap without adequate bearing support for the liner. The project was placed on hold until a solution for traversing the drip pot without having to excavate and remove it could be developed.

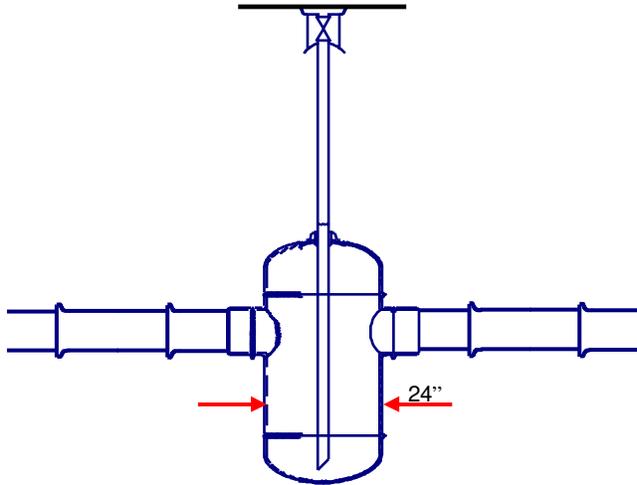
Figure 2. Drip pot schematic.

At the trade show, this specific product was reviewed along with the problems associated with traversing the drip pot. In effect, the concept involved using the FRP laminate to provide a free-span section of pipe across the 24-inch diameter liquid-separator drip pot in the pipeline. Since the CIPP liner system relies on the structural integrity of the host pipe, the laminate section is installed to perform as a stand-alone pressure-carrier section and interacts with the CIPP similar to the original carrier pipe. At that time, it was felt that the FRP laminate could potentially provide the necessary bearing support through the drip pot, which would then eventually be lined with the remainder of the 700-foot pipe segment. This would completely avoid the need to deal with the railroad authorities to replace that segment of the pipe containing the drip pot. This approach would avoid the time and cost with getting the necessary railroad authority approvals, permits, railroad flag people, etc., including PSE&G crew time to replace the fitting with straight pipe.

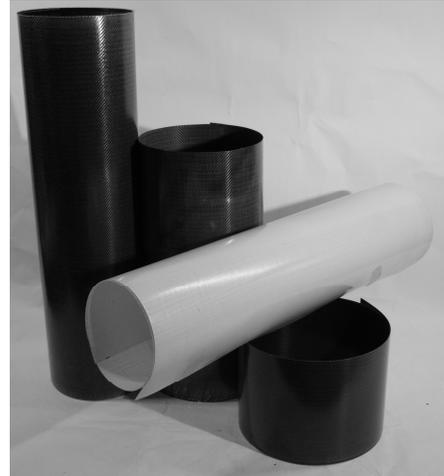
Figure 3. Samples of PipeMedic™ laminates constructed with carbon and glass fabric.

The laminate used for this project was constructed of carbon fibers sandwiched between two very thin glass scrims. Direct installation of carbon fabric on a steel pipe could result in galvanic corrosion of dissimilar metals. The common practice in repair and retrofit projects using carbon FRP is to use a layer of glass fabric as a dielectric barrier between the carbon and steel to prevent direct contact between these materials. The fact that these laminates included such a scrim on both faces eliminated any concern for long-term durability of the system due to corrosion. The carbon laminate is only 0.026 in. thick, with sufficient flexibility to be coiled for insertion into the 16-inch diameter pipe. It is supplied in rolls 4-ft wide x 150-ft long that can be easily cut to any size in the field. The tensile strength of the laminate is 101 ksi in the longitudinal direction and 64 ksi in the transverse direction. Other thinner laminates made of glass fiber are also available for repair of smaller diameter pipes.

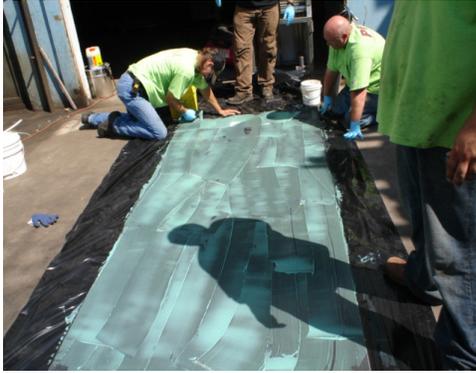
Figure 4. Adhesive application.

1. Applying adhesive to the one side of the laminate (Figure 4).
2. Rolling laminate onto the inflatable pig (Figure 5).
3. Inserting the pig into the pipe (Figure 6).
4. Inflating the pig to expand laminate at simulated drip pot gap (Figure 7).
5. FRP laminate section bridging 24-inch gap and curing (Figure 8).

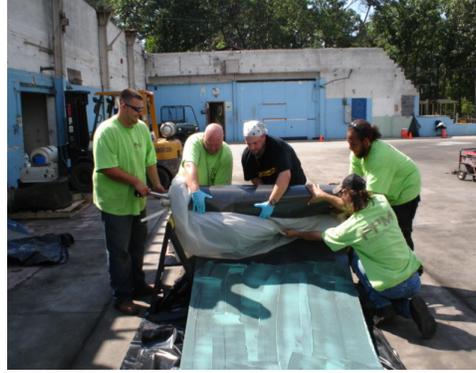
Figure 5. Laminate installed onto inflatable pig.

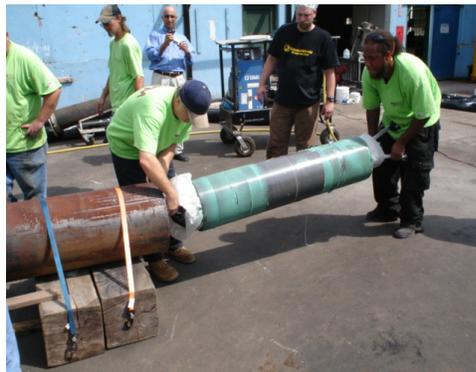
Figure 6. Insertion into pipe section.

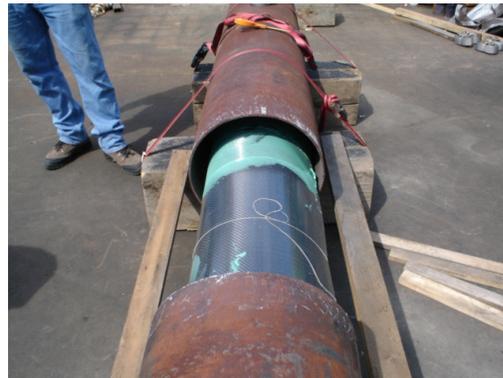
Figure 7. Laminate in position and pig being inflated.

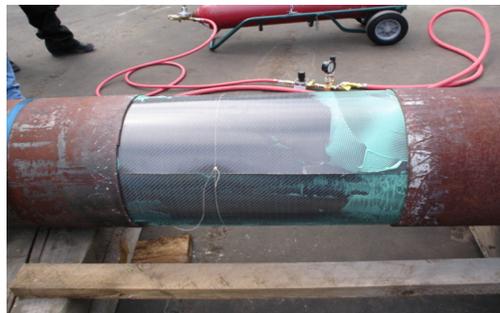
Figure 8. Final installation in simulated drip pot.

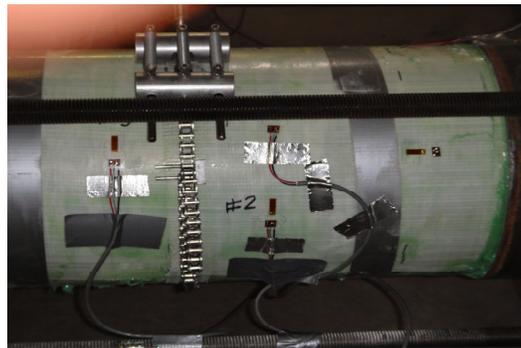
- 1) Simulate the free-span or gap of a drip pot by separating 2 section of pipe by a distance of 24 inches (Figure 9). This is a worst case scenario, since drip pot sizes are generally one or two pipe diameters larger than the pipe itself. For example, a typical 12-inch diameter pipeline would utilize a drip pot 16 inches in diameter, but sometimes it may have a drip pot as large as 24-inches in diameter. A 6-inch diameter pipeline would typically use an 8-inch diameter drip pot. For sake of consistency, it was decided to simulate a 24-inch diameter drip pot for all three different piping diameters tested by GTI. This span also acts as the worst case scenario for abandoned laterals which also would need to be cut-out and replaced with straight pipe.

Figure 9. Typical instrumented test specimen with 24-inch free-span.

The pipe sections were all tested in the same way and under stepped hydrostatic pressures. The pressure was increased every 2 hours in 50 psig increments up to a maximum of 250 psig. The test results demonstrated that the liner-composite sections could withstand the applied pressure without leakage.

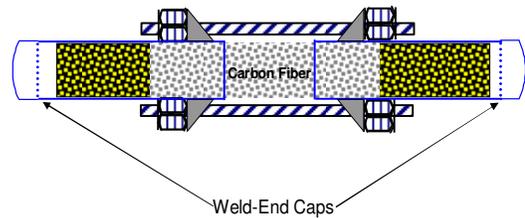
- 6) Install weld-end caps, thread-o-lets and threaded rods for thrust restraint (Figure 13).
- 7) Fill with water and pressure test in stepped increments to 250 psig.

Figure 13. Ends capped for pressure testing

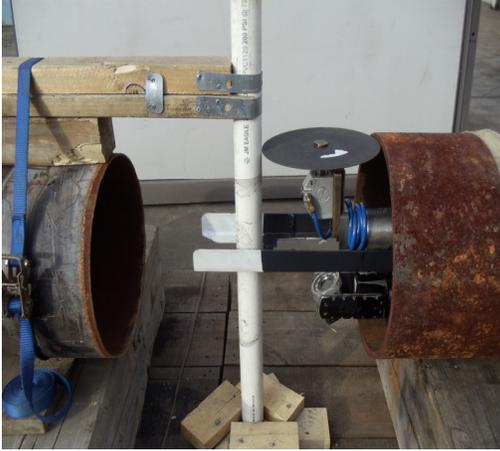
The remaining major challenge was to develop a means for removing the ¾-inch diameter internal steel standpipe robotically working from inside the pipe. Several ideas were considered, but required access to the top of the standpipe as a minimum, which was prohibited by virtue of its location under the active railroad tracks. The final design included the internal cutting of the standpipe by a support bridge which had the ability to scaffold/sled across the opening or gap of the drip pot. The scaffold or sled was designed to straddle the opening close enough to the standpipe allowing the existing camera/cutter assembly access to the standpipe, making it possible for the cutaway. (Figure 14)

Figure 14. Simulated drip pot with standpipe laboratory test set-up.

After several design iterations and shop trials, the sled resembled a two-tiered bridge and proved to work as intended. The camera/cutter combination, located one above the other, and the bi-level bridge is pulled into the pipe simultaneously up to the drip standpipe. The cutting assembly first cuts the standpipe below the invert of the pipe and then makes a second cut above the crown of the pipe. This is all done robotically from inside the pipe without any excavation or external pipe access required. The cut pipe sections fall into the pot section of the fitting allowing the CF to have clear access across the simulated drip pot gap (shown in Figure 14).

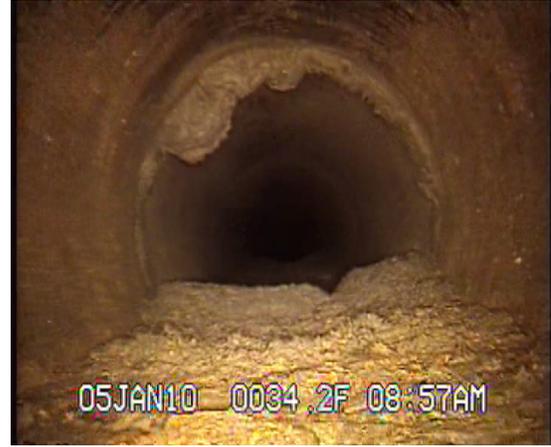
Figure 15. Heavily debris-laden pipe ID.

Conventional internal sandblasting tooling proved ineffective in adequately removing the heavy debris. The sandblasting tool head was modified on-site to deflect the majority of the grit towards the bottom of the main in an effort to remove the excessive debris. This equipment modification included the successful adaptation of using a camera to view the sandblasting operation simultaneously - something that had never been done before. While somewhat successful, the modified tooling still provided insufficient cleaning power to open-up the main to its full 16-inch diameter.

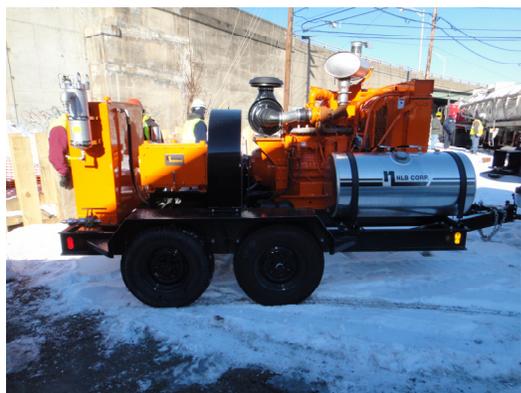
Additional cleaning was required and high pressure water jet blasting equipment was the next logical step (Figure 16). This equipment uses water at 15,000 psig and is capable of cleaning out the heavy debris. However, this now posed an additional set of unique problems involving equipment freeze-ups, working in the dead of winter, water supply/removal/disposal, hazardous material collection trucks, and heaters with associated project time delays. Before water jetting could be implemented, PSE&G's Environmental Department needed to oversee and manage the collection of all the waste-water material to ensure compliance with applicable environmental regulations using a vacuum collection tanker (Figure 17).

Figure 16. Equipment utilized for water jetting operation.

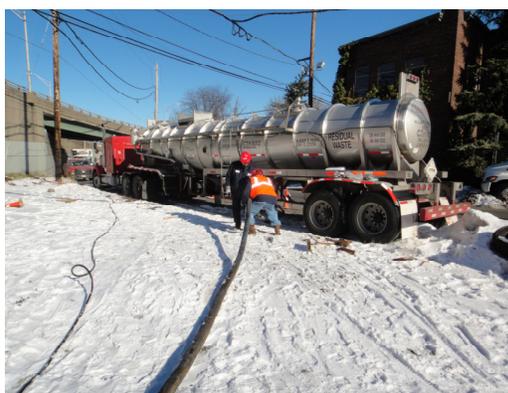
Figure 17. Vacuum tanker collection truck.

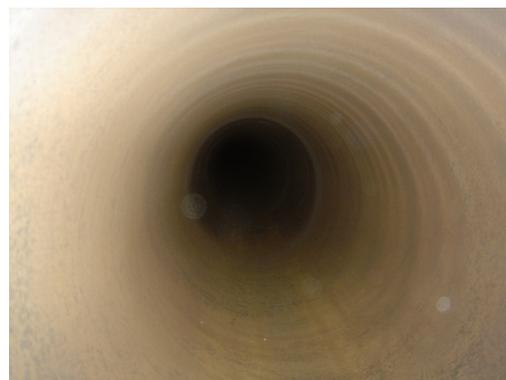
Figure 18. Pipeline ID fully cleaned.

The water jetting was followed by removal of the water using foam pigs and then an extensive period of time was spent on drying the inside of the pipe using hot air injected into the pipeline. Once dry, the normal sandblasting operation was started and successfully brought the ID of the pipe down to a bright white metal finish (Figure 18) in preparation for cutting the drip pot standpipe internally, installing the FRP laminate and then lining through the entire 700-foot segment of pipe.

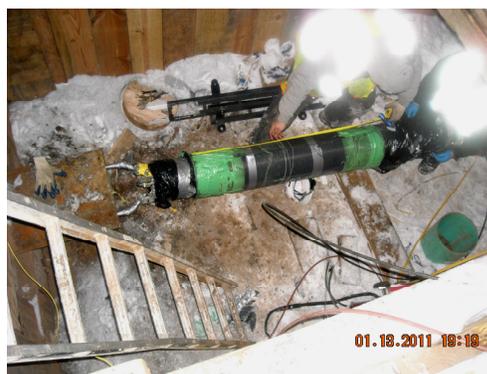
Figure 19. Inflatable pig/laminate being inserted.

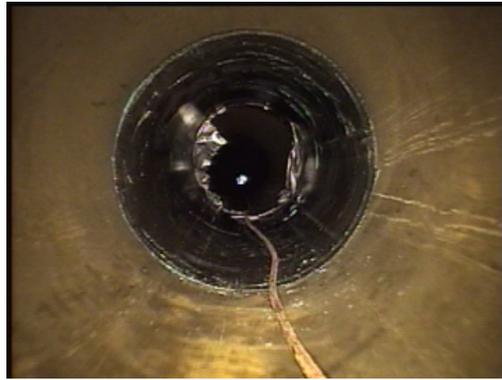
Figure 20. Final drip pot bridge laminate assembly with residual duct tape in rear.

The ¾-inch diameter steel drip pot standpipe was successfully cut off in two cuts as planned using the specially designed and built robotics platform. This cleared the way for installing the FRP laminate internal sleeve/bridge as the final step before lining the entire abandoned segment of pipe. With the help of QuakeWraps's technicians, the FRP laminate installation went smoothly. Figure 19 depicts the inflatable pig with the FRP laminate sleeve installed onto it being ready to be pulled out to the drip pot. The adhesives used for the FRP laminate normally cure over one night, but due to the extremely cold weather it took three nights. After the third night, the inflatable pig was deflated and removed with the FRP laminate bridge in final place spanning the drip pot gap (Figure 20). Residual duct tape used to temporarily secure the bridge to the pig was subsequently removed with grinding.

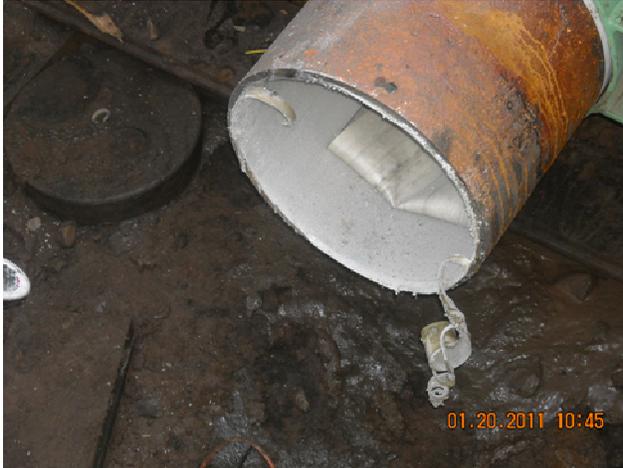
Figure 21. Excess liner being trimmed at pipe-ends.

The pipeline ends were trimmed of liner for facilitating connections to the existing piping (Figure 21) and final internal CCTV inspection was performed as a part of the acceptance criteria. This inspection confirmed a perfect lining job from end-to-end of the pipeline right through the FRP laminate bridge (Figure 22) creating a gas tight condition and resolving the nagging leaks in the area.

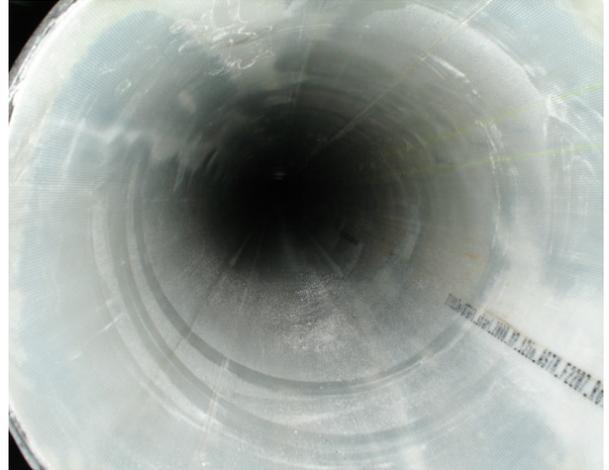
Figure 22. Completed liner installation with the FRP laminate through the drip pot.
