PROJECT OVERVIEW

Colorado Siphon Pipe Rehab

Palisade, CO

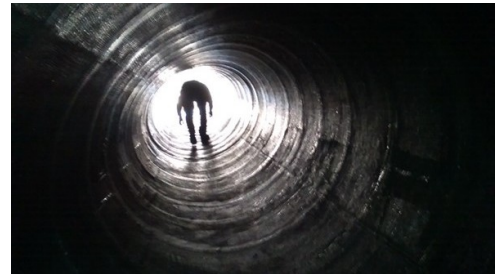
Existing steel pipe profile (not to scale)

A 54" steel siphon pipe used to convey Colorado River water to the Orchard Mesa Irrigation District near Palisade, CO had experienced the delamination of a polyurea liner during the 2017 irrigation season. The ¼" thick pipe was corroded and leaking and had experienced a collapse due to a highway project that introduced higher-than-design loads on the buried siphon. A sketch of the pipe profile is shown to right, note the relatively steep incline.

The irrigation district manager contacted QuakeWrap, which recommended an FRP system consisting of bidirectional fiberglass, chopped mat and carbon fiber (along the structurally deficient segment) to rehabilitate the compromised pipe and stop the leaking. Urethane injection coupled with spot welding of steel patches to the inside of the pipe was used to stop leaks prior to the installation of the FRP. A layer of fiberglass with chopped mat was applied after a thickened epoxy coating, followed by unidirectional carbon fabric and two coats of epoxy. EPDM compression seals (Weko) were installed at the end terminations.
