## Internal PCCP Force Main Deterioration – Analysis and Rehabilitation

### Abstract

This paper presents a case study of a Prestressed Concrete Cylinder Pipe (PCCP) system that is experiencing deterioration and a failure resulting from internal corrosion. The corrosion mechanism is Sulfuric Acid attack due to Hydrogen Sulfide gas (H<sub>2</sub>S) generated from the wastewater. The PCCP pipeline is located in Regina, Saskatchewan, Canada and was constructed in 1979. The nominal inside diameter is 1350 mm (54") and the pipeline was designed as a sewage force main. In 1999, approximately 75 m (246 feet) of the pipe failed and was replaced with HDPE pipe. In 2008, an internal inspection was conducted downstream of the failed section. The inspection was conducted using man entry and by close circuit television (CCTV). The inspection found five (5) pipe sections under severe corrosion attack where the interior concrete surfaces near the crown of the pipe had deteriorated exposing the reinforcing. Another nine (9) sections also showed early signs of H<sub>2</sub>S attack.

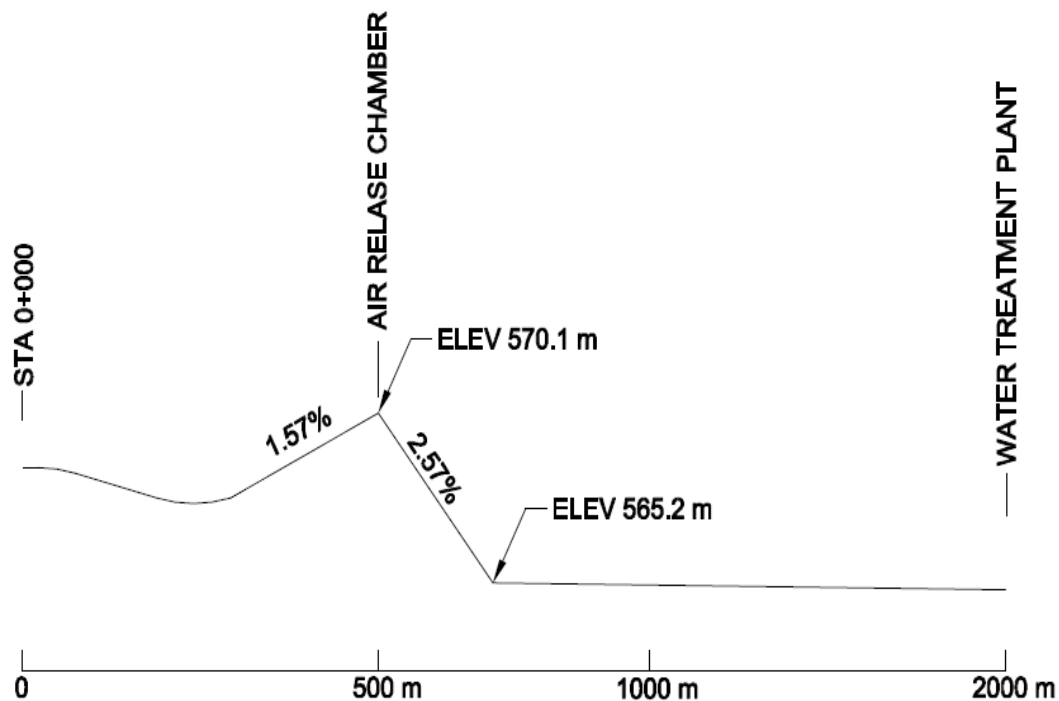
Figure 1. 1350 mm diameter Force main Profile

Figure 1 shows the profile of the force main system. The total length of the PCCP force main is 1900 m. The assessment program focused on about 200 meters of the force main from Station 0+700 to Station 0+900.

As shown in Figure 1, the force main section that is the subject of this assessment is located at about Station 1+000. The pipe was constructed with the following slopes:

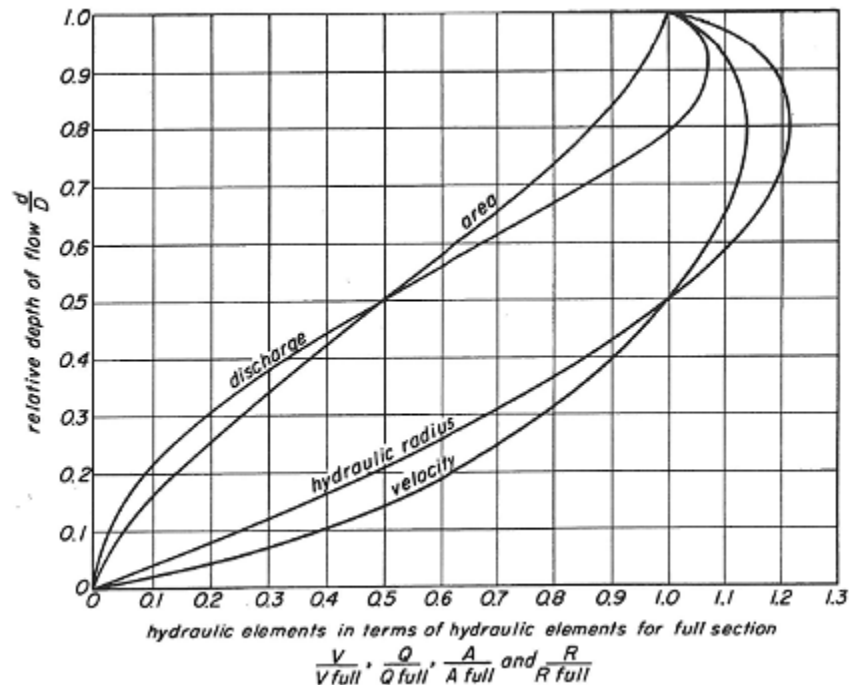
**Figure 5. Hydraulic elements-relative flow properties of circular pipe**

A comparison of recorded flows and theoretical flows confirmed that some of the time, the force main operates at partial flow conditions. For example, for the case of -2.57% slope at a flow of 250 ML/D, the ratio of actual flow (q) to full capacity (Q<sub>full</sub>) or q/Q<sub>full</sub> is 0.32 (2.89 m<sup>3</sup>/s / 8.93 m<sup>3</sup>/s). Using Figure 5, Hydraulic Elements Graph for circular pipe, the following partial full flow ratios are determined:

- $\frac{d_1}{D_{full}} = 0.40$  and  $\frac{v}{V_{full}} = 0.90$
- Partial depth (d<sub>1</sub>) = 0.40 x 1350 mm = 540 mm or 0.54 m
- Velocity or v = 0.90 x V<sub>full</sub> = 0.90 (8.93/1.48) = 5.46 m/s

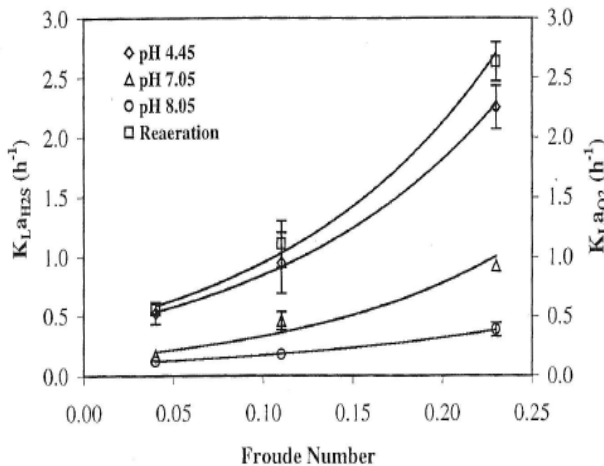
**Figure 6. Mass transfer coefficient for H<sub>2</sub>S versus Froude numbers at different pH values.**

in the water film). Increased turbulence can also make the interfacial area larger, thereby giving a higher possibility of H<sub>2</sub>S molecules being transferred. This is illustrated in Figure 6 showing a relationship between the overall hydrogen sulfide mass-transfer coefficient (K<sub>L</sub>a<sub>H<sub>2</sub>S</sub>) versus Froude numbers (Yongsiri et al, 2004). The Froude number is a ratio of inertia to gravitational forces and is a reasonable representative for expressing the increase in turbulence level at a hydraulic jump.

Although the data shown in Figure 6 was derived from low Froude Numbers, the laboratory data clearly shows an increasing trend for the overall hydrogen sulfide mass transfer coefficient with increasing Froude Number. This confirms the strong influence of turbulence and release of H<sub>2</sub>S from the liquid phase into the air phase.

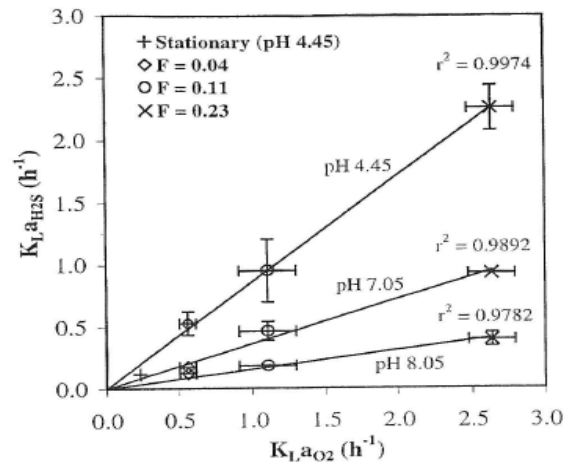
**Figure 7. Relationship between H<sub>2</sub>S and O<sub>2</sub> mass transfer coefficients.**

Figure 7, also from Yongsiri, shows the relationship between the K<sub>L</sub>a<sub>(H<sub>2</sub>S)</sub> and mass transfer coefficient of oxygen, K<sub>L</sub>a<sub>(O<sub>2</sub>)</sub> at different pH levels. It is interesting to note that the H<sub>2</sub>S transfer process in water was always slower than that of the re-aeration process at any Froude number investigated.
