Chicago, Illinois
May 2-7, 2010

Paper A-4-02

REHAB OF 100-YEAR-OLD LARGE SIZE CIRCULAR AND NON-CIRCULAR SEWERS

Michael I. Spero, P.E.¹, and Datta Shirodkar²

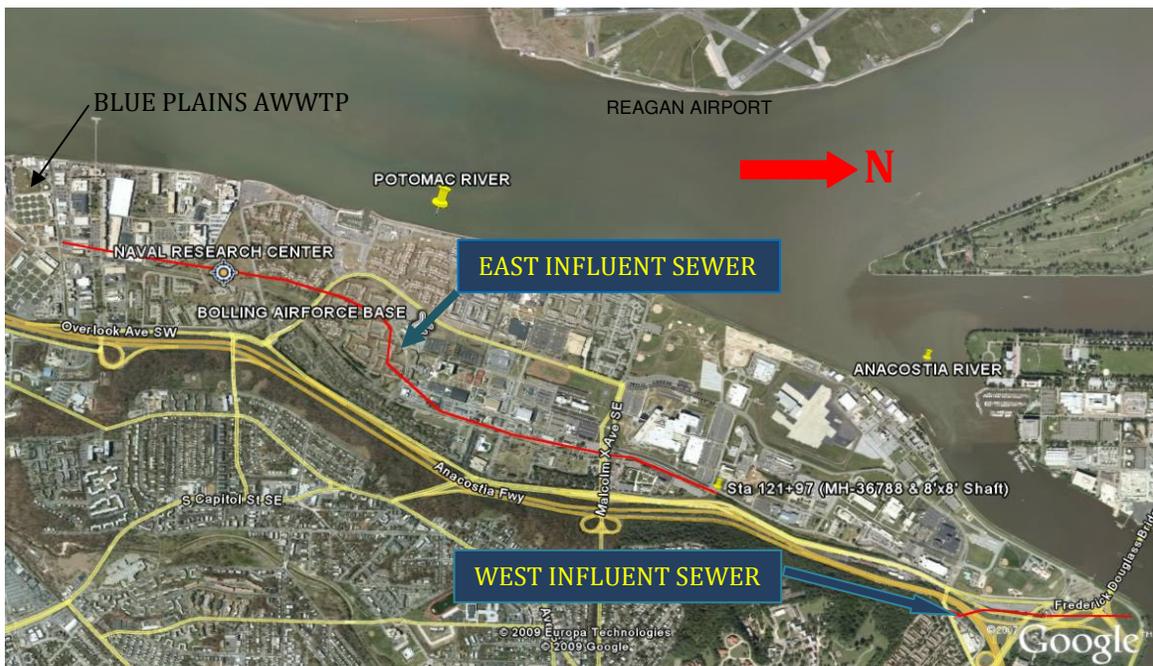
Figure 11. Site Map

The sewer runs parallel to Interstate 295, starting at the Blue Plains Advanced WWTP and ending at the Anacostia River Siphon Structure [Figure 11]. The sewer runs underneath the Naval Research Center and Bolling Air Force Base which are extremely high security military facilities.

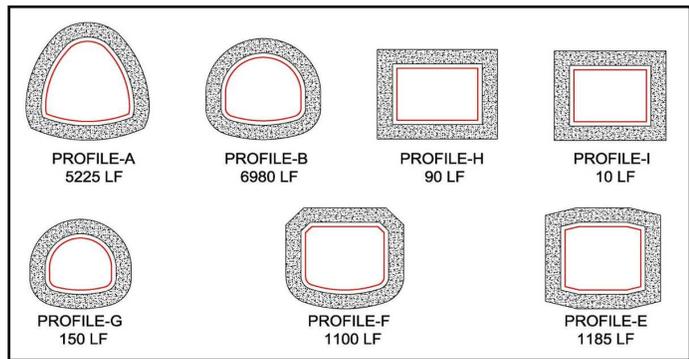
Figure 12. Shape and Length of Sewers (proportionally correct)

As can be seen from Table 1 and Figure 12 the project consists of seven different sewer shapes and sizes. The project also consists of various structures (Junction boxes) which also need to be rehabilitated. This paper will focus on the rehabilitation of the sewers using the Danby Grouted-In-Place liner system. The entire project is divided into two sections, the East Influent sewer and the West Influent Sewer. To rehabilitate the East influent sewer, the flow will be diverted to the West Influent Sewer and vice-versa. The East Influent sewer consists of the entire Type A sewer (5225 ft), majority of Type B sewer (6687 ft) and the complete Type H (90 ft) and Type I (10ft) which are a part of the structure 1 B. The West Influent Sewer consists of Type B (293ft) , Type G (150 ft) , Type E (1185 ft) and Type F (1100 ft). There are 11 transitions in the project. 4 transitions are located in the East Influent Sewer and 7 are located in the west Influent sewer. Each transition is 6-10 ft long and transitions from one sewer shape to another. There are 10 curves along the length of the sewer. Out of the 10 curves 3 are smooth radius curves and 7 are chord curves. 6 curves are located in the East Influent Sewer and 5 are located in the West Influent Sewer.
