WORLD'S LARGEST PROJECT ON PIPE RENOVATION WITH FRP COMPLETED AHEAD OF SCHEDULE

Mo Ehsani, Ph.D., P.E., S.E. & Carlos Peña, M.S., P.E.

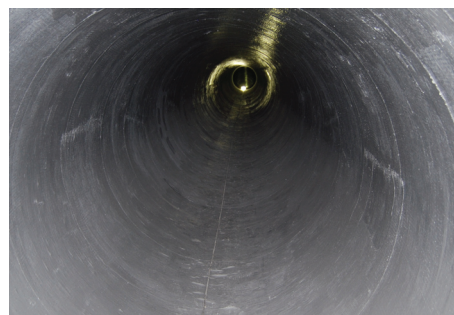
Figure 10: Completed segment of the FRP installation

The FRP lining installation was completed on July 8th, 2009, and pressurized test runs were successfully completed. Figure 10 shows a completed lining installation prior to testing.

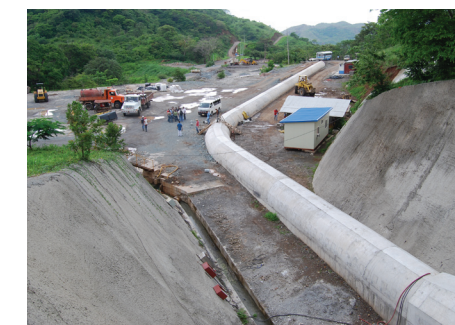
Figure 1: Above ground segment of the "El Encanto" pipeline

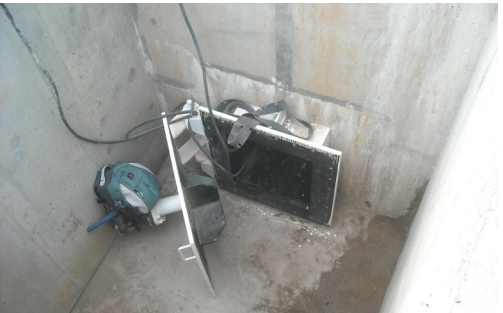
The 5,742 ft. long pipeline had four lateral access points at the locations of relief valves, with spacing ranging from 1,000 ft. to 1,500 ft. These 24" x 24" access points (Figure 6) were

Figure 6: Typical 2 ft. x 2 ft. access point

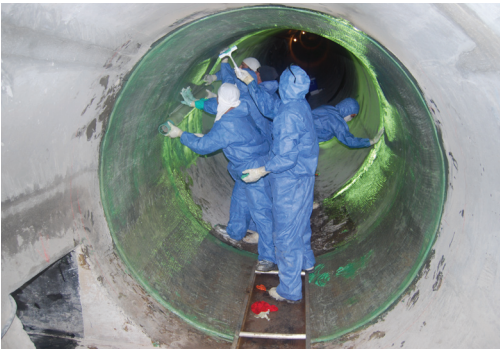
Figure 7(b): Installation of FRP lining

Figure 7a illustrates the application of an epoxy paste to the top half of the pipeline; the main purpose of the paste is to prevent peeling due to the weight of the saturated FRP fabric, and to seal the surface to prevent excessive absorption by the dry concrete surface of the epoxy resin from the saturated FRP fabric. Figure 7b shows the installation of the first roll of FRP lining material at one of the

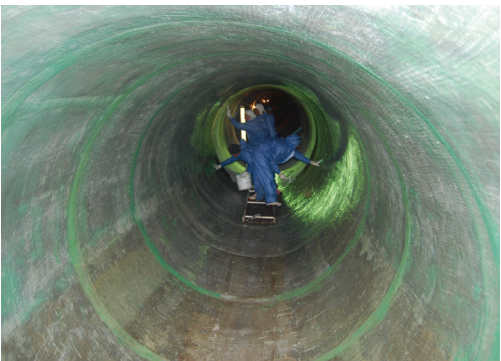
Figure 7(d): Detailing of FRP lining
