Pressure Testing of PipeMedic™ Laminate

Link-Pipe

Mo Ehsani, Ph.D., P.E., S.E.

This report summarizes a test of a PipeMedic™ laminate that was conducted at the offices of Link-Pipe in Richmond Hill, ON.

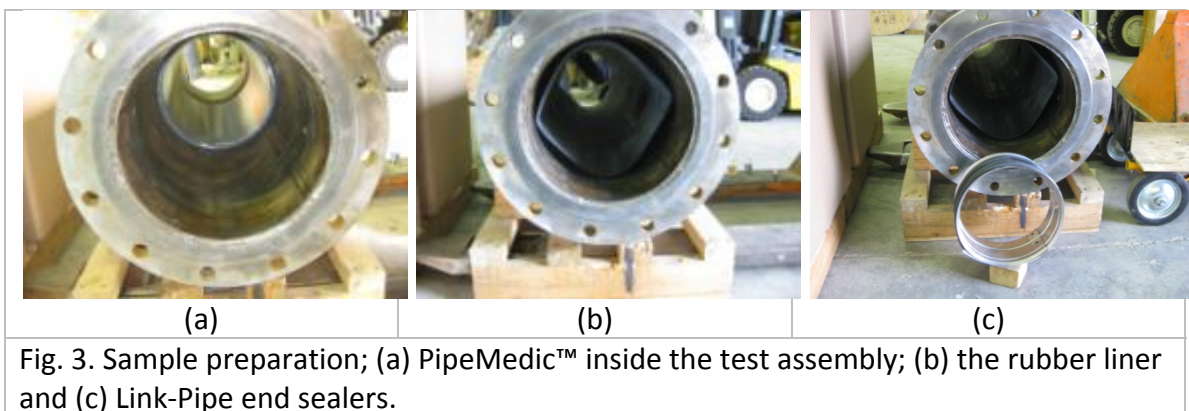
During the assembly of PipeMedic™, a small bulging (buckling) of the laminate developed at one end when the 2-inch wide end support rings were being bonded (Fig. 3a). This was caused by over-tightening of the hose clamps that were used to affix the end support rings to the PipeMedic™. Attempts to fix this were not successful and the defect remained. Additionally, three small areas where the bumps were intentionally introduced along the PipeMedic™ assembly (Figs. 3b and 3c) to simulate the protrusions that may be present in a damaged pipe or a pipe surface that has not been properly prepared or sandblasted.

The PipeMedic™ cylinder was inserted into the pipe. The circular end support rings were lubricated with grease to allow shoving of the PipeMedic™ cylinder into its final position, which was near the midspan of the assembly (Fig. 3a)

A 4-ft long x 12-inch diameter x 1/8-inch thick rubber liner was inserted inside the test assembly (Fig. 3b). At each end of the rubber liner, two strips of

Next, 6-inch wide stainless steel Link-Pipe end sealers were inserted into the ends of the rubber liner (Fig. 3c) and were installed using high pressure air (Figs. 4a and 4b). This arrangement ensured that the ends of the rubber liner were perfectly sealed against the steel pipe and no fluid could get behind the liner. Air or water placed in the assembly would cause the rubber liner to expand and that pressure would in turn be applied to the PipeMedic™ laminate.

It is interesting to note that the final failure of PipeMedic™ was not due to the defects that were introduced during its assembly, namely the buckled portion at one end and the burnt epoxy shown in Fig. 3.

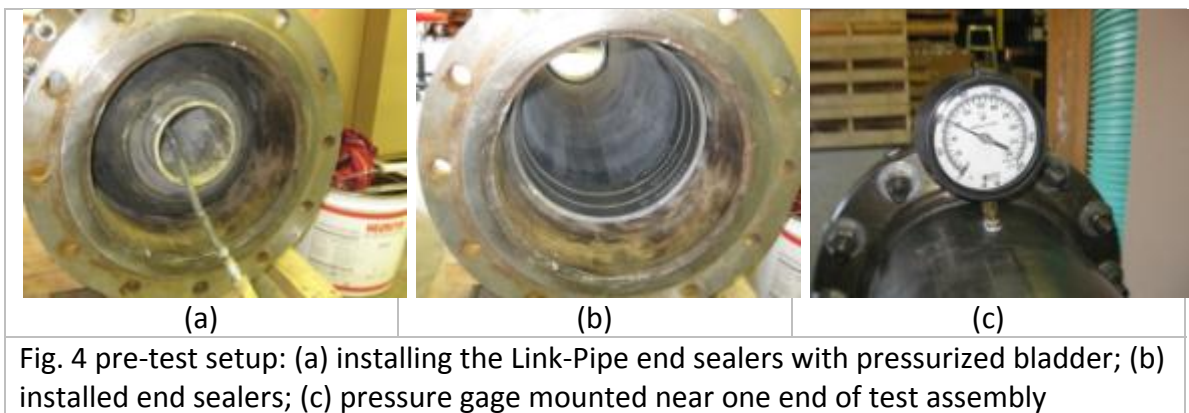
Fig. 4 pre-test setup: (a) installing the Link-Pipe end sealers with pressurized bladder; (b) installed end sealers; (c) pressure gage mounted near one end of test assembly
