Evaluation of Seven Flexible Linings to Determine Suitability as an Alternative to Mortar Lining

PROJECT BACKGROUND

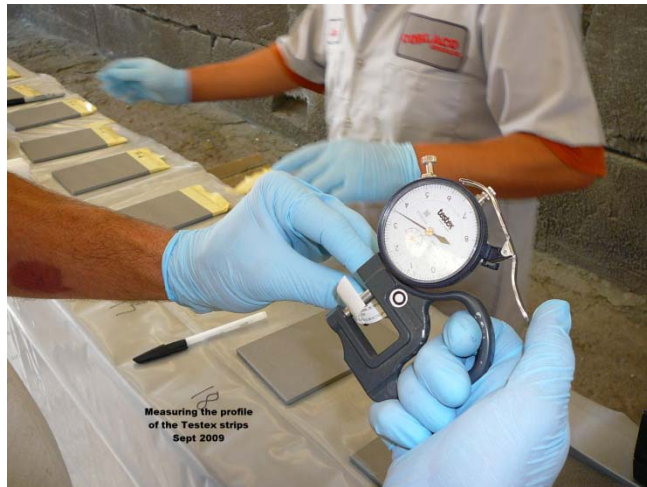
Figure 1 – Replica Tape Testing

At the beginning of each application, the required number of plates were transported to the surface preparation site and abrasive blast cleaned to a White Metal Blast (SSPC-SP 5/NACE No. 1) with a minimum relative peak count (Rpc) of 90 and a 3.25 (± 0.25) mil surface profile depth. Each plate was examined using SSPC VIS 1 and replica tape. (Figure 1) Sample plates from each batch were assessed for relative peak count characteristics (Figure 2). Each plate then received a unique identifier number: an alphabetic identifier to indicate the manufacturer and a “P” or “R,” indicating “Parent” or “Repair” material, respectively.

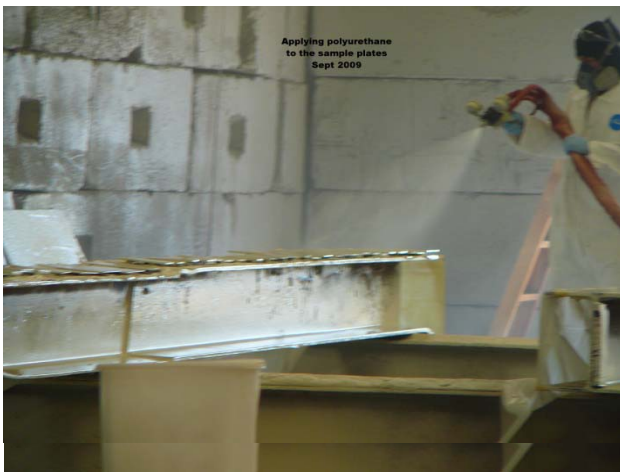
Figure 3 Application

Application of the material was applied by hand spraying, within a temperature-controlled, environmental setting (Figure 3). The coating was allowed to dry prior to

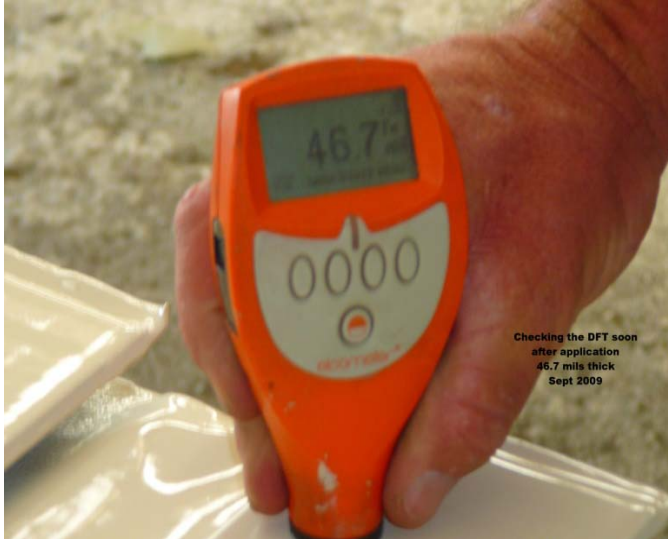
Figure 4 Dry Film Thickness Measurement

Following application of material, each sample was examined to verify that the required dry film thickness had been achieved. Measurements were taken at each corner of the plate, front and back (Figure 4). If the applied thickness deviated by more than 10% of the required thickness, the plate was rejected and a new test plate was prepared and coated. During the application process, two liquid samples of each material being applied was taken from the shipping container or drum. These liquid samples were sealed, labeled and set aside. The liquid samples were included in the shipment to the testing facility. The purpose of the liquid samples was to provide material to be analyzed, utilizing infrared spectrometry analysis, thus identifying the chemical "fingerprint" of the materials. The intent of this testing was to identify, chemically, each material against possible future "formulations" of similar products.

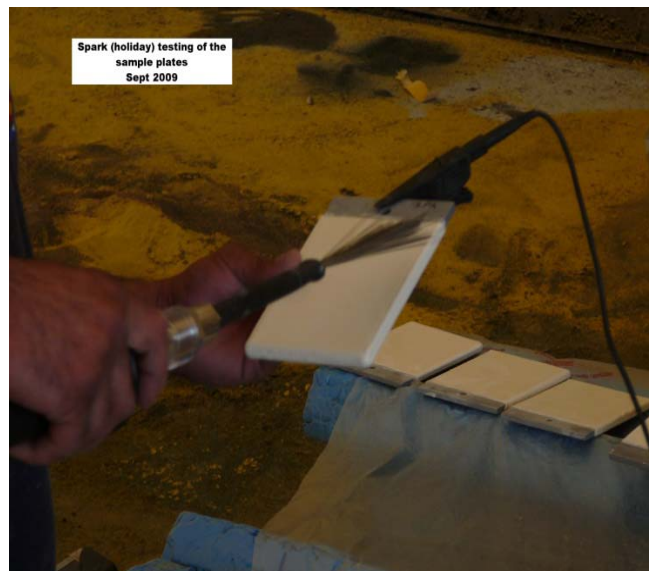
Figure 5 Holiday Testing of Coated Sample Plates

After each sample plate had fully cured, a final visual examination and holiday test (Figure 5) was conducted. The samples were then boxed and shipped to the testing facility. Each material’s test samples, “free films” and Q-plates were shipped “whole” and complete, with no other manufacturer’s material included in the same shipment. This was done to minimize confusion and mixing of samples at the testing facility.

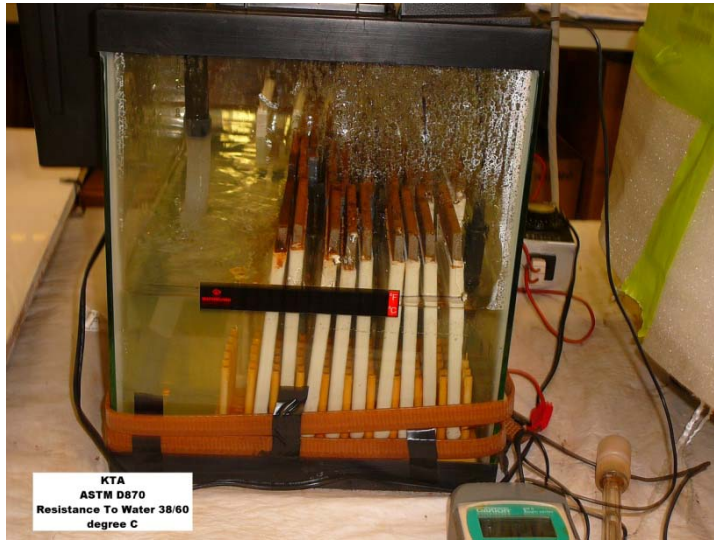
Figure 6 Test 1 Resistance to Water

Test 1, Resistance to Water Immersion (ASTM D 870). Testing involved immersing coated panels in de-ionized water baths at $100^{\circ}\text{F}\pm 2^{\circ}$ ($38^{\circ}\text{C}\pm 2^{\circ}$) and $140^{\circ}\text{F}\pm 2^{\circ}$ ($60^{\circ}\text{C}\pm 2^{\circ}$), with evaluations at 30, 60, 90, 120, and 180 days. (Figure 6).

Test 1A- Resistance to Water Immersion @ 100°F (38°C)	ASTM D87	Base	30 days	60 days	90 days	120 days	150 days	180 days
Parent		PSI						
Poly	min	2361	1115	960	566	694	1347	904
Poly	max	3000	2143	1933	2293	2903	2547	1838
Epoxy	min	2342	2042	1645	1545	1604	2093	1757
Epoxy	max	2951	2275	2209	1917	1924	2102	2141
	avg	2744	1779	1650	1590	1667	1856	1550
Repair								
Epoxy	min	2173	1277	1080	1249	1261	1427	1308
Epoxy	max	2988	2095	2070	1777	1929	2145	1768
Poly	min	2048	1415	1048	1029	865	1246	1391
Poly	max	2386	1661	1419	1347	1109	1593	1442
	avg	2477	1633	1535	1429	1481	1750	1530

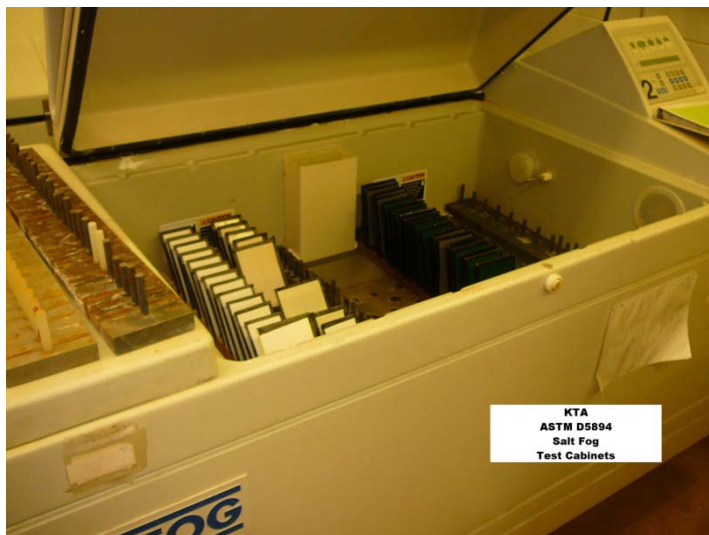
Figure 9 Test 7 Salt Fog Testing

temperatures range between 95°F-140°F (35°C- 60° C). The fog consisted of 0.05% sodium chloride and 0.35% ammonium sulfate. (Figure 9)

Test 7, Cyclic Salt Fog/UV Exposure (ASTM D 5894) was conducted in a cycling salt fog/dry cabinet (Figure 10) and a fluorescent UV/Heat condensation cabinet. The

For Test 7, Cyclic Salt Fog and QUV, there was no effect on the samples after 30 days. After 120 days, one sample showed slight failure, registering 9.9/10.

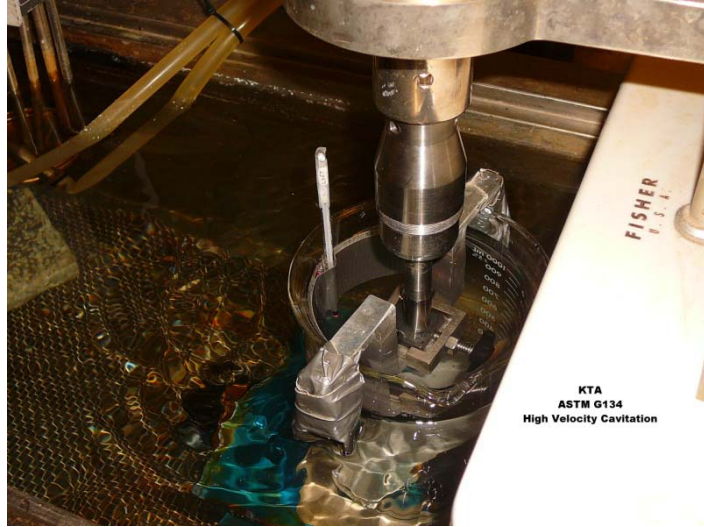
Figure 10 Test 9 Cavitation

Test 9, High Velocity Cavitation (ASTM G 32). The test apparatus utilizes a 500 watt ultrasonic probe, oscillating at 20 kHz. (Figure 10) The erosion rate is determined by calculating the net weight loss after testing.

Test 9 - Cavitation	1 hr	11 hr	24 hr
Parent	Rate of Loss, mg/hr		
BP	2.3	1.1	1.2
KP	2.3	4.6	2.8
QP	1.7	1.2	1.5
LP	0.7	3.2	3.7
TP	5.5	3.6	n/a
JP(E)	11	13.9	n/a
SP(E)	5.5	6.8	n/a
Repair			
BR(E)	5.1	1.6	3.9
KR(E)	8.6	4.7	4.3
QR(E)	4.7	n/a	n/a
JR(E)	18	n/a	n/a
SR(E)	2.4	11.2	10.8
LR	4.2	4.9	6.5
TR	4.8	3.8	n/a
