Transitioning from Leak Detection to Leak Prevention: Proactive Repair of Steel Pipelines Using Fiber Reinforced Polymer (FRP) Composites

Mark Geraghty¹, Anna Pridmore PhD², Julio Sanchez³

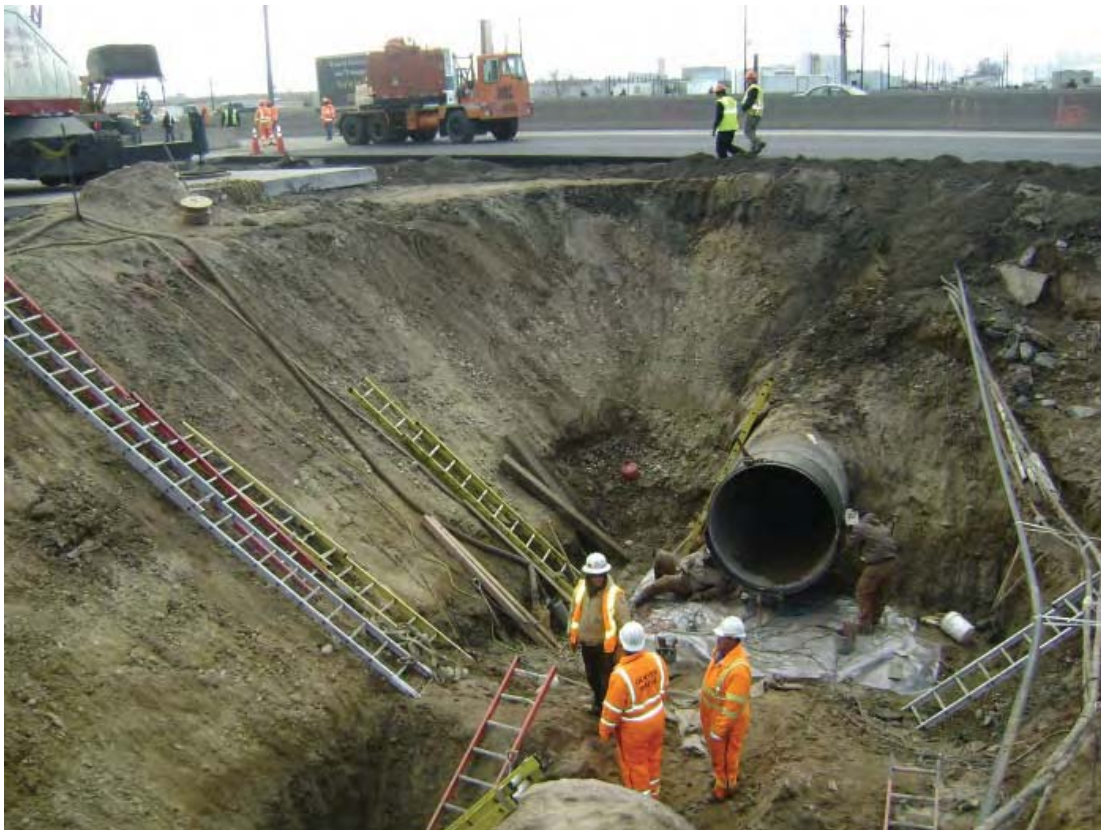
In February 2008, Denver Water experienced a catastrophic failure in a 66-in. diameter section of steel pipe in Conduit 94 because of a pump failure as shown in Figure 1.

Figure 1. Failed pipeline segment for Denver Water (EPA 2009)

The failed section, located near an elbow where the steel pipe transitioned to PCCP, was replaced on an emergency basis with 40 ft of new cement–mortar-lined steel pipe that was procured from the inventory of a local steel pipe manufacturer. The two new sections were 0.307-in. and 0.375-in. thick, which didn't meet the Denver Water Board's specified factor of safety of 2 for the pipeline's design working pressure of 225 psi and surge pressure of 90 psi (Gedalia et al, 2010). Due to the location of the line 15 ft directly underneath the highway, CFRP repair was the only available option to upgrade the pipe. CFRP design considered safety factors for long-term load, short-term load, core crushing, and radial tensile strength. The cement–mortar lining was

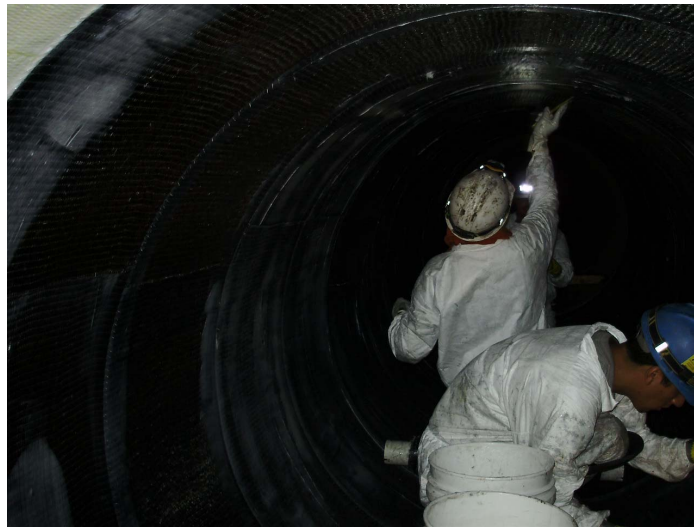
removed, and one longitudinal layer of glass fiber served as a dielectric barrier in order to prevent galvanic corrosion from occurring between the steel and carbon fiber because carbon is conductive. After the installation of the glass layers, the necessary number or layers of carbon fiber fabric were applied in the hoop direction in order to provide the required structural strengthening, as shown in Figure 2. The project was completed in a week during a scheduled maintenance shutdown.

Figure 2. Interior of Denver Water Steel Pipe

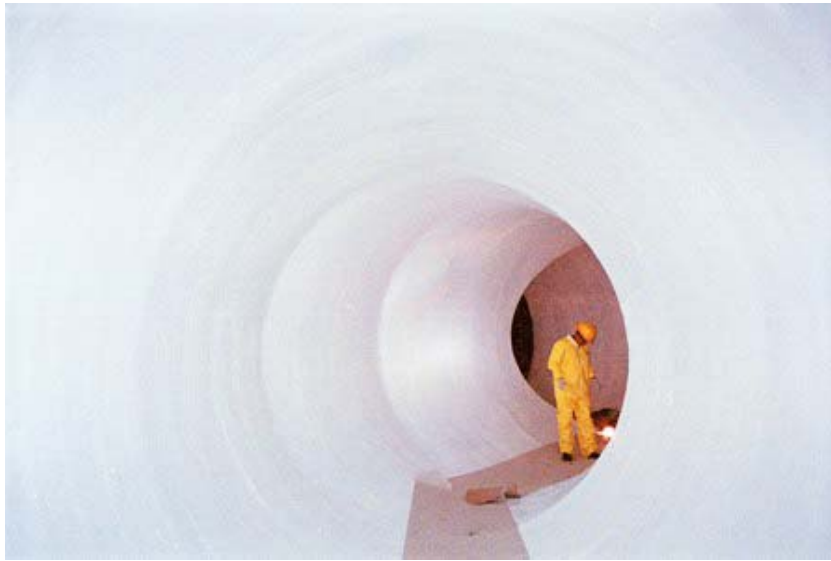
The 120” diameter steel pipe at this power plant was severely rusted due to the corrosive environment. A repair solution was needed that could withstand the harsh environment and be installed with minimal shut down time at the plant. A repair solution was designed using the Tyfo[®] Fibrwrap[®] System. One layer of the Tyfo[®] SEH glass composite system was installed longitudinally in the pipe. The glass composite provided strength in the longitudinal direction and also acted as a dielectric barrier between the steel and the carbon composite. This was followed by the necessary number or layers of the Tyfo[®] SCH carbon composite system in the circumferential direction. A coating of Tyfo[®] PWC was provided, as shown in Figure 3 as a durability coating and to allow for ease of future inspection.

Figure 3. Interior View of Dominion Pipe

Small crews certified to work in confined spaces installed the composite materials during a regularly scheduled shut down window. A unique scaffolding system was designed to allow access to all sides of the pipe at one time. This ensured that the circumferential layer of the composite could be applied continuously around the pipe. The FRP composite solution to this pipe deterioration provided a quick repair technique to repair the deteriorated steel. There was minimal impact on the power plant operations and the solution has held up well in this aggressive environment.
