# North American Society for Trenchless Technology 2008 No-Dig Conference & Exhibition

Dallas, Texas April 27 – May 2, 2008

# **NEW DEVELOPMENTS IN LINER DESIGN DUE TO ATV-M 127-2**

Bernhard Falter<sup>1</sup>

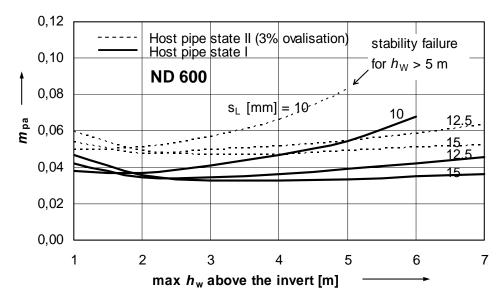
Figure 4. Invert bending moment factors for a lining with ND 600, source: Appendix A4 in M 127-2

The section forces M and N caused by groundwater pressure  $p_a$  are calculated by means of dimensionless factors  $m_{pa}$  and  $n_{pa}$  given in appendix A4 of M 127-2 for the diameters ND 200 - 600, cf. Figure 4.

$$M_{\text{pa}} = m_{\text{pa}} \cdot p_{\text{a}} \cdot r_{\text{L}}^2$$
 with  $m_{\text{pa}}$  due to appendix A4 in Code M 127-2 [2a]

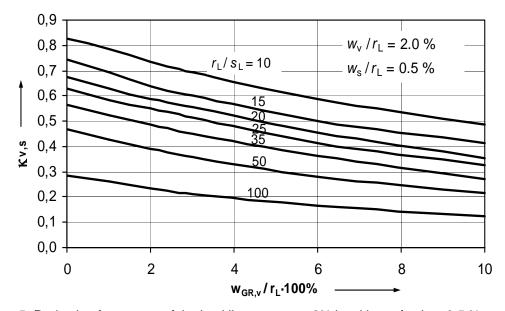
Figure 5. Reduction factors  $\kappa_{v,s}$  of the buckling pressure, 2% local imperfection, 0.5 % annular gap and arbitrary global imperfection (Falter, 2003)

The regular values for most rehabilitation situations with CIPP-liners are 2% local imperfection, 0.5% annular gap and an arbitrary global imperfection. For this constellation only one chart with reduction factors  $\kappa_{vs}$  for the critical pressure is necessary, cf. Figure 5.

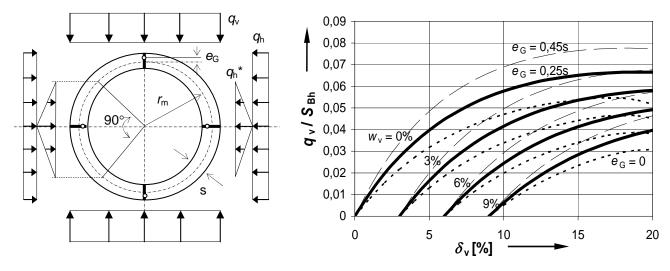
Figure 8. Pipe with longitudinal cracks and soil pressures  $q_v$ ,  $q_h$  and  $q_h^*$  (support)

Figure 9. Load deflection-curves of the pipe soil-system for soil group 1, varying imperfections + hinge excentricities e<sub>G</sub>

In order to prove the host pipe soil-system the equilibrium of a rigid circular ring with four excentric hinges is investigated, cf. Figure 8. For regular cases with elastic soil behaviour the load deflection curve is described by the following equation:

Eq. 4 yields the dimensionsless ratio of the crown loading  $q_v$  and the horizontal bedding stiffness  $S_{\rm Bh}$  of the soil. The equation has been extended for initial deformations and plastic soil behaviour. The resulting load deflection curves show maximum values crit  $q_v$  which are valid for cracked pipes surrounded by soil. In appendix A6 of the Design Code ATV-M 127-2 Eq. 1 has been evaluated for varying soil groups and hinge excentricities, cf. Figure 9.
