### CARBON FRP RETROFIT OF CONCRETE PIPES IN NUCLEAR POWER PLANT

Name: Nuclear Power Plant Type: Industrial Facility Location: Classified/ Confidential Completed: September 1999

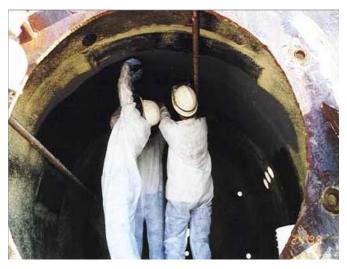
A major Nuclear Power Plant in the U.S. uses 9-ft diameter Prestressed Cylindrical Concrete Pipes (PCCP) to carry water throughout the plant. Inadequate cover concrete caused corrosion of Prestressing cables in many pipes. Replacement of the pipes required significant downtime that was unacceptable to the plant operators.

To minimize downtime, excavation was not desirable, so a repair system had to be designed to repair the concrete pipes from the inside.

QuakeWrap, Inc. developed a very strong biaxial carbon fabric through the PipeWrap<sup>™</sup> division. The FRP fabric was specially designed and manufactured for this project to allow repair of the pipes from inside in record time and to withstand the high internal design pressures.

The nuclear power plant set up field tests of the FRP retrofitted concrete pipe and the tests were stopped when the internal pressure exceeded the original design value. This proved that the FRP repair system could also be used as a strengthening procedure.
